Manhole Inspection Report

Date:	04/11/2018	Weather:		Coding:	RZMACP
MH#:	M-403-009	Owner:	NA	Len. Surveyed:	3.7
P.O.#:		Surveyor:	John Kuglmaier	Rim to Invert:	4.6
Customer:		Cert. #:	U-1215-07002349	Wall Material:	Concrete (reinforced)

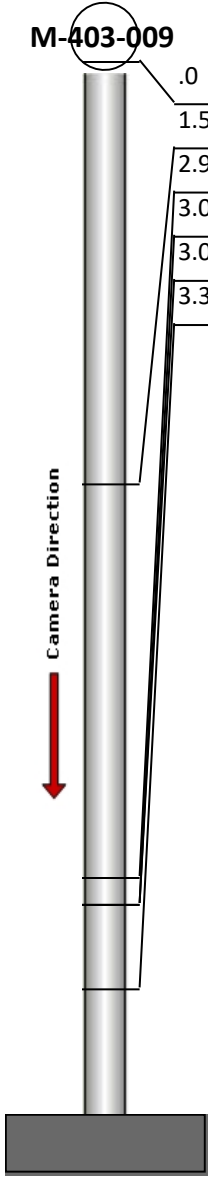
Position	Code	Observation	Video (sec)	Grade

M-403-009				
	.0	MGP	General Photo	10	NA
	1.5	MGP	General Photo	27	NA
	2.9	DAZ	Deposits Attached Other	43	M 3
	3.0	OBB	Obstacle Brick	55	M 2
	3.0	OBB	Obstacle Brick	66	M 2
	3.3	MGO	General Observation	79	NA

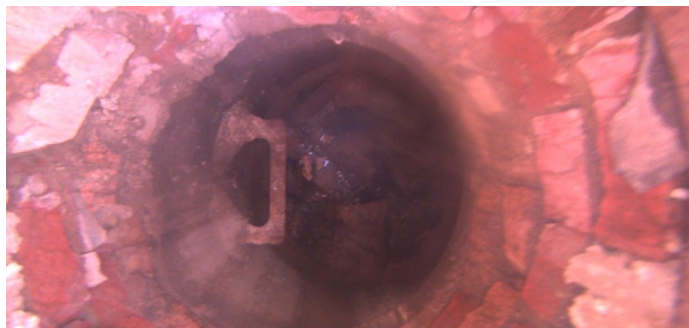
Code: **MGP**
Description: **General Photo**

Distance (ft): **.0**
Structural Grade: **0**
O&M Grade: **0**
Clock Start/From:
Clock To:
1st Value:
2nd Value:
Value Percent:
Step: **NO**
Remarks:

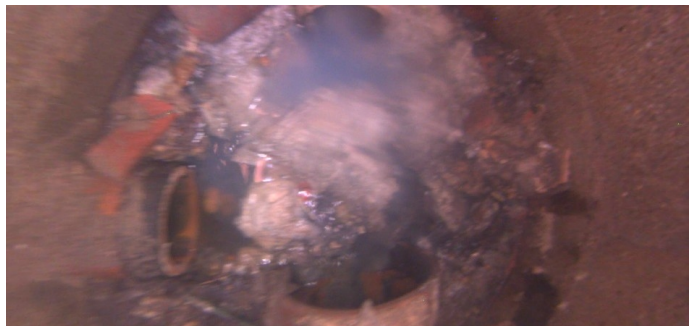
Code: **DAZ**
Description: **Deposits Attached Other**

Distance (ft): **2.9**
Structural Grade: **0**
O&M Grade: **3**
Clock Start/From: **12**
Clock To: **12**
1st Value:
2nd Value:
Value Percent: **15.000**
Step: **NO**
Remarks: **Mixed materials**

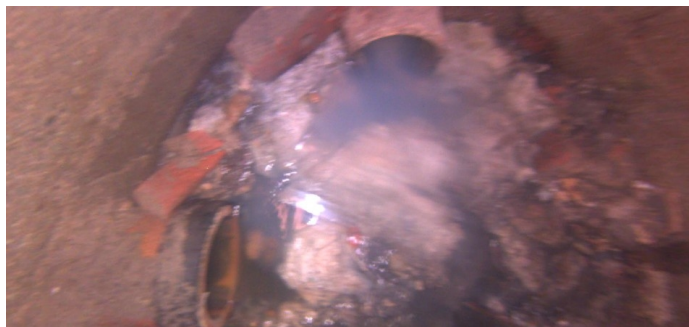
Code: **OBB**
Description: **Obstacle Brick**

Distance (ft): **3.0**
Structural Grade: **0**
O&M Grade: **2**
Clock Start/From: **9**
Clock To: **10**
1st Value:
2nd Value:
Value Percent: **5.000**
Step: **NO**
Remarks:

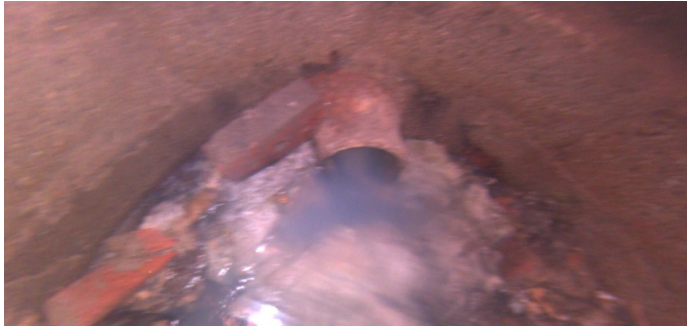
Code: **OBB**
Description: **Obstacle Brick**

Distance (ft): **3.0**
Structural Grade: **0**
O&M Grade: **2**
Clock Start/From: **11**
Clock To:
1st Value:
2nd Value:
Value Percent: **5.000**
Step: **NO**
Remarks:

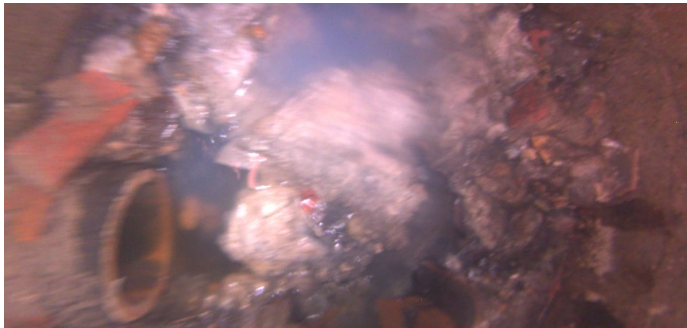
Code: **MGO**
Description: **General Observation**

Distance (ft): **3.3**
Structural Grade: **0**
O&M Grade: **0**
Clock Start/From:
Clock To:
1st Value:
2nd Value:
Value Percent:
Step: **NO**
Remarks: **Ins. Comp.**
