# Manhole Inspection Report

Date:	05/13/2018	Weather:		Coding:	RZMACP
MH#:	M-404-002.1	Owner:	NA	Len. Surveyed:	11.5
P.O.#:		Surveyor:	Jen Costello	Rim to Invert:	11.3
Customer:		Cert. #:	U-907-5518	Wall Material:	Brick

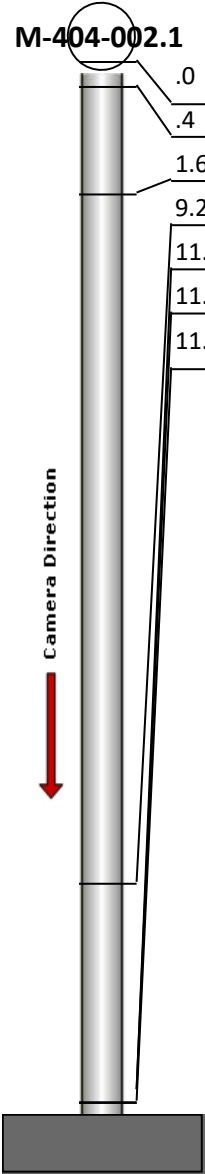
.0	MGO	General Observation	10	NA
	.4	B	Broken	21	S 5
	1.6	MGO	General Observation	36	NA
	9.2	DSF	Deposits Settled Fine	64	M 2
	11.5	RFB	Roots Fine Barrel	81	M 2
	11.5	RFB	Roots Fine Barrel	93	M 2
	11.5	MGO	General Observation	104	NA

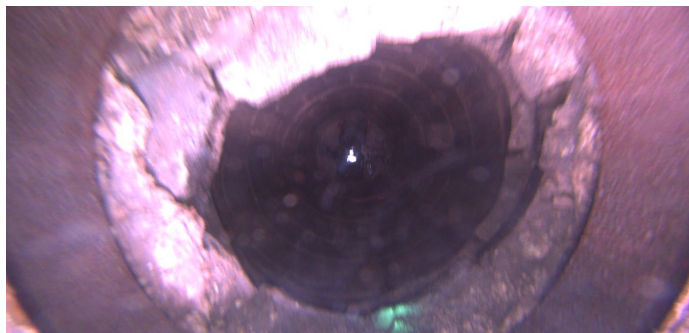
Code: **MGO**  
Description: **General Observation**

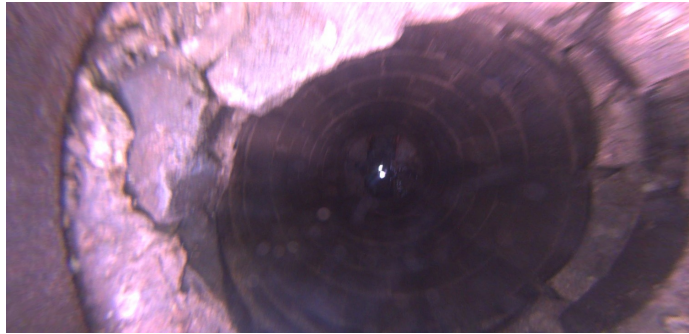
Code: **B**  
Description: **Broken**

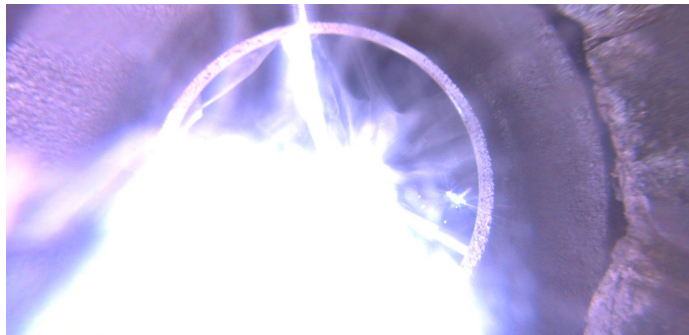
Code: **MGO**  
Description: **General Observation**
