Manhole Inspection Report

| MH#: | M-404-002 | Owner: | NA | Len. Surveyed: | 11.0 |

| Street: | Cleveland Ave. 165' West of Wilson | Project: | Hobart, IN |

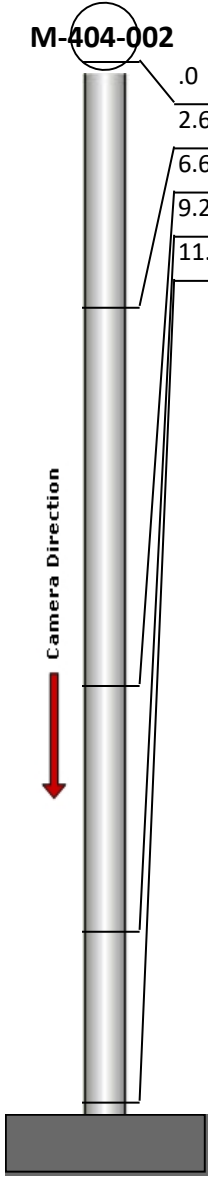
| | Position | Code | Observation | Video (sec) | Grade |
|--|---|---|---|---|---|
| | .0 | MGO | General Observation | 10 | NA |
| | 2.6 | MGO | General Observation | 29 | NA |
| | 6.6 | MGO | General Observation | 50 | NA |
| | 9.2 | DSGV | Deposits Settled Gravel | 67 | M 2 |
| | 11.0 | MGO | General Observation | 82 | NA |

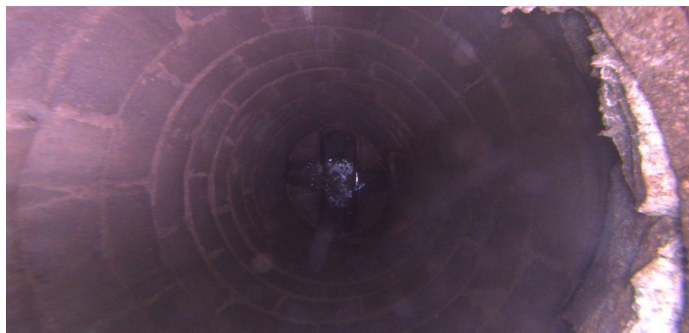
Code: **MGO**
Description: **General Observation**

Distance (ft): **.0**
Structural Grade: **0**
O&M Grade: **0**
Clock Start/From:
Clock To:
1st Value:
2nd Value:
Value Percent:
Step: **NO**
Remarks: **access MH**

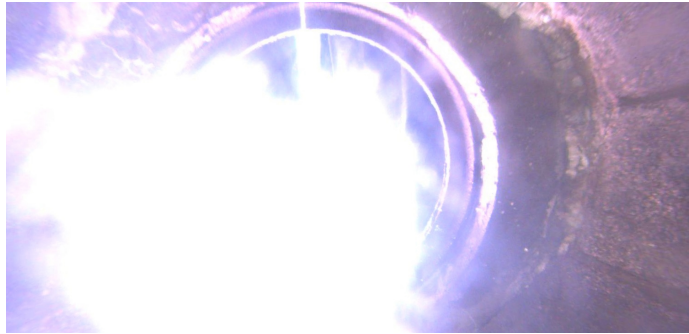
| Description: | General Observation |
| Distance (ft): | 2.6 |
| Remarks: | UNDERSIDE OF FRAME |

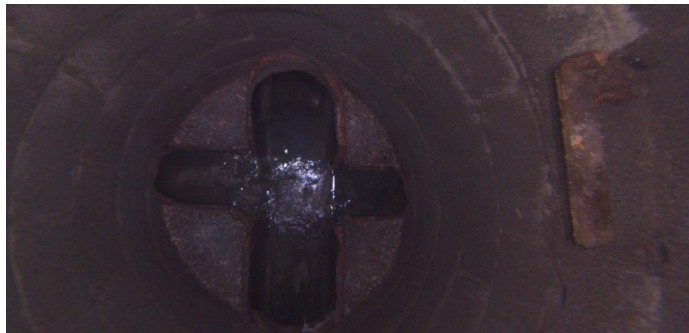
| Distance (ft): | 6.6 |
| Step: | YES |
| Remarks: | MISSING AND BROKEN STEPS |

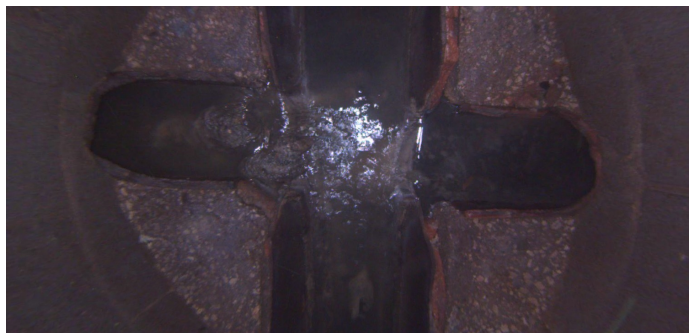
| Description: | Deposits Settled Gravel |
| Distance (ft): | 9.2 |
| O&M Grade: | 2 |
| Clock Start/From: | 12 |
| Value Percent: | 5.000 |

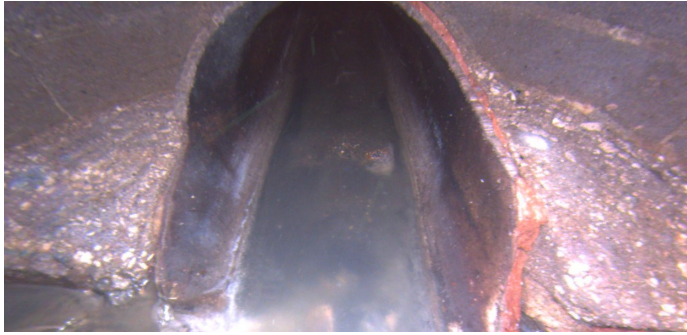
Code: **MGO**
Description: **General Observation**

Distance (ft): **11.0**
Structural Grade: **0**
O&M Grade: **0**
Clock Start/From:
Clock To:
1st Value:
2nd Value:
Value Percent:
Step: **NO**
Remarks: **END SURVEY**
