Manhole Inspection Report

| MH#: | M-404-005 | Owner: | NA | Len. Surveyed: | 12.0 |

| Street: | Home Ave. 168' East of Wabash St. | Project: | Hobart, IN |

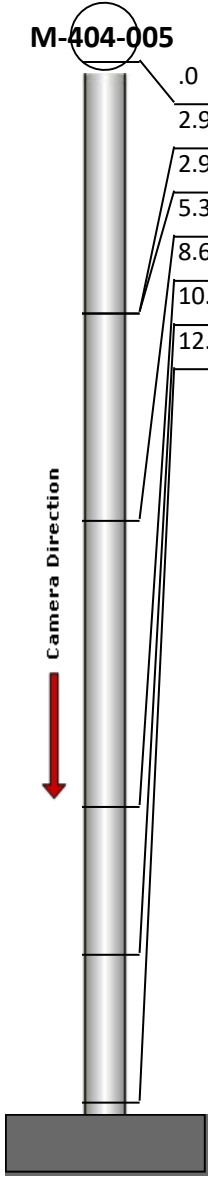
| | Position | Code | Observation | Video (sec) | Grade |
|--|---|---|---|---|---|
| | .0 | MGO | General Observation | 10 | NA |
| | 2.9 | IW | Infil Weeper | 27 | M 2 |
| | 2.9 | MGO | General Observation | 41 | NA |
| | 5.3 | IW | Infil Weeper | 59 | M 2 |
| | 8.6 | IW | Infil Weeper | 78 | M 2 |
| | 10.3 | IW | Infil Weeper | 93 | M 2 |
| | 12.0 | MGO | General Observation | 108 | NA |

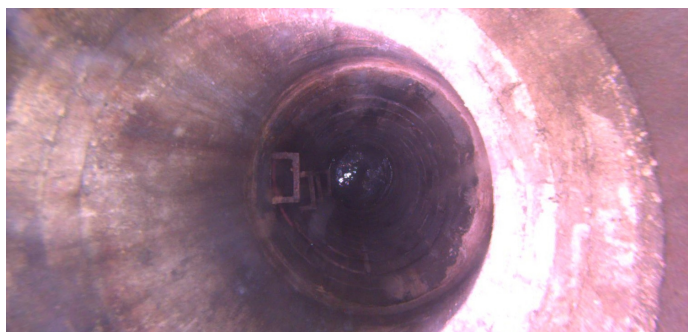
Code: **MGO**
Description: **General Observation**

Distance (ft): **.0**
Structural Grade: **0**
O&M Grade: **0**
Clock Start/From:
Clock To:
1st Value:
2nd Value:
Value Percent:
Step: **NO**
Remarks: **ACCESS MH**

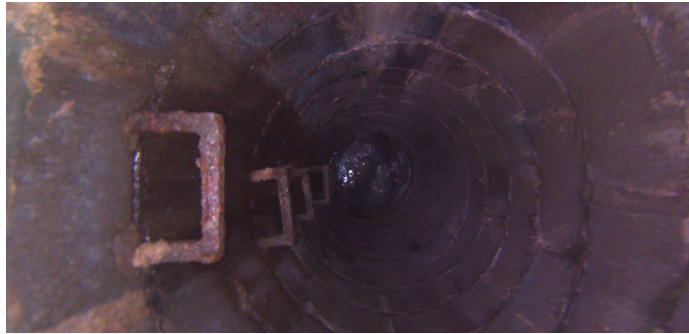
Code: **IW**
Description: **Infil Weeper**

Distance (ft): **2.9**
Structural Grade: **0**
O&M Grade: **2**
Clock Start/From: **8**
Clock To: **10**
1st Value:
2nd Value:
Value Percent:
Step: **NO**
Remarks:

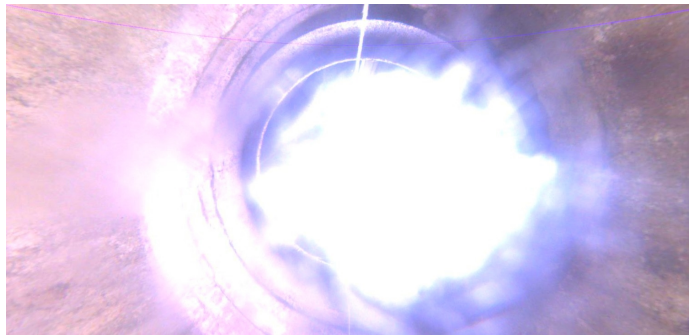
Code: **MGO**
Description: **General Observation**

Distance (ft): **2.9**
Structural Grade: **0**
O&M Grade: **0**
Clock Start/From:
Clock To:
1st Value:
2nd Value:
Value Percent:
Step: **NO**
Remarks: **UNDERSIDE OF FRAME**

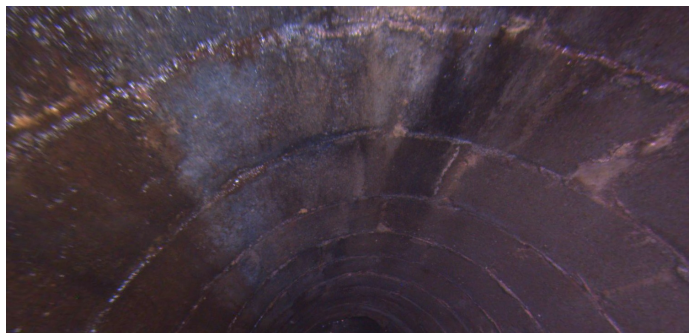
Code: **IW**
Description: **Infil Weeper**

Distance (ft): **5.3**
Structural Grade: **0**
O&M Grade: **2**
Clock Start/From: **12**
Clock To:
1st Value:
2nd Value:
Value Percent:
Step: **NO**
Remarks:

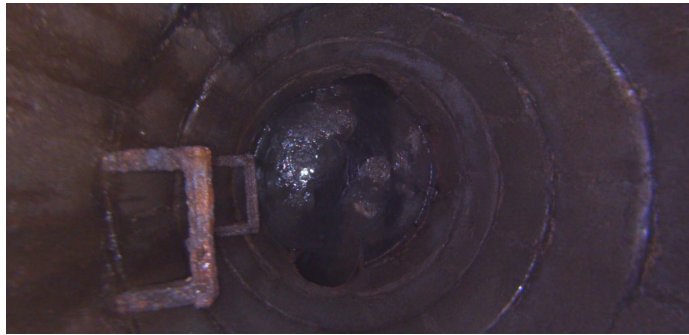
Code: **IW**
Description: **Infil Weeper**

Distance (ft): **8.6**
Structural Grade: **0**
O&M Grade: **2**
Clock Start/From: **8**
Clock To: **11**
1st Value:
2nd Value:
Value Percent:
Step: **NO**
Remarks:

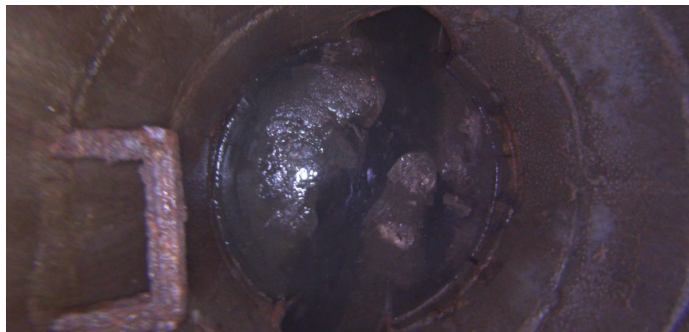
Code: **IW**
Description: **Infil Weeper**

Distance (ft): **10.3**
Structural Grade: **0**
O&M Grade: **2**
Clock Start/From: **8**
Clock To: **10**
1st Value:
2nd Value:
Value Percent:
Step: **NO**
Remarks:

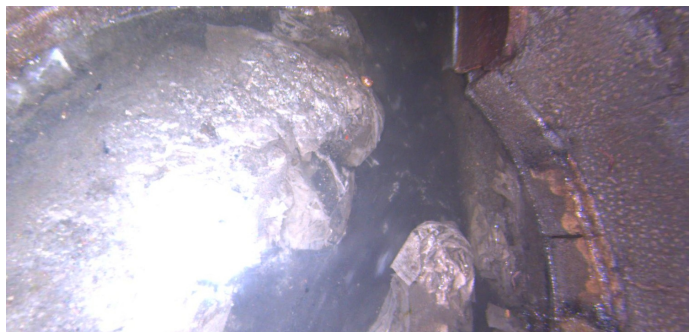
Code: **MGO**
Description: **General Observation**

Distance (ft): **12.0**
Structural Grade: **0**
O&M Grade: **0**
Clock Start/From:
Clock To:
1st Value:
2nd Value:
Value Percent:
Step: **NO**
Remarks: **END SURVEY**
