# Manhole Inspection Report

Date:	05/14/2018	Weather:		Coding:	RZMACP
MH#:	M-404-007	Owner:	NA	Len. Surveyed:	6.2
P.O.#:		Surveyor:	Jen Costello	Rim to Invert:	7.2
Customer:		Cert. #:	U-907-5518	Wall Material:	Concrete (reinforced)

Street:	43rd Ave. 165' East of Wabash St.	Project:	Hobart, IN
City:	Hobart, IN	GPS Northing:	41.54009628
Location:		GPS Easting:	-87.27883148
Drain Area:	West	GPS Accuracy:	Nearest Meter
Cover Shape:	Circular	Evidence of Surcharge:	No
Cover Size:	22.5	Potential for Runoff:	None
Comments:

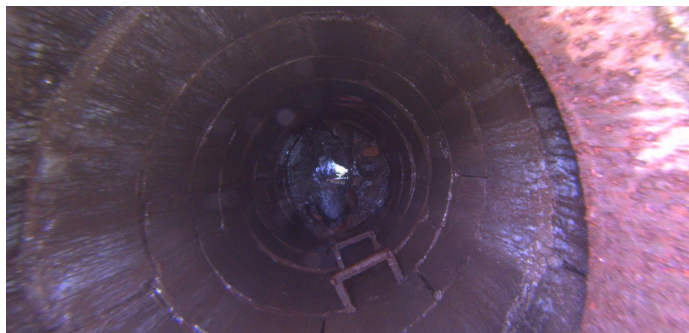
Code: **MGO**  
Description: **General Observation**

Distance (ft): **.0**  
Structural Grade: **0**  
O&M Grade: **0**  
Clock Start/From:  
Clock To:  
1st Value:  
2nd Value:  
Value Percent:  
Step: **NO**  
Remarks: **ACCESS MH**

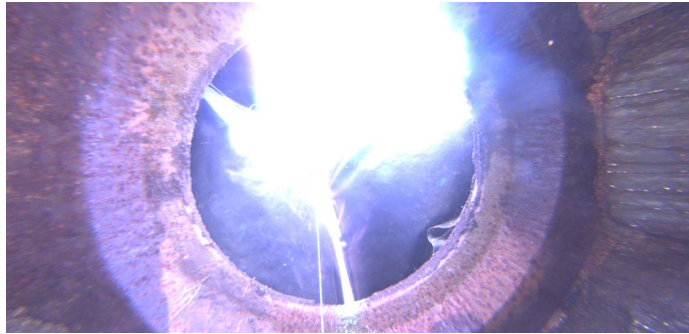
Code:	<b>MGO</b>
Description:	<b>General Observation</b>
Distance (ft):	<b>1.7</b>
Structural Grade:	<b>0</b>
O&M Grade:	<b>0</b>
Clock Start/From:	
Clock To:	
1st Value:	
2nd Value:	
Value Percent:	
Step:	<b>NO</b>
Remarks:	<b>UNDERSIDE OF FRAME</b>

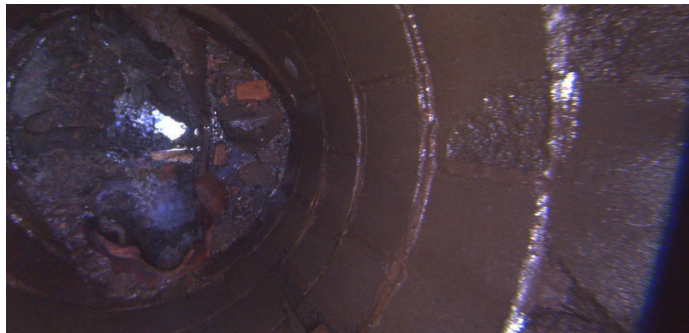
Code:	<b>SSS</b>
Description:	<b>Surface Spalling</b>
Distance (ft):	<b>3.2</b>
Structural Grade:	<b>2</b>
O&M Grade:	<b>0</b>
Clock Start/From:	<b>3</b>
Clock To:	
1st Value:	
2nd Value:	
Value Percent:	
Step:	<b>NO</b>
Remarks:

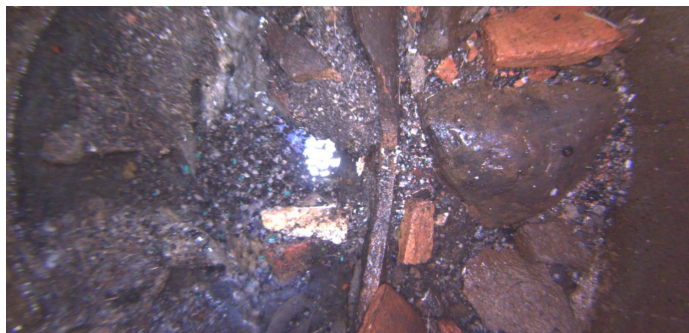
Code:	<b>OBM</b>
Description:	<b>Obstacle Pipe Material</b>
Distance (ft):	<b>6.0</b>
Structural Grade:	<b>0</b>
O&M Grade:	<b>2</b>
Clock Start/From:	<b>12</b>
Clock To:	<b>6</b>
1st Value:	
2nd Value:	
Value Percent:	<b>10.000</b>
Step:	<b>NO</b>
Remarks:

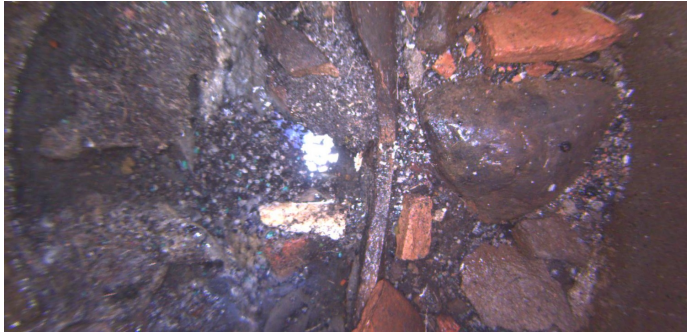
Code:	<b>DSF</b>
Description:	<b>Deposits Settled Fine</b>
Distance (ft):	<b>6.0</b>
Structural Grade:	<b>0</b>
O&M Grade:	<b>5</b>
Clock Start/From:	<b>3</b>
Clock To:	<b>9</b>
1st Value:	
2nd Value:	
Value Percent:	<b>40.000</b>
Step:	<b>NO</b>
Remarks:

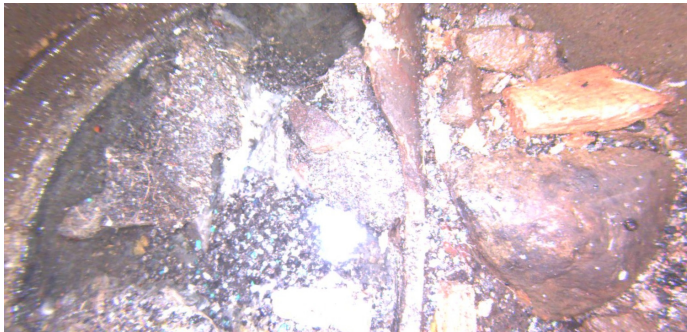
Code:	<b>MGO</b>
Description:	<b>General Observation</b>
Distance (ft):	<b>6.2</b>
Structural Grade:	<b>0</b>
O&M Grade:	<b>0</b>
Clock Start/From:	
Clock To:	
1st Value:	
2nd Value:	
Value Percent:	
Step:	<b>NO</b>
Remarks:	<b>END SURVEY</b>
