Manhole Inspection Report

Date:	10/12/2022	Weather:		Coding:	RZMACP
MH#:	M-404-009	Owner:	NA	Len. Surveyed:	5.0
P.O.#:		Surveyor:	Jen Costello	Rim to Invert:	5.8
Customer:		Cert. #:	U-907-5518	Wall Material:	Concrete (cast in place)

Street:	North of 43rd Ave. 156' East of Wab	Project:	Hobart, IN
City:	Hobart, IN	GPS Northing:	2292027.377
Location:	Alley	GPS Easting:	2899206.645
Drain Area:	West	GPS Accuracy:	Sub-Meter
Cover Shape:	Circular	Evidence of Surcharge:	No
Cover Size:	24.0	Potential for Runoff:	None
Comments:

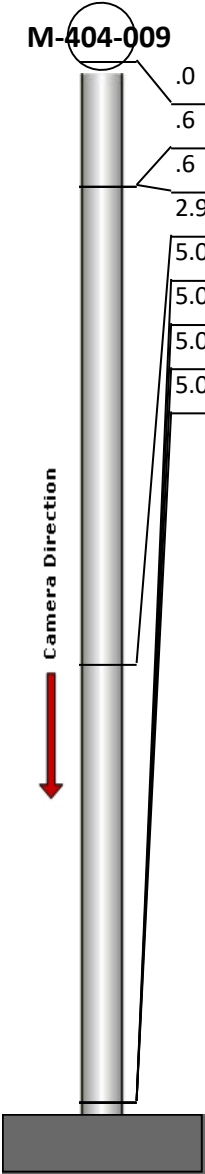
Position	Code	Observation	Video (sec)	Grade
M-404-009

.0	MGO	General Observation	10	NA
	.6	MMC	Material Change	23	NA
	.6	SAV	Surface Aggregate Visible	34	S 3
	2.9	MGO	General Observation	52	NA
	5.0	DSF	Deposits Settled Fine	70	M 2
	5.0	SAV	Surface Aggregate Visible	81	S 3
	5.0	MGO	General Observation	93	NA
	5.0	DSF	Deposits Settled Fine	104	M 3

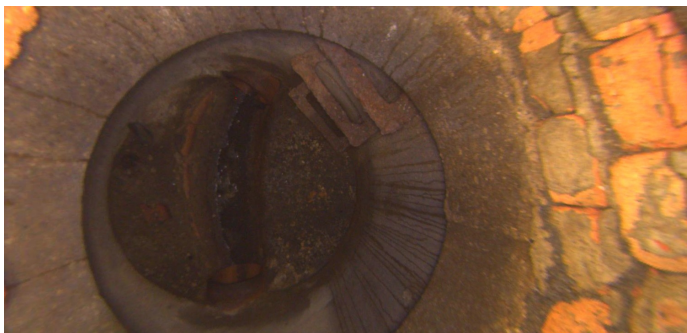
Code: **MGO**
Description: **General Observation**

Distance (ft): **.0**
Structural Grade: **0**
O&M Grade: **0**
Clock Start/From:
Clock To:
1st Value:
2nd Value:
Value Percent:
Step: **NO**
Remarks: **access mh**

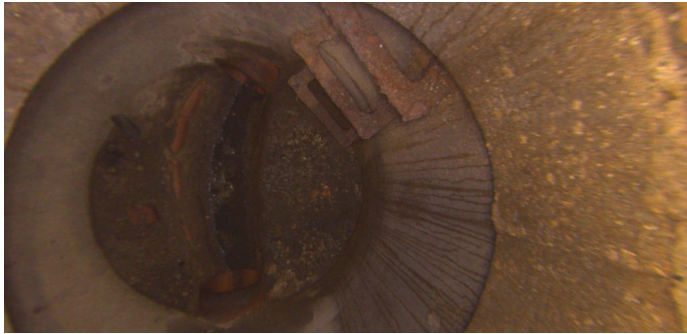
Code: **MMC**
Description: **Material Change**

Distance (ft): **.6**
Structural Grade: **0**
O&M Grade: **0**
Clock Start/From:
Clock To:
1st Value:
2nd Value:
Value Percent:
Step: **NO**
Remarks: **concrete**

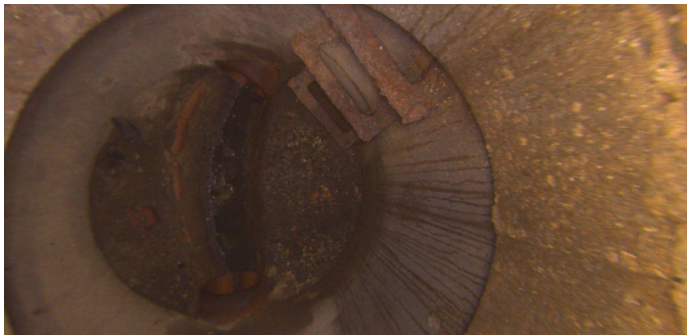
Code: **SAV**
Description: **Surface Aggregate Visible**

Distance (ft): **.6**
Structural Grade: **3**
O&M Grade: **0**
Clock Start/From: **12**
Clock To: **12**
1st Value:
2nd Value:
Value Percent:
Step: **NO**
Remarks:

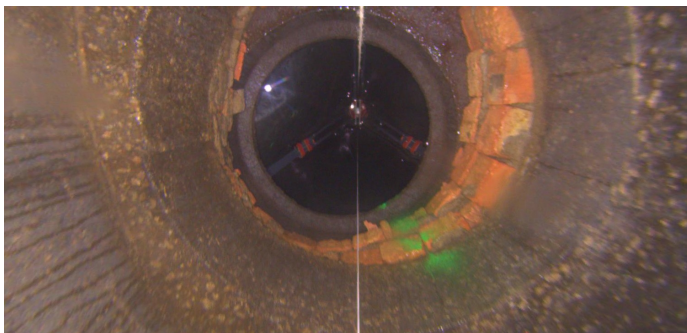
Code: **MGO**
Description: **General Observation**

Distance (ft): **2.9**
Structural Grade: **0**
O&M Grade: **0**
Clock Start/From:
Clock To:
1st Value:
2nd Value:
Value Percent:
Step: **NO**
Remarks: **underside of frame**

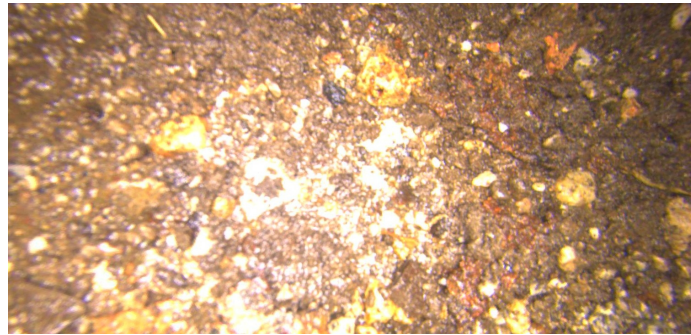
Code: **DSF**
Description: **Deposits Settled Fine**

Distance (ft): **5.0**
Structural Grade: **0**
O&M Grade: **2**
Clock Start/From: **12**
Clock To: **12**
1st Value:
2nd Value:
Value Percent: **5.000**
Step: **NO**
Remarks:

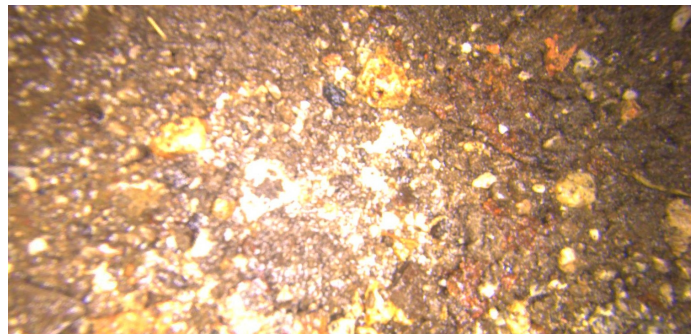
Code: **SAV**
Description: **Surface Aggregate Visible**

Distance (ft): **5.0**
Structural Grade: **3**
O&M Grade: **0**
Clock Start/From: **12**
Clock To: **12**
1st Value:
2nd Value:
Value Percent:
Step: **NO**
Remarks:

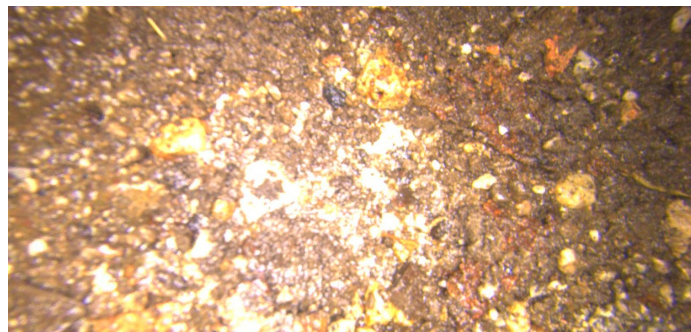
Code: **MGO**
Description: **General Observation**

Distance (ft): **5.0**
Structural Grade: **0**
O&M Grade: **0**
Clock Start/From:
Clock To:
1st Value:
2nd Value:
Value Percent:
Step: **NO**
Remarks: **end of survey**

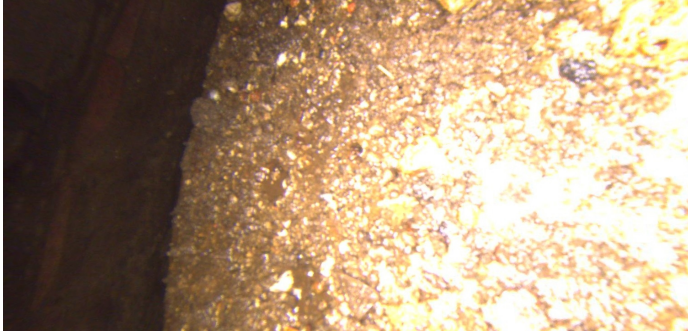
Code:	DSF
Description:	Deposits Settled Fine
Distance (ft):	5.0
Structural Grade:	0
O&M Grade:	3
Clock Start/From:	4
Clock To:	8
1st Value:	
2nd Value:	
Value Percent:	20.000
Step:	NO
Remarks:
