# Manhole Inspection Report

Date:	05/14/2018	Weather:		Coding:	RZMACP
MH#:	M-404-010	Owner:	NA	Len. Surveyed:	5.5
P.O.#:		Surveyor:	Jen Costello	Rim to Invert:	5.5
Customer:		Cert. #:	U-907-5518	Wall Material:	Concrete (reinforced)

Street:	Wabash St. 176' South of Old Ridge	Project:	Hobart, IN
City:	Hobart, IN	GPS Northing:	41.54064941
Location:		GPS Easting:	-87.27888489
Drain Area:	West	GPS Accuracy:	Nearest Meter
Cover Shape:	Circular	Evidence of Surcharge:	No
Cover Size:	22.5	Potential for Runoff:	None
Comments:

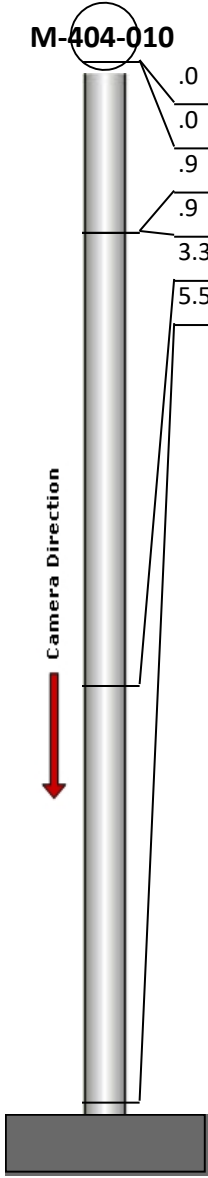
.0	MGO	General Observation	10	NA
	.0	DB	Displaced Brick	21	S 3
	.9	CL	Crack Longitudinal	35	S 2
	.9	SRI	Surface Roughness Increased	46	S 1
	3.3	DSGV	Deposits Settled Gravel	63	M 2
	5.5	MGO	General Observation	79	NA

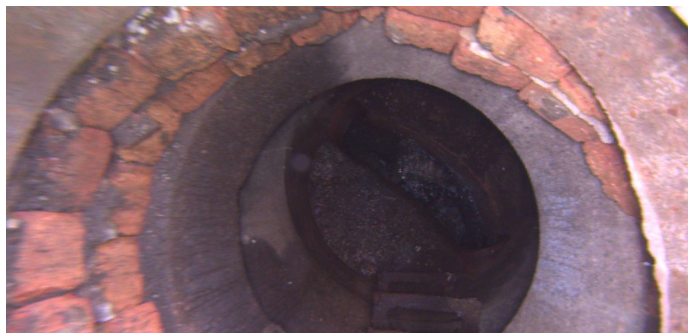
Code: **MGO**  
Description: **General Observation**

Distance (ft): **.0**  
Structural Grade: **0**  
O&M Grade: **0**  
Clock Start/From:  
Clock To:  
1st Value:  
2nd Value:  
Value Percent:  
Step: **NO**  
Remarks: **ACCESS MH**

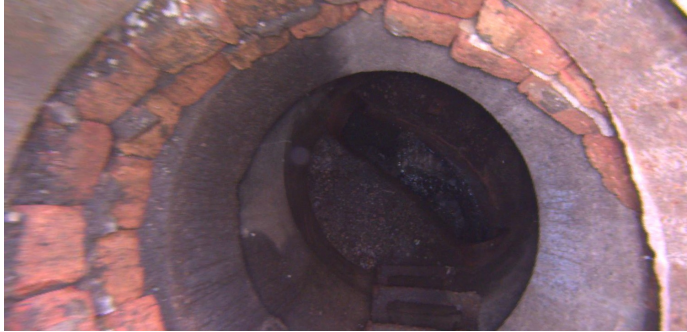
Code: **DB**  
Description: **Displaced Brick**

Distance (ft): **.0**  
Structural Grade: **3**  
O&M Grade: **0**  
Clock Start/From: **10**  
Clock To: **2**  
1st Value:  
2nd Value:  
Value Percent:  
Step: **NO**  
Remarks:

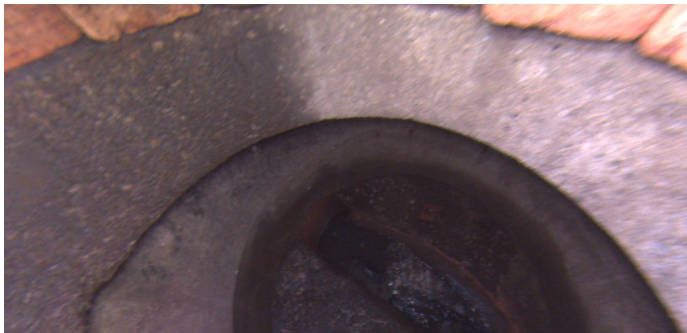
Code: **CL**  
Description: **Crack Longitudinal**

Distance (ft): **.9**  
Structural Grade: **2**  
O&M Grade: **0**  
Clock Start/From: **11**  
Clock To:  
1st Value:  
2nd Value:  
Value Percent:  
Step: **NO**  
Remarks:

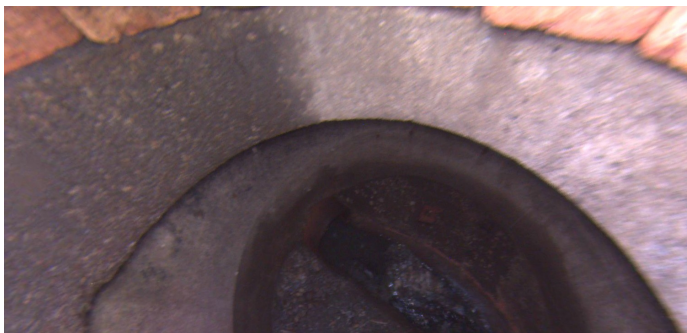
Code: **SRI**  
Description: **Surface Roughness Increased**

Distance (ft): **.9**  
Structural Grade: **1**  
O&M Grade: **0**  
Clock Start/From: **12**  
Clock To: **12**  
1st Value:  
2nd Value:  
Value Percent:  
Step: **NO**  
Remarks:

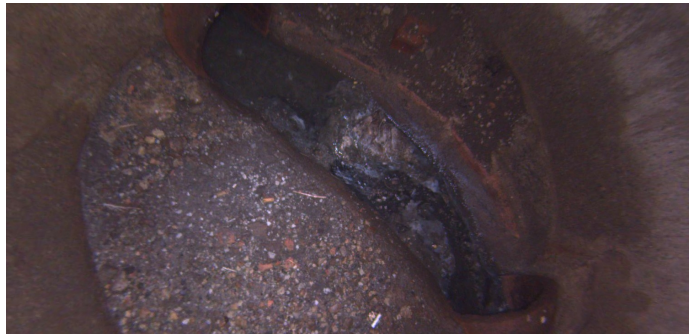
Code:	<b>DSGV</b>
Description:	<b>Deposits Settled Gravel</b>
Distance (ft):	<b>3.3</b>
Structural Grade:	<b>0</b>
O&M Grade:	<b>2</b>
Clock Start/From:	<b>12</b>
Clock To:	<b>12</b>
1st Value:	
2nd Value:	
Value Percent:	<b>5.000</b>
Step:	<b>NO</b>
Remarks:

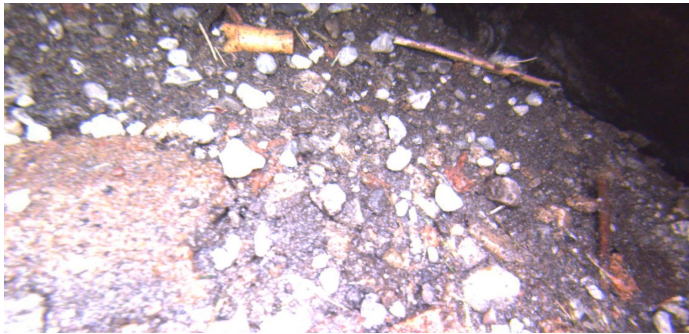
Code:	<b>MGO</b>
Description:	<b>General Observation</b>
Distance (ft):	<b>5.5</b>
Structural Grade:	<b>0</b>
O&M Grade:	<b>0</b>
Clock Start/From:	
Clock To:	
1st Value:	
2nd Value:	
Value Percent:	
Step:	<b>NO</b>
Remarks:	<b>END SURVEY</b>
