Manhole Inspection Report

Date:	05/14/2018	Weather:		Coding:	RZMACP
MH#:	M-404-011	Owner:	NA	Len. Surveyed:	4.7
P.O.#:		Surveyor:	Jen Costello	Rim to Invert:	5.2
Customer:		Cert. #:	U-907-5518	Wall Material:	Concrete (reinforced)

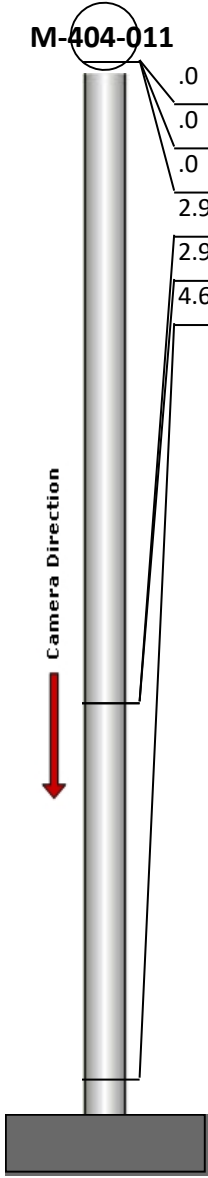
.0	MGO	General Observation	10	NA
	.0	SAV	Surface Aggregate Visible	22	S 3
	.0	RFJ	Roots Fine Joint	33	M 1
	2.9	OBP	Obstacle External Pipe or Cable	51	M 2
	2.9	DSF	Deposits Settled Fine	63	M 2
	4.6	MGO	General Observation	78	NA

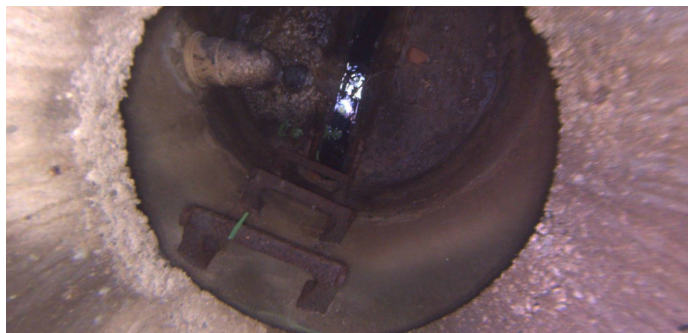
Code: **MGO**
Description: **General Observation**

Distance (ft): **.0**
Structural Grade: **0**
O&M Grade: **0**
Clock Start/From:
Clock To:
1st Value:
2nd Value:
Value Percent:
Step: **NO**
Remarks: **ACCESS MH**

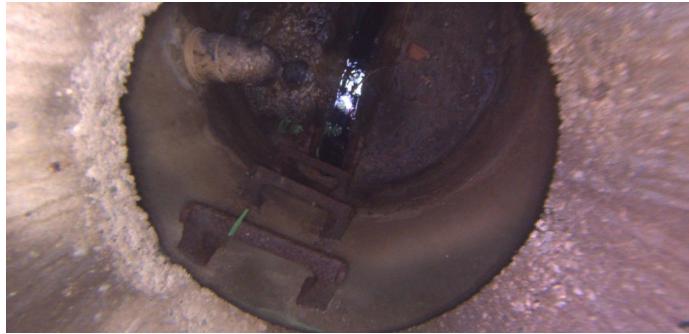
Code: **SAV**
Description: **Surface Aggregate Visible**

Distance (ft): **.0**
Structural Grade: **3**
O&M Grade: **0**
Clock Start/From: **12**
Clock To: **12**
1st Value:
2nd Value:
Value Percent:
Step: **NO**
Remarks:

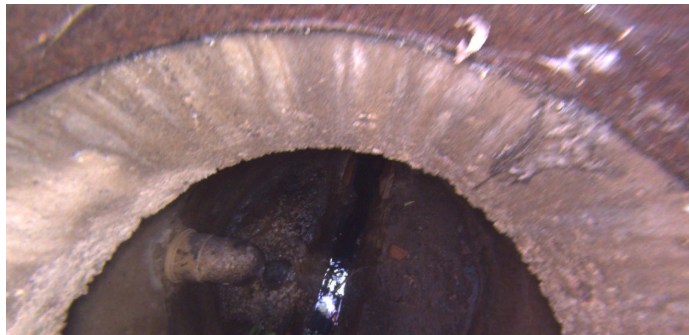
Code: **RFJ**
Description: **Roots Fine Joint**

Distance (ft): **.0**
Structural Grade: **0**
O&M Grade: **1**
Clock Start/From: **1**
Clock To:
1st Value:
2nd Value:
Value Percent:
Step: **NO**
Remarks:

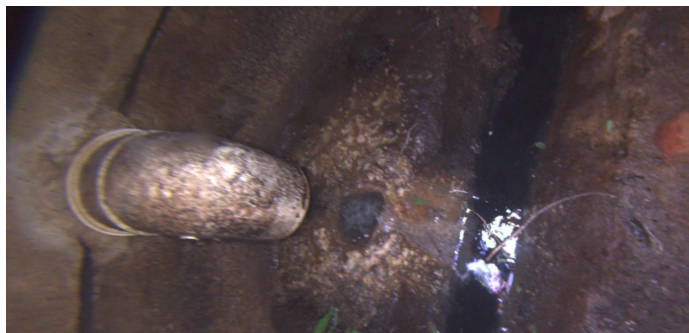
Code: **OBP**
Description: **Obstacle External Pipe or Cable**

Distance (ft): **2.9**
Structural Grade: **0**
O&M Grade: **2**
Clock Start/From: **9**
Clock To:
1st Value:
2nd Value:
Value Percent: **10.000**
Step: **NO**
Remarks:

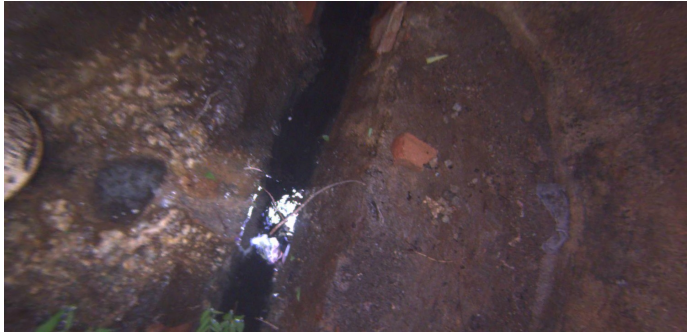
Code:	DSF
Description:	Deposits Settled Fine
Distance (ft):	2.9
Structural Grade:	0
O&M Grade:	2
Clock Start/From:	12
Clock To:	12
1st Value:	
2nd Value:	
Value Percent:	5.000
Step:	NO
Remarks:

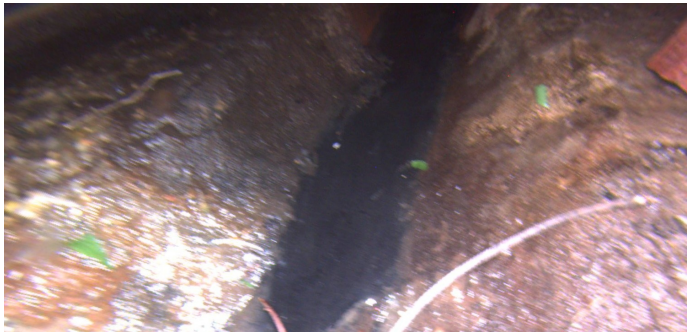
Code:	MGO
Description:	General Observation
Distance (ft):	4.6
Structural Grade:	0
O&M Grade:	0
Clock Start/From:	
Clock To:	
1st Value:	
2nd Value:	
Value Percent:	
Step:	NO
Remarks:	END SURVEY
