# Manhole Inspection Report

Date:	05/14/2018	Weather:		Coding:	RZMACP
MH#:	M-404-012	Owner:	NA	Len. Surveyed:	3.7
P.O.#:		Surveyor:	Jen Costello	Rim to Invert:	.0
Customer:		Cert. #:	U-907-5518	Wall Material:	Concrete (reinforced)

**M-404-012**

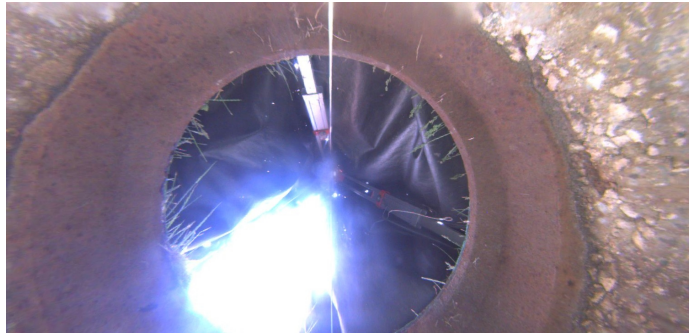
Code:	<b>MGO</b>
Description:	<b>General Observation</b>
Distance (ft):	<b>1.4</b>
Structural Grade:	<b>0</b>
O&M Grade:	<b>0</b>
Clock Start/From:	
Clock To:	
1st Value:	
2nd Value:	
Value Percent:	
Step:	<b>NO</b>
Remarks:	<b>UNDERSIDE OF FRAME</b>

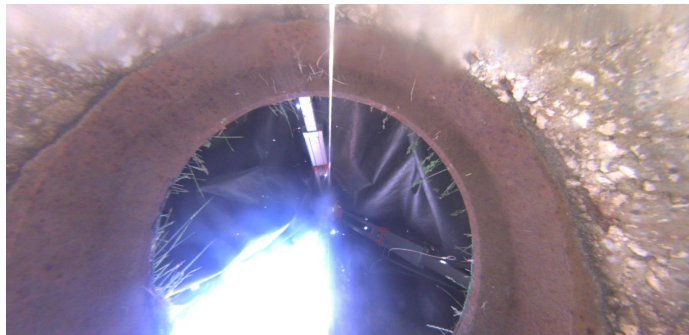
Code:	<b>SAP</b>
Description:	<b>Surface Aggregate Projecting</b>
Distance (ft):	<b>1.4</b>
Structural Grade:	<b>3</b>
O&M Grade:	<b>0</b>
Clock Start/From:	<b>12</b>
Clock To:	<b>12</b>
1st Value:	
2nd Value:	
Value Percent:	
Step:	<b>NO</b>
Remarks:

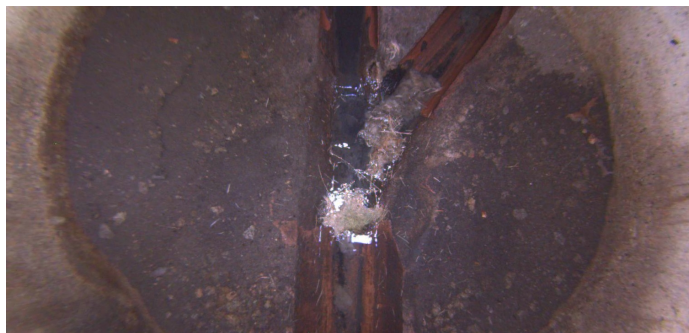
Code:	<b>DSF</b>
Description:	<b>Deposits Settled Fine</b>
Distance (ft):	<b>1.4</b>
Structural Grade:	<b>0</b>
O&M Grade:	<b>2</b>
Clock Start/From:	<b>12</b>
Clock To:	<b>12</b>
1st Value:	
2nd Value:	
Value Percent:	<b>5.000</b>
Step:	<b>NO</b>
Remarks:

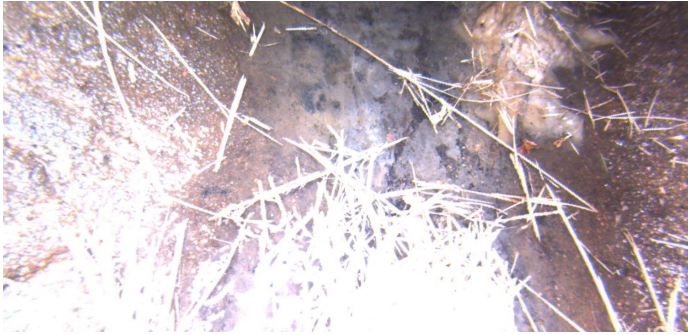
Code: **MGO**  
Description: **General Observation**

Distance (ft): **3.7**  
Structural Grade: **0**  
O&M Grade: **0**  
Clock Start/From:  
Clock To:  
1st Value:  
2nd Value:  
Value Percent:  
Step: **NO**  
Remarks: **END SURVEY**
