Manhole Inspection Report

Date:	05/15/2018	Weather:		Coding:	RZMACP
MH#:	M-404-019	Owner:	NA	Len. Surveyed:	2.6
P.O.#:		Surveyor:	Jen Costello	Rim to Invert:	3.5
Customer:		Cert. #:	U-907-5518	Wall Material:	Concrete (reinforced)

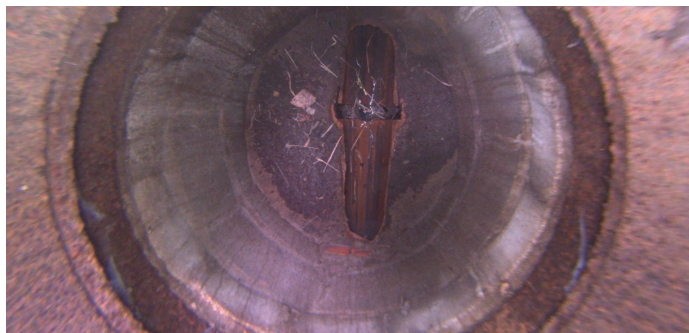
Code: **MGO**
Description: **General Observation**

Distance (ft): **.0**
Structural Grade: **0**
O&M Grade: **0**
Clock Start/From:
Clock To:
1st Value:
2nd Value:
Value Percent:
Step: **NO**
Remarks: **ACCESS MH**

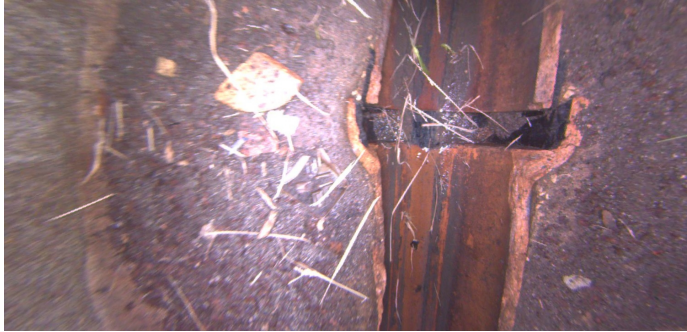
Code: **DSF**
Description: **Deposits Settled Fine**

Distance (ft): **2.1**
Structural Grade: **0**
O&M Grade: **2**
Clock Start/From: **12**
Clock To: **12**
1st Value:
2nd Value:
Value Percent: **5.000**
Step: **NO**
Remarks:

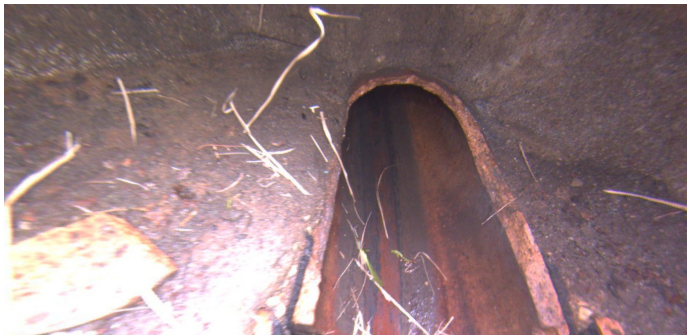
Code: **MGO**
Description: **General Observation**

Distance (ft): **2.6**
Structural Grade: **0**
O&M Grade: **0**
Clock Start/From:
Clock To:
1st Value:
2nd Value:
Value Percent:
Step: **NO**
Remarks: **END SURVEY**
