Manhole Inspection Report

Date:	05/14/2018	Weather:		Coding:	RZMACP
MH#:	M-404-028.1	Owner:	NA	Len. Surveyed:	6.2
P.O.#:		Surveyor:	Jen Costello	Rim to Invert:	8.2
Customer:		Cert. #:	U-907-5518	Wall Material:	Concrete (reinforced)

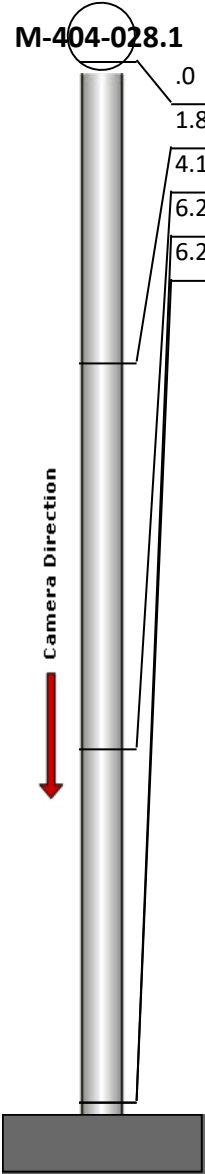
Position	Code	Observation	Video (sec)	Grade

.0	MGO	General Observation	10	NA
	1.8	MGO	General Observation	27	NA
	4.1	IW	Infil Weeper	45	M 2
	6.2	OBP	Obstacle External Pipe or Cable	61	M 5
	6.2	MSA	Abandoned Survey	72	NA

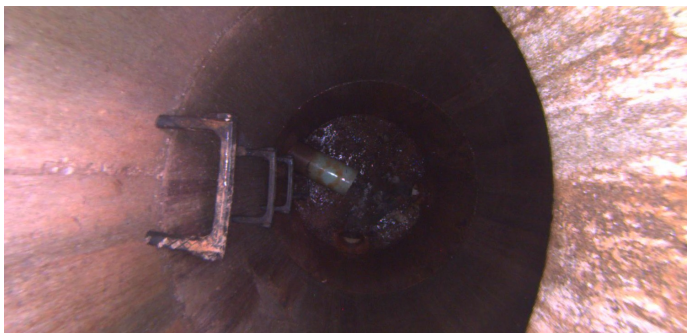
Code: **MGO**
Description: **General Observation**

Distance (ft): **.0**
Structural Grade: **0**
O&M Grade: **0**
Clock Start/From:
Clock To:
1st Value:
2nd Value:
Value Percent:
Step: **NO**
Remarks: **ACCESS MH**

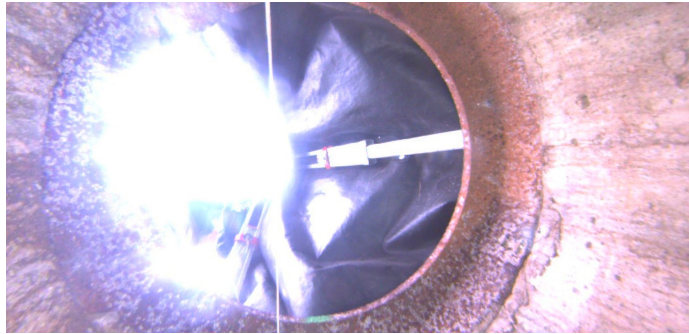
Code:	MGO
Description:	General Observation
Distance (ft):	1.8
Structural Grade:	0
O&M Grade:	0
Clock Start/From:	
Clock To:	
1st Value:	
2nd Value:	
Value Percent:	
Step:	NO
Remarks:	UNDERSIDE OF FRAME

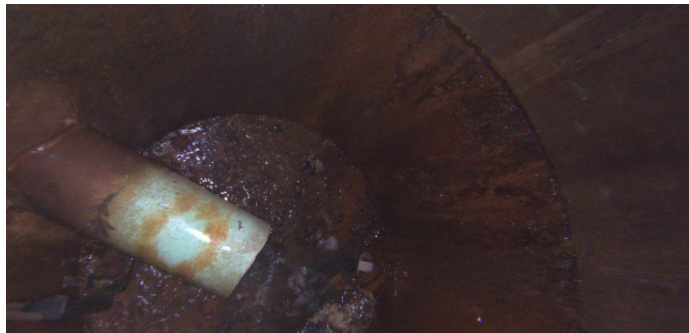
Code:	IW
Description:	Infil Weeper
Distance (ft):	4.1
Structural Grade:	0
O&M Grade:	2
Clock Start/From:	12
Clock To:	12
1st Value:	
2nd Value:	
Value Percent:	
Step:	NO
Remarks:

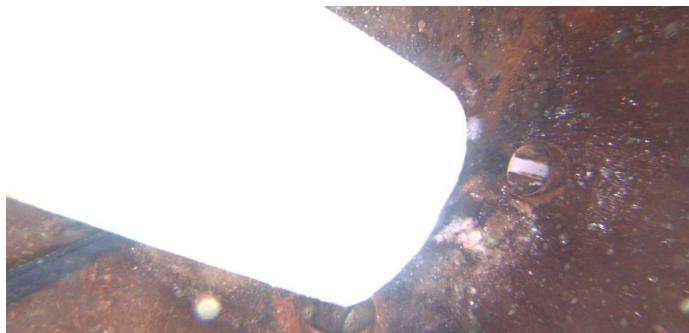
Code:	OBP
Description:	Obstacle External Pipe or Cable
Distance (ft):	6.2
Structural Grade:	0
O&M Grade:	5
Clock Start/From:	9
Clock To:	10
1st Value:	
2nd Value:	
Value Percent:	50.000
Step:	NO
Remarks:

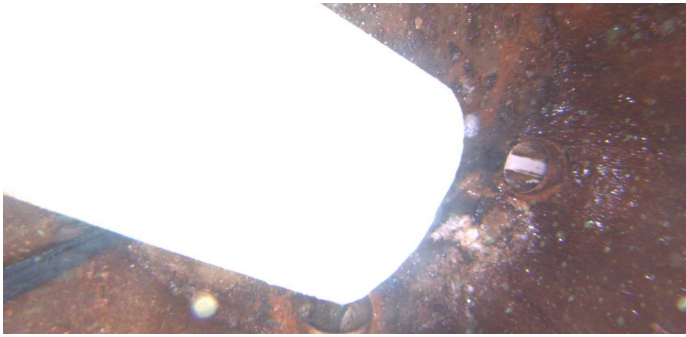
Code:	MSA
Description:	Abandoned Survey
Distance (ft):	6.2
Structural Grade:	0
O&M Grade:	0
Clock Start/From:	
Clock To:	
1st Value:	
2nd Value:	
Value Percent:	
Step:	NO
Remarks:	OBP
