# Manhole Inspection Report

Date:	<b>05/14/2018</b>	Weather:		Coding:	<b>RZMACP</b>
MH#:	<b>M-404-028</b>	Owner:	<b>NA</b>	Len. Surveyed:	<b>11.8</b>
P.O.#:		Surveyor:	<b>Jen Costello</b>	Rim to Invert:	<b>14.5</b>
Customer:		Cert. #:	<b>U-907-5518</b>	Wall Material:	<b>Concrete (reinforced)</b>

Street:	<b>Intersection of Ridge Rd. and Clark S</b>	Project:	<b>Hobart, IN</b>
City:	<b>Hobart, IN</b>	GPS Northing:	<b>41.54155731</b>
Location:		GPS Easting:	<b>-87.28188324</b>
Drain Area:	<b>Northwest</b>	GPS Accuracy:	<b>Nearest Meter</b>
Cover Shape:	<b>Circular</b>	Evidence of Surcharge:	<b>No</b>
Cover Size:	<b>22.5</b>	Potential for Runoff:	<b>None</b>
Comments:

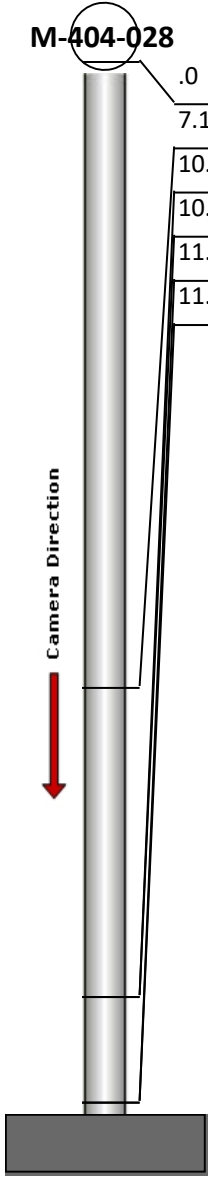
.0	MGO	General Observation	10	NA
	7.1	OBP	Obstacle External Pipe or Cable	36	M 2
	10.6	IW	Infil Weeper	55	M 2
	10.6	ID	Infil Dripper	66	M 3
	11.8	MGO	General Observation	80	NA
	11.8	SAV	Surface Aggregate Visible	92	S 3

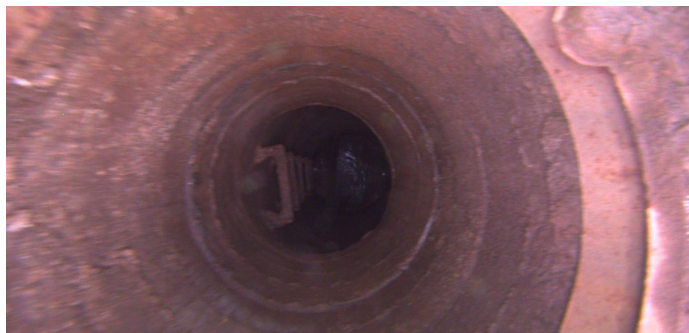
Code: **MGO**  
Description: **General Observation**

Distance (ft): **.0**  
Structural Grade: **0**  
O&M Grade: **0**  
Clock Start/From:  
Clock To:  
1st Value:  
2nd Value:  
Value Percent:  
Step: **NO**  
Remarks: **access MH**

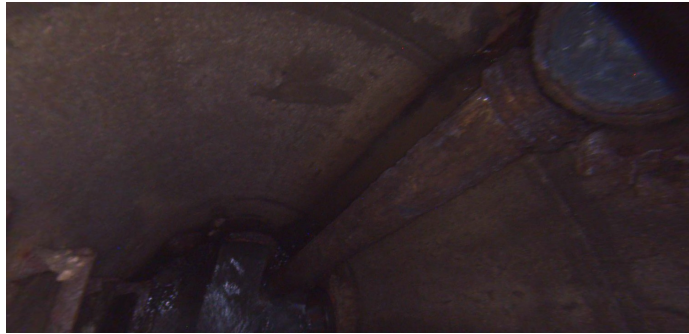
Code: **OBP**  
Description: **Obstacle External Pipe or Cable**

Distance (ft): **7.1**  
Structural Grade: **0**  
O&M Grade: **2**  
Clock Start/From: **2**  
Clock To:  
1st Value:  
2nd Value:  
Value Percent: **10.000**  
Step: **NO**  
Remarks:

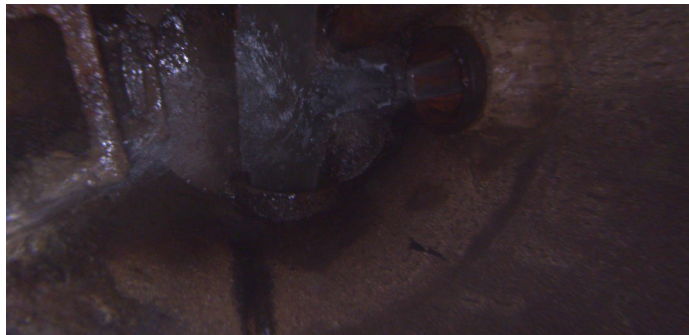
Code: **IW**  
Description: **Infil Weeper**

Distance (ft): **10.6**  
Structural Grade: **0**  
O&M Grade: **2**  
Clock Start/From: **6**  
Clock To:  
1st Value:  
2nd Value:  
Value Percent:  
Step: **NO**  
Remarks:

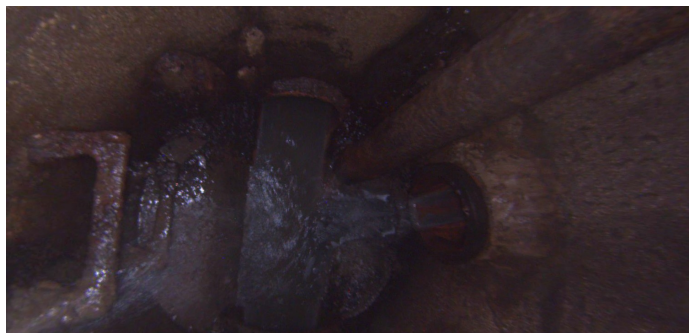
Code: **ID**  
Description: **Infil Dripper**

Distance (ft): **10.6**  
Structural Grade: **0**  
O&M Grade: **3**  
Clock Start/From: **10**  
Clock To: **2**  
1st Value:  
2nd Value:  
Value Percent:  
Step: **NO**  
Remarks:

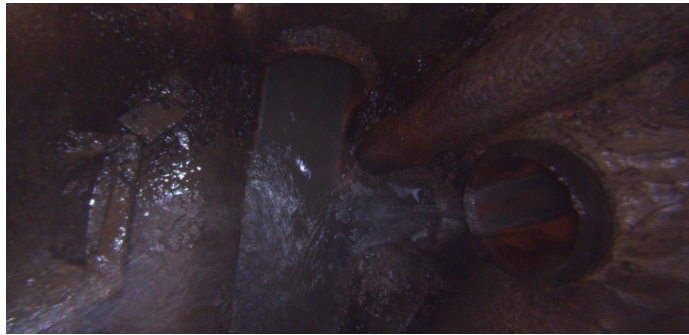
Code: **MGO**  
Description: **General Observation**

Distance (ft): **11.8**  
Structural Grade: **0**  
O&M Grade: **0**  
Clock Start/From:  
Clock To:  
1st Value:  
2nd Value:  
Value Percent:  
Step: **NO**  
Remarks: **END SURVEY**

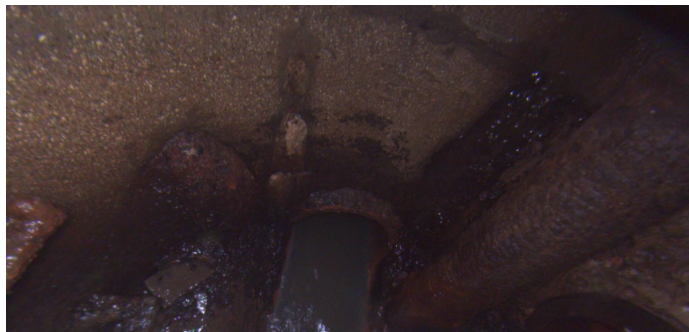
Code: **SAV**  
Description: **Surface Aggregate Visible**

Distance (ft): **11.8**  
Structural Grade: **3**  
O&M Grade: **0**  
Clock Start/From: **12**  
Clock To: **12**  
1st Value:  
2nd Value:  
Value Percent:  
Step: **NO**  
Remarks:
