Manhole Inspection Report

Date:	05/14/2018	Weather:		Coding:	RZMACP
MH#:	M-404-029	Owner:	NA	Len. Surveyed:	7.9
P.O.#:		Surveyor:	Jen Costello	Rim to Invert:	8.5
Customer:		Cert. #:	U-907-5518	Wall Material:	Concrete (reinforced)

Street:	Clark St. 319' North of Ridge Rd.	Project:	Hobart, IN
City:	Hobart, IN	GPS Northing:	41.54250336
Location:		GPS Easting:	-87.28189087
Drain Area:	Northwest	GPS Accuracy:	Nearest Meter
Cover Shape:	Circular	Evidence of Surcharge:	No
Cover Size:	22.5	Potential for Runoff:	None
Comments:

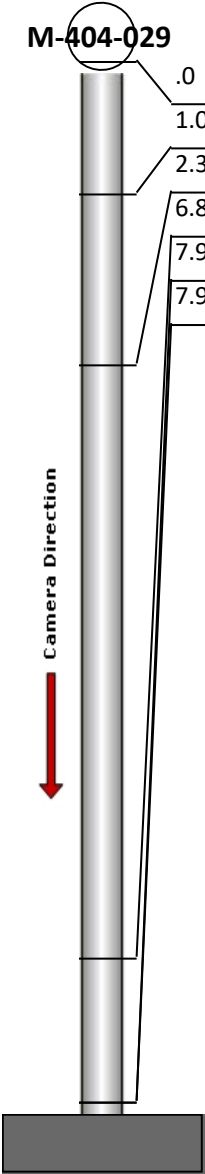
Position	Code	Observation	Video (sec)	Grade
M-404-029

.0	MGO	General Observation	10	NA
	1.0	IW	Infil Weeper	24	M 2
	2.3	IS	Infil Stain	38	NA
	6.8	DSGV	Deposits Settled Gravel	59	M 2
	7.9	MGO	General Observation	72	NA
	7.9	OBR	Obstacle Rocks	84	M 3

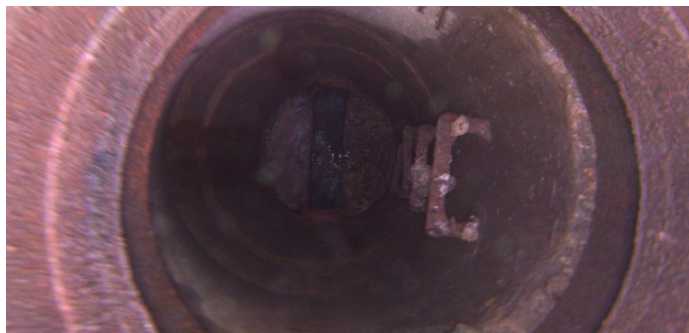
Code: **MGO**
Description: **General Observation**

Distance (ft): **.0**
Structural Grade: **0**
O&M Grade: **0**
Clock Start/From:
Clock To:
1st Value:
2nd Value:
Value Percent:
Step: **NO**
Remarks: **ACCESS MH**

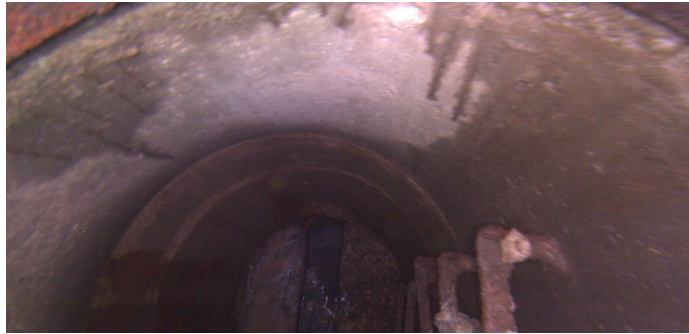
Code: **IW**
Description: **Infil Weeper**

Distance (ft): **1.0**
Structural Grade: **0**
O&M Grade: **2**
Clock Start/From: **10**
Clock To: **3**
1st Value:
2nd Value:
Value Percent:
Step: **NO**
Remarks:

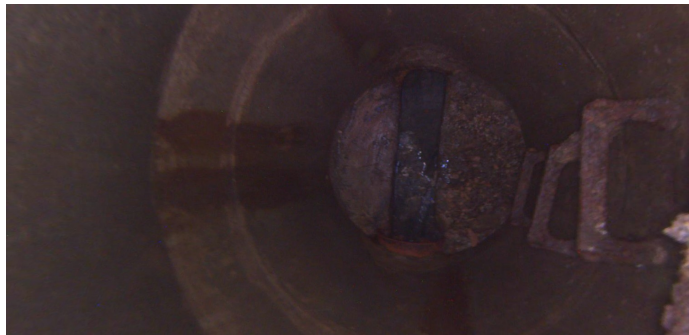
Code: **IS**
Description: **Infil Stain**

Distance (ft): **2.3**
Structural Grade: **0**
O&M Grade: **0**
Clock Start/From: **6**
Clock To: **11**
1st Value:
2nd Value:
Value Percent:
Step: **NO**
Remarks:

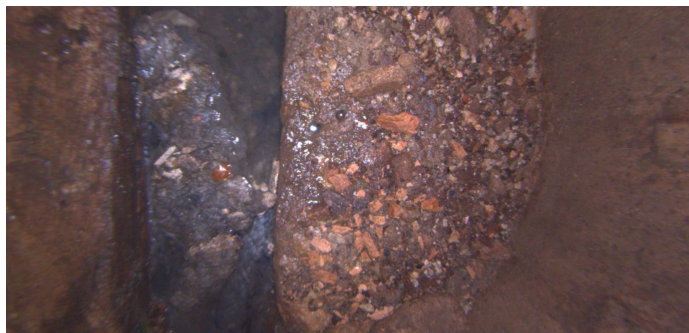
Code: **DSGV**
Description: **Deposits Settled Gravel**

Distance (ft): **6.8**
Structural Grade: **0**
O&M Grade: **2**
Clock Start/From: **12**
Clock To: **6**
1st Value:
2nd Value:
Value Percent: **5.000**
Step: **NO**
Remarks:

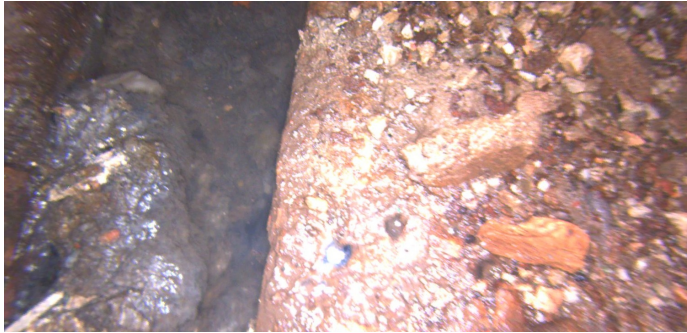
Code: **MGO**
Description: **General Observation**

Distance (ft): **7.9**
Structural Grade: **0**
O&M Grade: **0**
Clock Start/From:
Clock To:
1st Value:
2nd Value:
Value Percent:
Step: **NO**
Remarks: **END SURVEY**

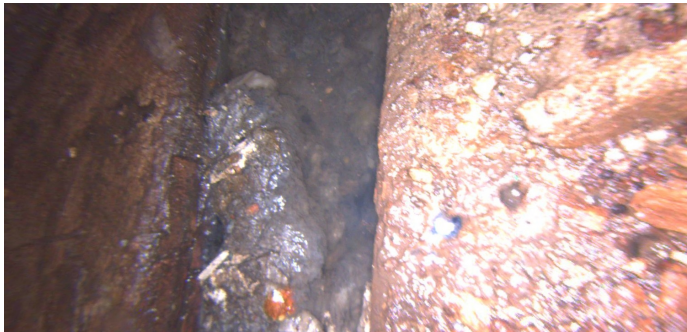
Code: **OBR**
Description: **Obstacle Rocks**

Distance (ft): **7.9**
Structural Grade: **0**
O&M Grade: **3**
Clock Start/From: **5**
Clock To: **7**
1st Value:
2nd Value:
Value Percent: **20.000**
Step: **NO**
Remarks:
