# Manhole Inspection Report

Date:	<b>05/14/2018</b>	Weather:		Coding:	<b>RZMACP</b>
MH#:	<b>M-404-040</b>	Owner:	<b>NA</b>	Len. Surveyed:	<b>5.4</b>
P.O.#:		Surveyor:	<b>Jen Costello</b>	Rim to Invert:	<b>5.2</b>
Customer:		Cert. #:	<b>U-907-5518</b>	Wall Material:	<b>Concrete (reinforced)</b>

Street:	<b>Old Ridge Rd. and Clark St. to the So</b>	Project:	<b>Hobart, IN</b>
City:	<b>Hobart, IN</b>	GPS Northing:	<b>41.54130936</b>
Location:		GPS Easting:	<b>-87.2818985</b>
Drain Area:	<b>Northwest</b>	GPS Accuracy:	<b>Nearest Meter</b>
Cover Shape:	<b>Circular</b>	Evidence of Surcharge:	<b>No</b>
Cover Size:	<b>22.5</b>	Potential for Runoff:	<b>None</b>
Comments:

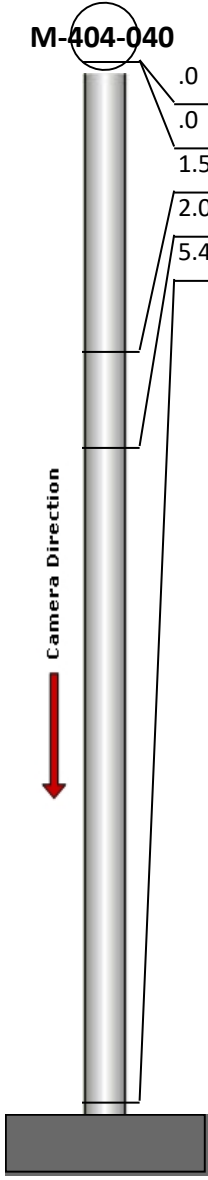
.0	MGO	General Observation	10	NA
	.0	IS	Infil Stain	21	NA
	1.5	MGO	General Observation	37	NA
	2.0	IS	Infil Stain	53	NA
	5.4	MGO	General Observation	74	NA

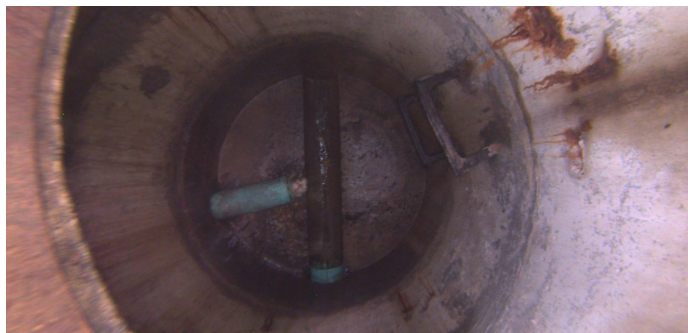
Code: **MGO**  
Description: **General Observation**

Distance (ft): **.0**  
Structural Grade: **0**  
O&M Grade: **0**  
Clock Start/From:  
Clock To:  
1st Value:  
2nd Value:  
Value Percent:  
Step: **NO**  
Remarks: **ACCESS MH**

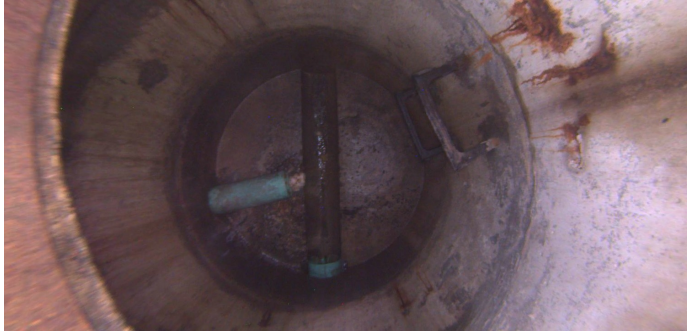
Code: **IS**  
Description: **Infil Stain**

Distance (ft): **.0**  
Structural Grade: **0**  
O&M Grade: **0**  
Clock Start/From: **2**  
Clock To: **3**  
1st Value:  
2nd Value:  
Value Percent:  
Step: **NO**  
Remarks:

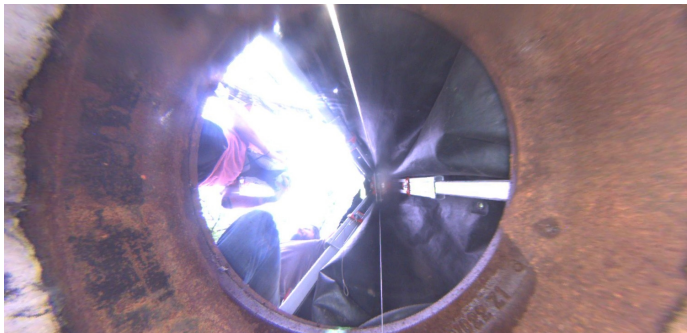
Code: **MGO**  
Description: **General Observation**

Distance (ft): **1.5**  
Structural Grade: **0**  
O&M Grade: **0**  
Clock Start/From:  
Clock To:  
1st Value:  
2nd Value:  
Value Percent:  
Step: **NO**  
Remarks: **UNDERSIDE OF FRAME**

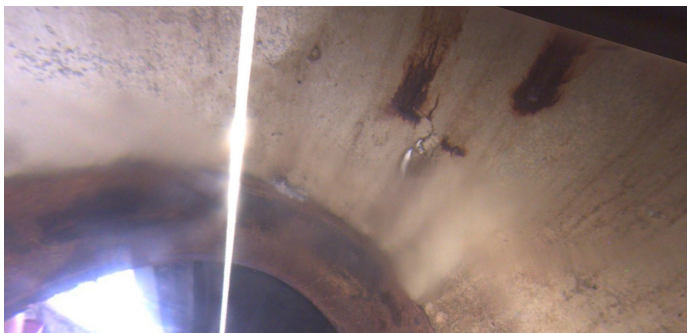
Code: **IS**  
Description: **Infil Stain**

Distance (ft): **2.0**  
Structural Grade: **0**  
O&M Grade: **0**  
Clock Start/From: **10**  
Clock To: **11**  
1st Value:  
2nd Value:  
Value Percent:  
Step: **NO**  
Remarks:

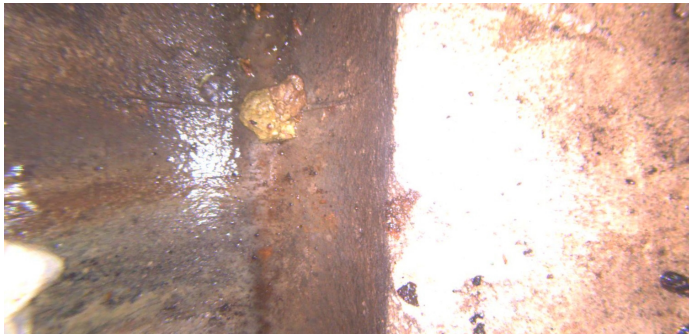
Code: **MGO**  
Description: **General Observation**

Distance (ft): **5.4**  
Structural Grade: **0**  
O&M Grade: **0**  
Clock Start/From:  
Clock To:  
1st Value:  
2nd Value:  
Value Percent:  
Step: **NO**  
Remarks: **END SURVEY**
