Manhole Inspection Report

Date:	05/14/2018	Weather:		Coding:	RZMACP
MH#:	M-404-041	Owner:	NA	Len. Surveyed:	1.1
P.O.#:		Surveyor:	Jen Costello	Rim to Invert:	1.2
Customer:		Cert. #:	U-907-5518	Wall Material:	Concrete (reinforced)

Street:	Old Ridge Rd. and Dearborn St. to th	Project:	Hobart, IN
City:	Hobart, IN	GPS Northing:	41.54095459
Location:		GPS Easting:	-87.28103638
Drain Area:	West	GPS Accuracy:	Nearest Meter
Cover Shape:	Circular	Evidence of Surcharge:	No
Cover Size:	22.5	Potential for Runoff:	None
Comments:

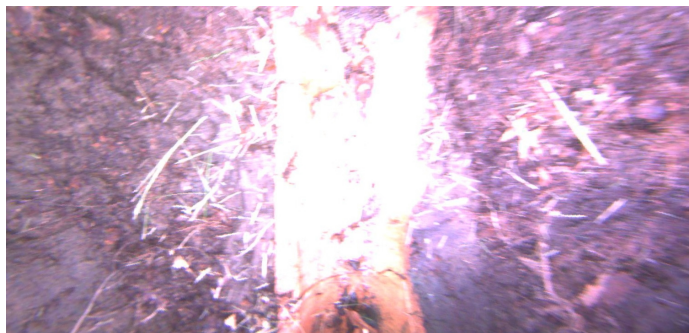
Code: **MGO**
Description: **General Observation**

Distance (ft): **.0**
Structural Grade: **0**
O&M Grade: **0**
Clock Start/From:
Clock To:
1st Value:
2nd Value:
Value Percent:
Step: **NO**
Remarks: **access mh**

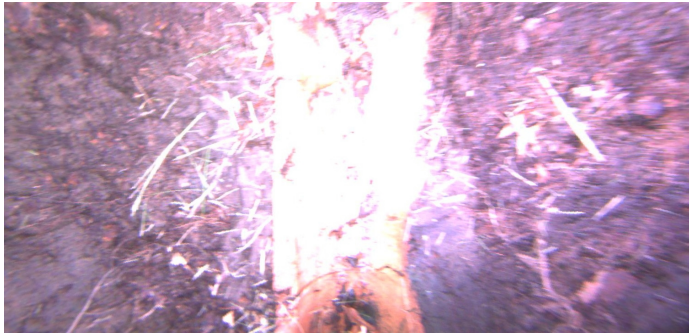
Code:	DSF
Description:	Deposits Settled Fine
Distance (ft):	.0
Structural Grade:	0
O&M Grade:	2
Clock Start/From:	12
Clock To:	12
1st Value:	
2nd Value:	
Value Percent:	10.000
Step:	NO
Remarks:

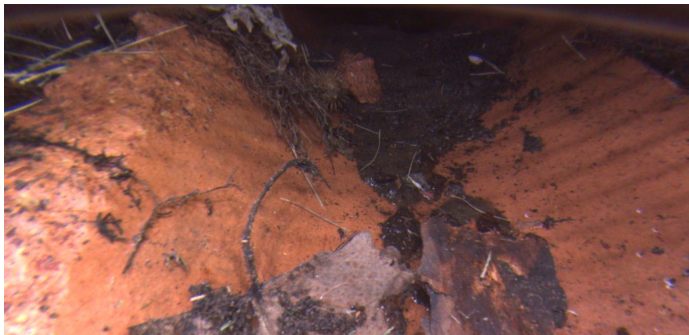
Code:	MGO
Description:	General Observation
Distance (ft):	1.1
Structural Grade:	0
O&M Grade:	0
Clock Start/From:	
Clock To:	
1st Value:	
2nd Value:	
Value Percent:	
Step:	NO
Remarks:	end survey
