Manhole Inspection Report

Date:	05/12/2018	Weather:		Coding:	RZMACP
MH#:	M-405-002.3	Owner:	NA	Len. Surveyed:	5.0
P.O.#:		Surveyor:	Jen Costello	Rim to Invert:	6.9
Customer:		Cert. #:	U-907-5518	Wall Material:	Concrete (reinforced)

Street:	Intersection of Wabash St. and 2nd	Project:	Hobart, IN
City:	Hobart, IN	GPS Northing:	41.53480148
Location:		GPS Easting:	-87.27957153
Drain Area:	West	GPS Accuracy:	Nearest Meter
Cover Shape:	Circular	Evidence of Surcharge:	No
Cover Size:	22.5	Potential for Runoff:	None
Comments:

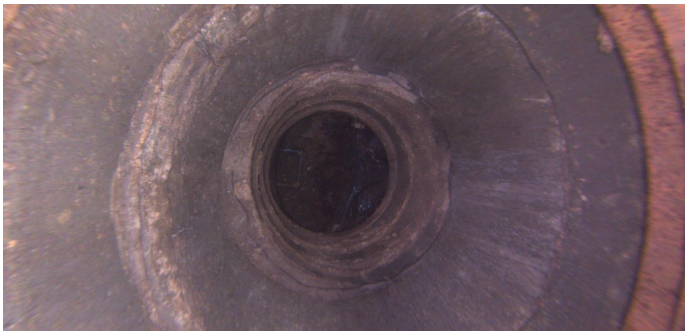
Code: **MGO**
Description: **General Observation**

Distance (ft):	.0
Structural Grade:	0
O&M Grade:	0
Clock Start/From:	
Clock To:	
1st Value:	
2nd Value:	
Value Percent:

Remarks: ACCESS MH

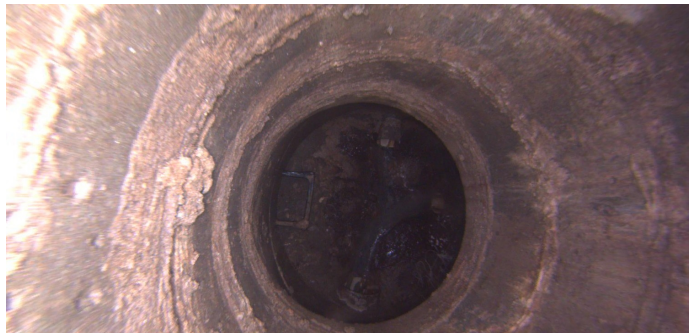
Code: **DAE**
Description: **Deposits Attached Encrustation**

Distance (ft): **1.9**
Structural Grade: **0**
O&M Grade: **2**
Clock Start/From: **12**
Clock To: **12**
1st Value:
2nd Value:
Value Percent: **5.000**
Step: **NO**
Remarks:

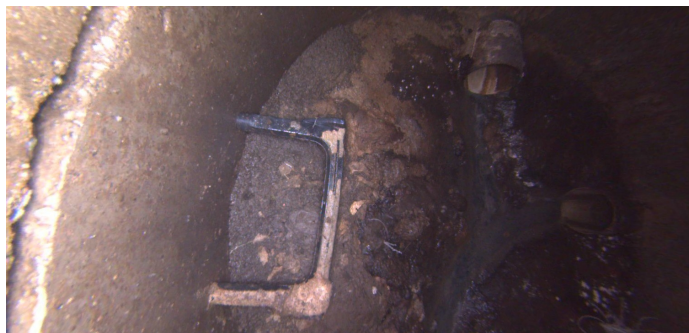
Code: **DSF**
Description: **Deposits Settled Fine**

Distance (ft): **5.0**
Structural Grade: **0**
O&M Grade: **2**
Clock Start/From: **12**
Clock To: **12**
1st Value:
2nd Value:
Value Percent: **5.000**
Step: **NO**
Remarks:

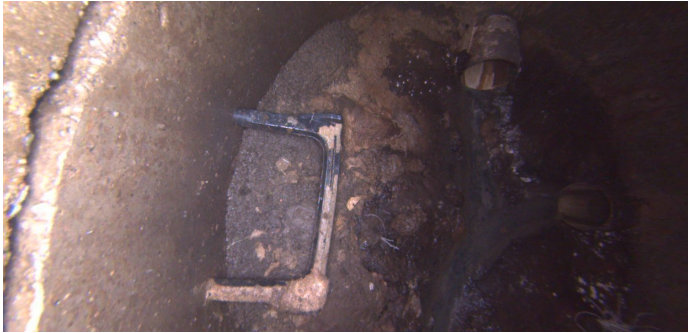
Code: **MGO**
Description: **General Observation**

Distance (ft): **5.0**
Structural Grade: **0**
O&M Grade: **0**
Clock Start/From:
Clock To:
1st Value:
2nd Value:
Value Percent:
Step: **NO**
Remarks: **END SURVEY**
