Manhole Inspection Report

| MH#: | M-405-013 | Owner: | NA | Len. Surveyed: | 9.4 |

| Street: | LaSalle Pl. 35' North of 3rd St. | Project: | Hobart, IN |

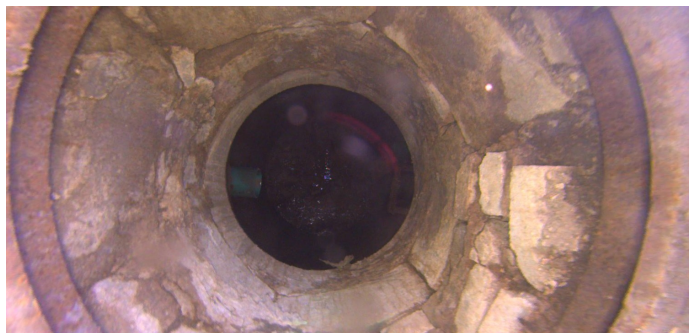
Code: **MGO**
Description: **General Observation**

Distance (ft): **.0**
Structural Grade: **0**
O&M Grade: **0**
Clock Start/From:
Clock To:
1st Value:
2nd Value:
Value Percent:
Step: **NO**
Remarks: **ACCESS MH**

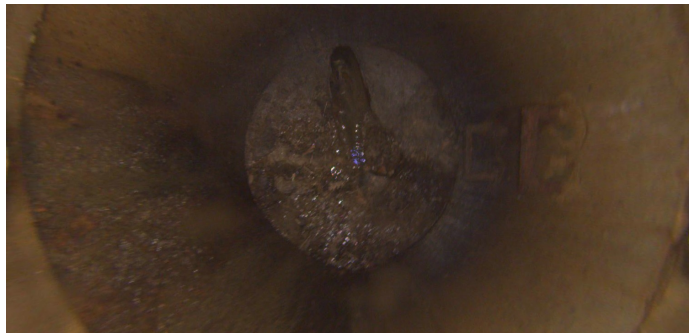
| Description: | Surface Aggregate Visible |
| Distance (ft): | 4.5 |
| Structural Grade: | 3 |
| Clock Start/From: | 6 |
| Clock To: | 9 |

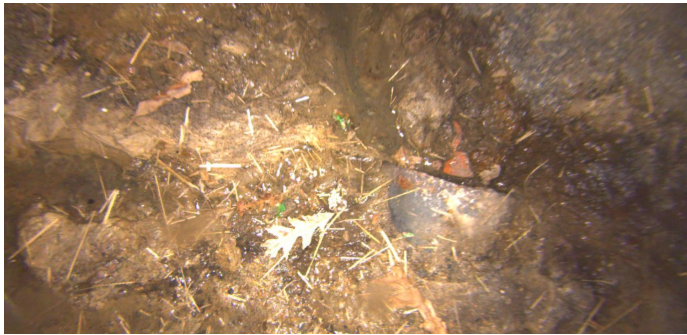
| Description: | Deposits Settled Other |
| Distance (ft): | 8.6 |
| O&M Grade: | 2 |
| Value Percent: | 5.000 |
| Remarks: | MISC |

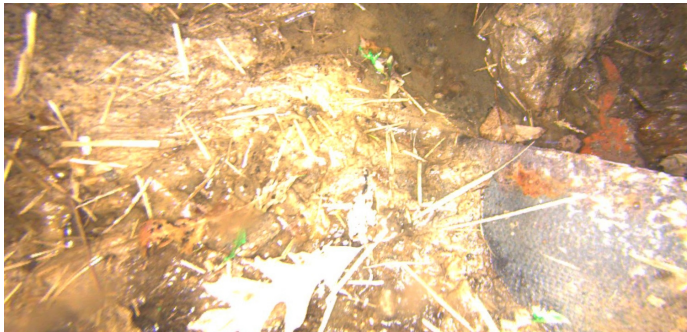
| Description: | General Observation |
| Distance (ft): | 9.4 |
| Remarks: | END SURVEY |
