Manhole Inspection Report

Date:	05/17/2018	Weather:		Coding:	RZMACP
MH#:	M-405-015	Owner:	NA	Len. Surveyed:	14.1
P.O.#:		Surveyor:	Jen Costello	Rim to Invert:	14.8
Customer:		Cert. #:	U-907-5518	Wall Material:	Concrete (reinforced)

Street:	317' South of 3rd St. East of LaSalle	Project:	Hobart, IN
City:	Hobart, IN	GPS Northing:	41.53198624
Location:		GPS Easting:	-87.28236389
Drain Area:	West	GPS Accuracy:	Nearest Meter
Cover Shape:	Circular	Evidence of Surcharge:	No
Cover Size:	22.5	Potential for Runoff:	None
Comments:

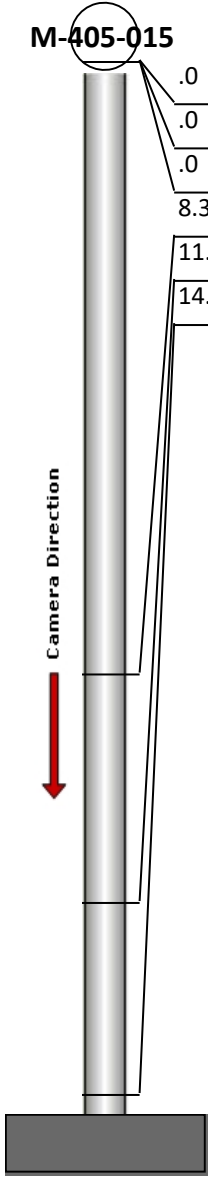
.0	MGO	General Observation	10	NA
	.0	B	Broken	21	S 5
	.0	CM	Crack Multiple	31	S 3
	8.3	MGO	General Observation	59	NA
	11.4	DSF	Deposits Settled Fine	76	M 2
	14.0	MGO	General Observation	92	NA

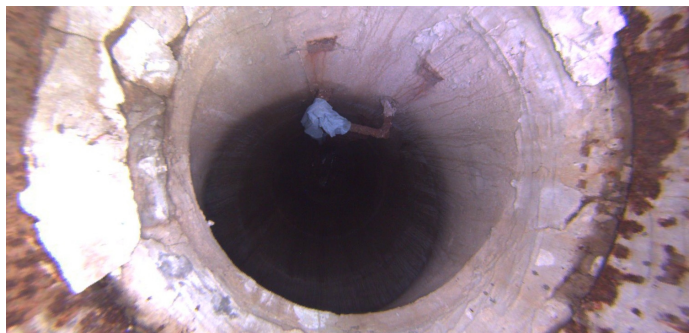
Code: **MGO**
Description: **General Observation**

Distance (ft): **.0**
Structural Grade: **0**
O&M Grade: **0**
Clock Start/From:
Clock To:
1st Value:
2nd Value:
Value Percent:
Step: **NO**
Remarks: **ACCESS MH**

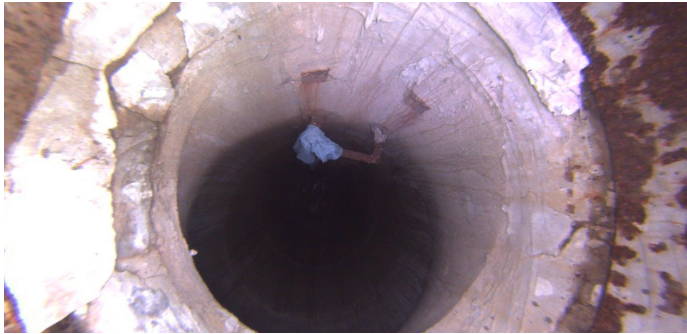
Code: **B**
Description: **Broken**

Distance (ft): **.0**
Structural Grade: **5**
O&M Grade: **0**
Clock Start/From: **8**
Clock To: **2**
1st Value:
2nd Value:
Value Percent:
Step: **NO**
Remarks:

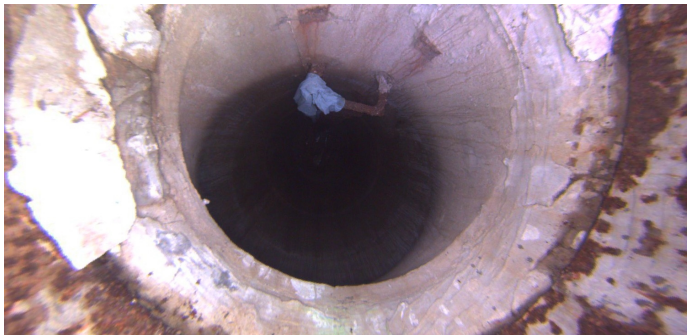
Code: **CM**
Description: **Crack Multiple**

Distance (ft): **.0**
Structural Grade: **3**
O&M Grade: **0**
Clock Start/From: **3**
Clock To: **4**
1st Value:
2nd Value:
Value Percent:
Step: **NO**
Remarks:

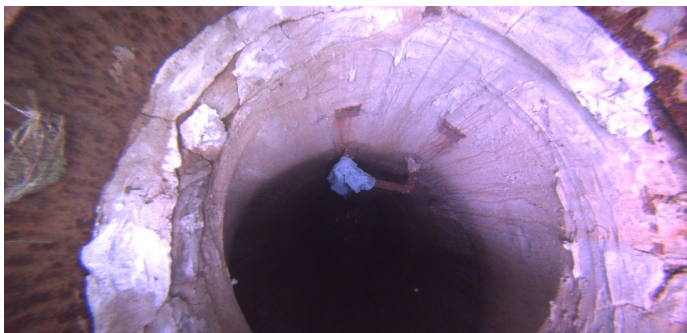
Code: **MGO**
Description: **General Observation**

Distance (ft): **8.3**
Structural Grade: **0**
O&M Grade: **0**
Clock Start/From:
Clock To:
1st Value:
2nd Value:
Value Percent:
Step: **NO**
Remarks: **MISSING AND BROKEN STEPS**

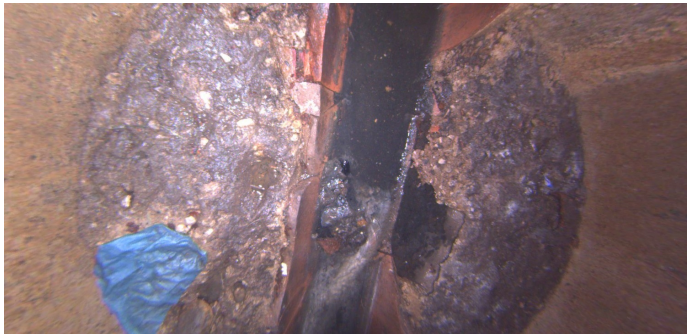
Code:	DSF
Description:	Deposits Settled Fine
Distance (ft):	11.4
Structural Grade:	0
O&M Grade:	2
Clock Start/From:	12
Clock To:	12
1st Value:	
2nd Value:	
Value Percent:	5.000
Step:	NO
Remarks:

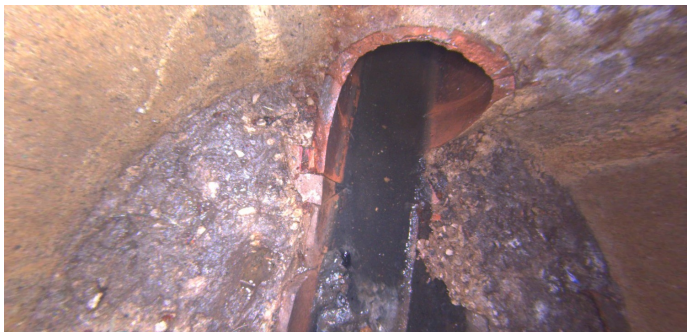
Code:	MGO
Description:	General Observation
Distance (ft):	14.0
Structural Grade:	0
O&M Grade:	0
Clock Start/From:	
Clock To:	
1st Value:	
2nd Value:	
Value Percent:	
Step:	NO
Remarks:	END SURVEY
