Manhole Inspection Report

Date:	05/17/2018	Weather:		Coding:	RZMACP
MH#:	M-405-017	Owner:	NA	Len. Surveyed:	15.4
P.O.#:		Surveyor:	Jen Costello	Rim to Invert:	15.5
Customer:		Cert. #:	U-907-5518	Wall Material:	Brick

Street:	618' South of 3rd St. East of LaSalle	Project:	Hobart, IN
City:	Hobart, IN	GPS Northing:	2898244.559
Location:		GPS Easting:	2898244.559
Drain Area:	West	GPS Accuracy:	Sub-Meter
Cover Shape:	Circular	Evidence of Surcharge:	No
Cover Size:	24.0	Potential for Runoff:	None
Comments:

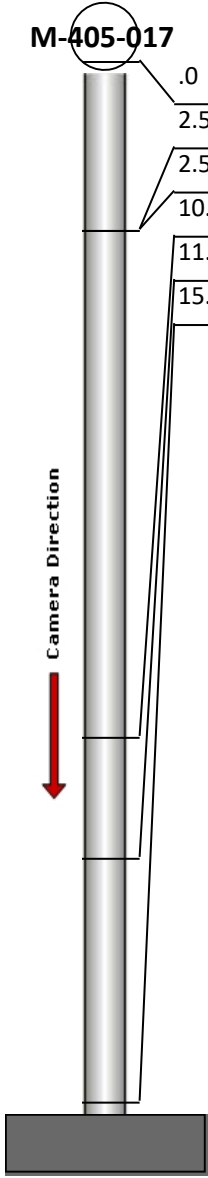
.0	MGO	General Observation	10	NA
	2.5	FM	Fracture Multiple	26	S 4
	2.5	FL	Fracture Longitudinal	38	S 3
	10.0	RFC	Roots Fine Connection	64	M 1
	11.8	RFB	Roots Fine Barrel	79	M 2
	15.4	DSF	Deposits Settled Fine	98	M 2

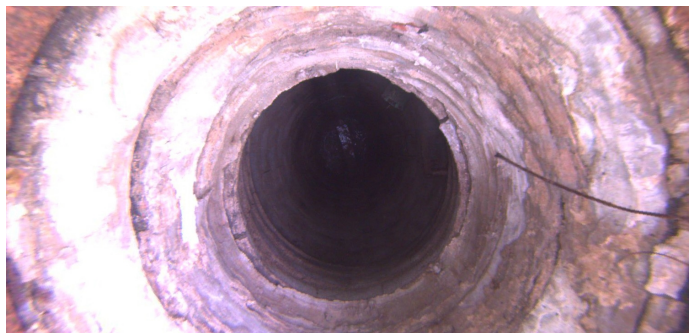
Code: **MGO**
Description: **General Observation**

Distance (ft): **.0**
Structural Grade: **0**
O&M Grade: **0**
Clock Start/From:
Clock To:
1st Value:
2nd Value:
Value Percent:
Step: **NO**
Remarks: **ACCESS MH**

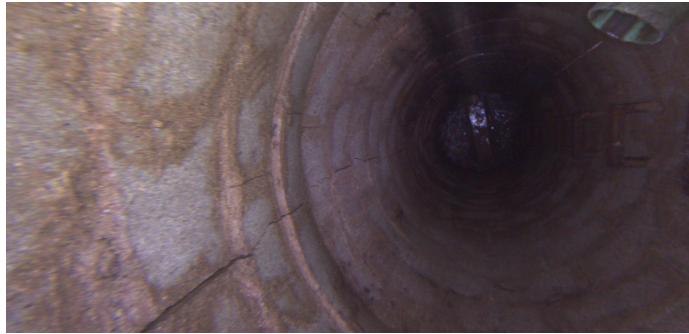
Code: **FM**
Description: **Fracture Multiple**

Distance (ft): **2.5**
Structural Grade: **4**
O&M Grade: **0**
Clock Start/From: **8**
Clock To: **9**
1st Value:
2nd Value:
Value Percent:
Step: **NO**
Remarks:

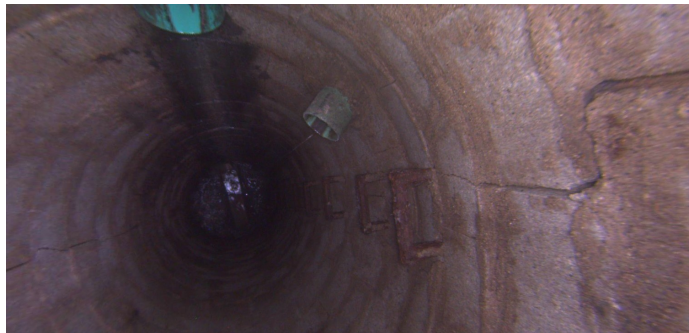
Code: **FL**
Description: **Fracture Longitudinal**

Distance (ft): **2.5**
Structural Grade: **3**
O&M Grade: **0**
Clock Start/From: **3**
Clock To:
1st Value:
2nd Value:
Value Percent:
Step: **NO**
Remarks:

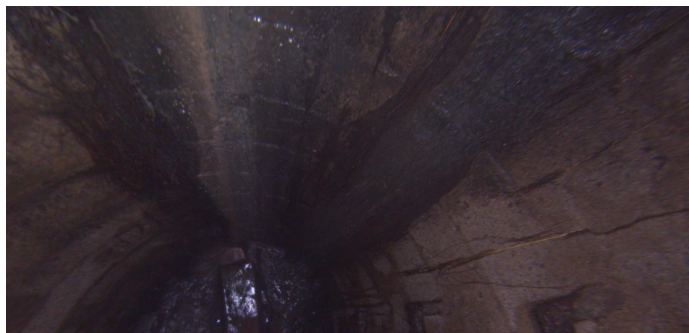
Code: **RFC**
Description: **Roots Fine Connection**

Distance (ft): **10.0**
Structural Grade: **0**
O&M Grade: **1**
Clock Start/From: **12**
Clock To: **1**
1st Value:
2nd Value:
Value Percent:
Step: **NO**
Remarks:

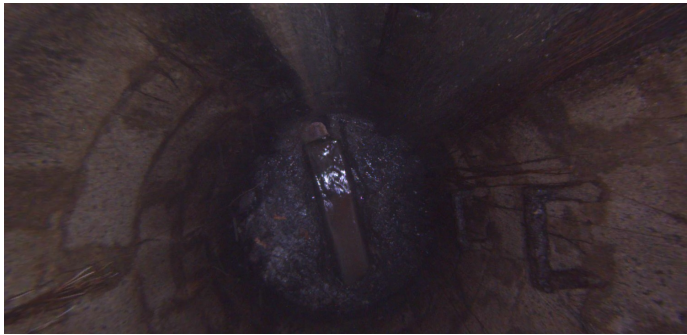
Code: **RFB**
Description: **Roots Fine Barrel**

Distance (ft): **11.8**
Structural Grade: **0**
O&M Grade: **2**
Clock Start/From: **9**
Clock To:
1st Value:
2nd Value:
Value Percent:
Step: **NO**
Remarks:

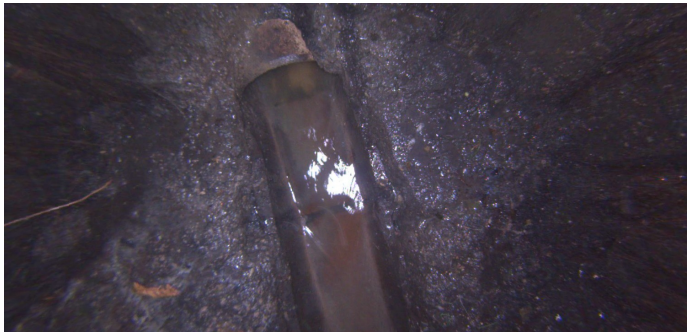
Code: **DSF**
Description: **Deposits Settled Fine**

Distance (ft): **15.4**
Structural Grade: **0**
O&M Grade: **2**
Clock Start/From: **12**
Clock To: **12**
1st Value:
2nd Value:
Value Percent: **5.000**
Step: **NO**
Remarks:
