# Manhole Inspection Report

| MH#: | <b>M-405-020</b> | Owner: | <b>NA</b> | Len. Surveyed: | <b>15.9</b> |

| Street: | <b>Intersection of 3rd St. and Driftwoo</b> | Project: | <b>Hobart, IN</b> |

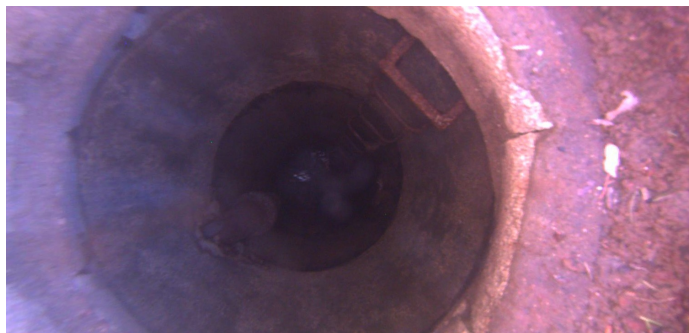
Code: **MGO**  
Description: **General Observation**

Distance (ft): **.0**  
Structural Grade: **0**  
O&M Grade: **0**  
Clock Start/From:  
Clock To:  
1st Value:  
2nd Value:  
Value Percent:  
Step: **NO**  
Remarks: **ACCESS MH**

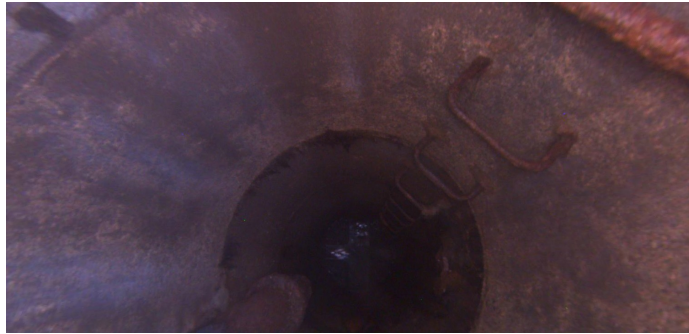
Code: **SAV**  
Description: **Surface Aggregate Visible**

Distance (ft): **1.5**  
Structural Grade: **3**  
O&M Grade: **0**  
Clock Start/From: **12**  
Clock To: **12**  
1st Value:  
2nd Value:  
Value Percent:  
Step: **NO**  
Remarks:

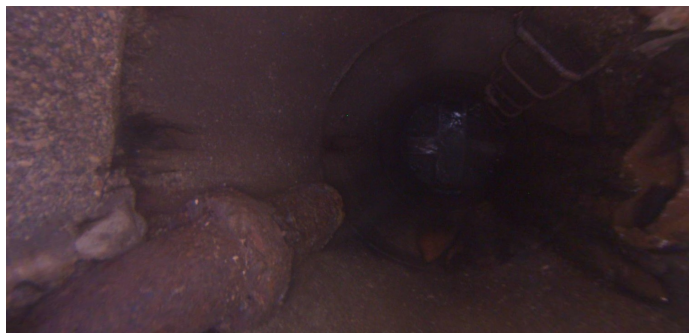
Code: **OBP**  
Description: **Obstacle External Pipe or Cable**

Distance (ft): **4.5**  
Structural Grade: **0**  
O&M Grade: **2**  
Clock Start/From: **8**  
Clock To:  
1st Value:  
2nd Value:  
Value Percent: **10.000**  
Step: **NO**  
Remarks:

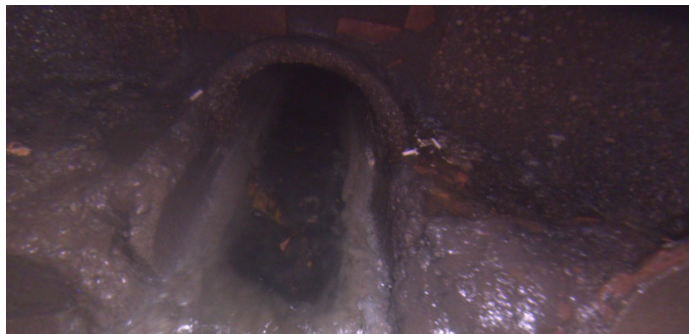
Code: **MGO**  
Description: **General Observation**

Distance (ft): **15.9**  
Structural Grade: **0**  
O&M Grade: **0**  
Clock Start/From:  
Clock To:  
1st Value:  
2nd Value:  
Value Percent:  
Step: **NO**  
Remarks: **END SURVEY**

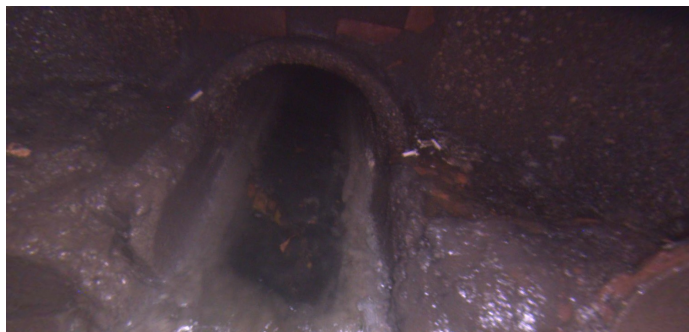
Code: **SAV**  
Description: **Surface Aggregate Visible**

Distance (ft): **15.9**  
Structural Grade: **3**  
O&M Grade: **0**  
Clock Start/From: **12**  
Clock To: **12**  
1st Value:  
2nd Value:  
Value Percent:  
Step: **NO**  
Remarks:
