Manhole Inspection Report

Date:	05/17/2018	Weather:		Coding:	RZMACP
MH#:	M-405-026	Owner:	NA	Len. Surveyed:	9.3
P.O.#:		Surveyor:	Jen Costello	Rim to Invert:	9.5
Customer:		Cert. #:	U-907-5518	Wall Material:	Concrete (reinforced)

Street:	North of 49th Ave. 135' West of Drif	Project:	Hobart, IN
City:	Hobart, IN	GPS Northing:	2897373.641
Location:		GPS Easting:	2897373.641
Drain Area:	West	GPS Accuracy:	Sub-Meter
Cover Shape:	Circular	Evidence of Surcharge:	No
Cover Size:	22.5	Potential for Runoff:	None
Comments:

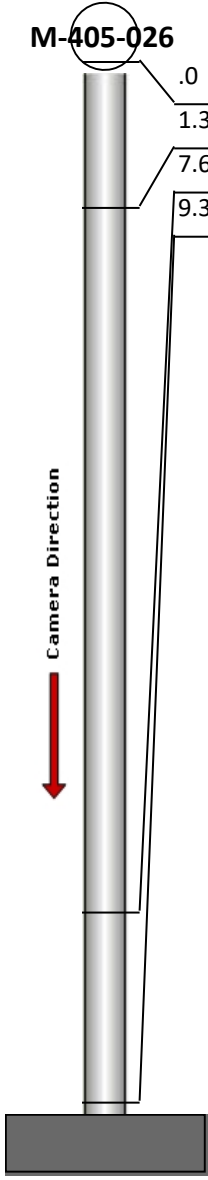
M-405-026				
	.0	MGO	General Observation	10	NA
	1.3	MGO	General Observation	26	NA
	7.6	DSF	Deposits Settled Fine	51	M 2
	9.3	MGO	General Observation	67	NA

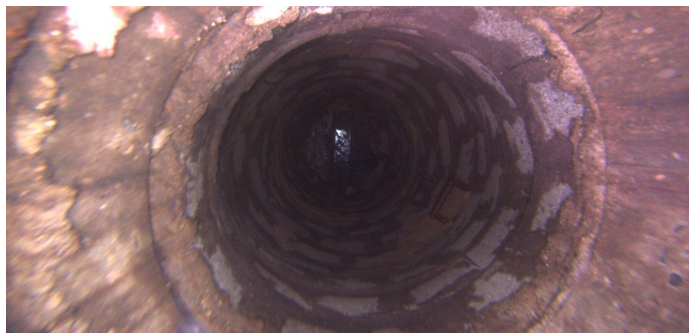
Code: **MGO**
Description: **General Observation**

Distance (ft): **.0**
Structural Grade: **0**
O&M Grade: **0**
Clock Start/From:
Clock To:
1st Value:
2nd Value:
Value Percent:
Step: **NO**
Remarks: **ACCESS MH**

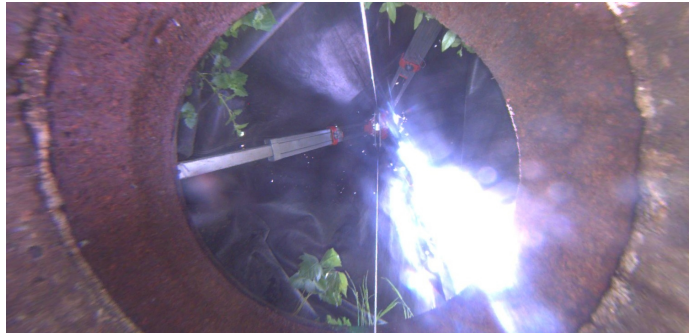
Code: **MGO**
Description: **General Observation**

Distance (ft): **1.3**
Structural Grade: **0**
O&M Grade: **0**
Clock Start/From:
Clock To:
1st Value:
2nd Value:
Value Percent:
Step: **NO**
Remarks: **UNDERSIDE OF FRAME**

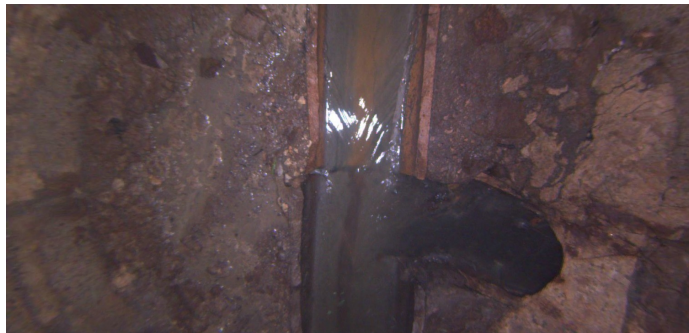
Code: **DSF**
Description: **Deposits Settled Fine**

Distance (ft): **7.6**
Structural Grade: **0**
O&M Grade: **2**
Clock Start/From: **12**
Clock To: **12**
1st Value:
2nd Value:
Value Percent: **5.000**
Step: **NO**
Remarks:

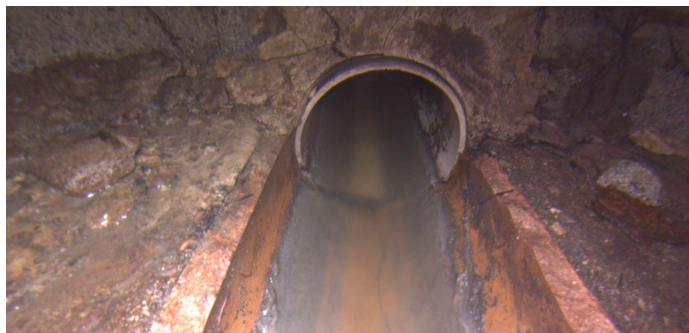
Code: **MGO**
Description: **General Observation**

Distance (ft): **9.3**
Structural Grade: **0**
O&M Grade: **0**
Clock Start/From:
Clock To:
1st Value:
2nd Value:
Value Percent:
Step: **NO**
Remarks: **END SURVEY**
