# Manhole Inspection Report

Date:	05/17/2018	Weather:		Coding:	RZMACP
MH#:	M-405-029	Owner:	NA	Len. Surveyed:	9.1
P.O.#:		Surveyor:	Jen Costello	Rim to Invert:	8.5
Customer:		Cert. #:	U-907-5518	Wall Material:	Concrete (reinforced)

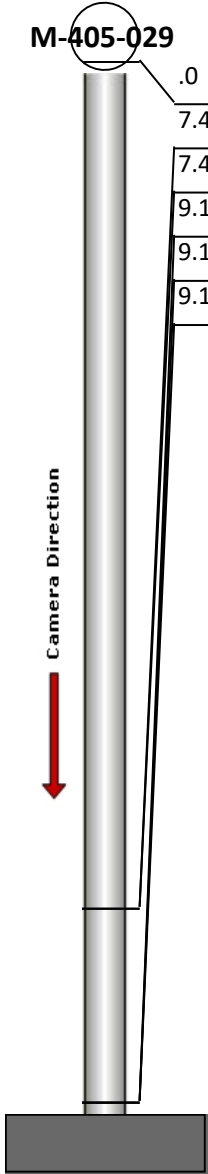
M-405-029				
	.0	MGO	General Observation	10	NA
	7.4	DSF	Deposits Settled Fine	35	M 2
	7.4	OBM	Obstacle Pipe Material	46	M 2
	9.1	MGO	General Observation	60	NA
	9.1	DAE	Deposits Attached Encrustation	71	M 2
	9.1	RMB	Roots Medium Barrel	81	M 4

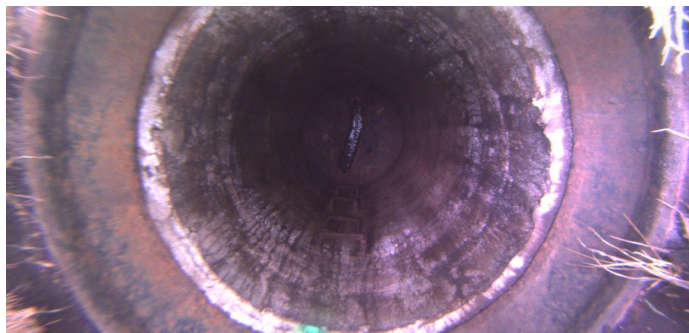
Code: **MGO**  
Description: **General Observation**

Distance (ft): **.0**  
Structural Grade: **0**  
O&M Grade: **0**  
Clock Start/From:  
Clock To:  
1st Value:  
2nd Value:  
Value Percent:  
Step: **NO**  
Remarks: **ACCESS MH**

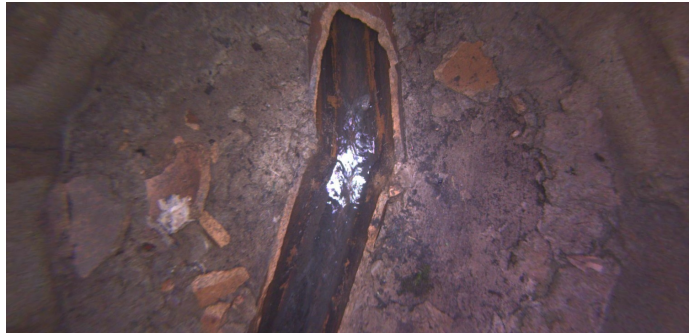
Code: **DSF**  
Description: **Deposits Settled Fine**

Distance (ft): **7.4**  
Structural Grade: **0**  
O&M Grade: **2**  
Clock Start/From: **12**  
Clock To: **12**  
1st Value:  
2nd Value:  
Value Percent: **5.000**  
Step: **NO**  
Remarks:

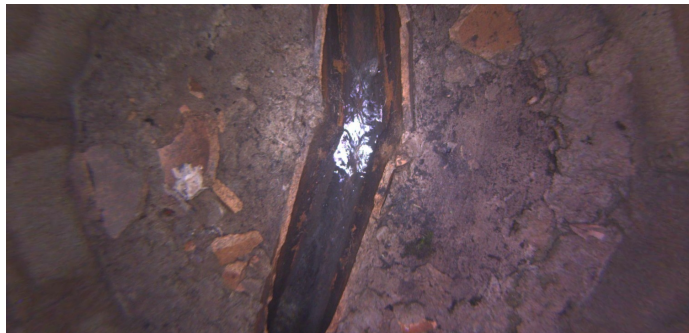
Code: **OBM**  
Description: **Obstacle Pipe Material**

Distance (ft): **7.4**  
Structural Grade: **0**  
O&M Grade: **2**  
Clock Start/From: **8**  
Clock To: **2**  
1st Value:  
2nd Value:  
Value Percent: **5.000**  
Step: **NO**  
Remarks:

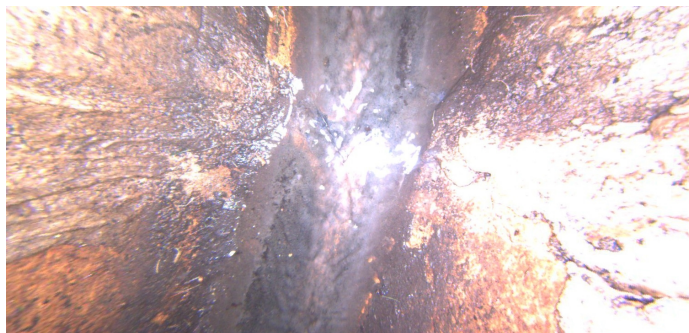
Code: **MGO**  
Description: **General Observation**

Distance (ft): **9.1**  
Structural Grade: **0**  
O&M Grade: **0**  
Clock Start/From:  
Clock To:  
1st Value:  
2nd Value:  
Value Percent:  
Step: **NO**  
Remarks: **END SURVEY**

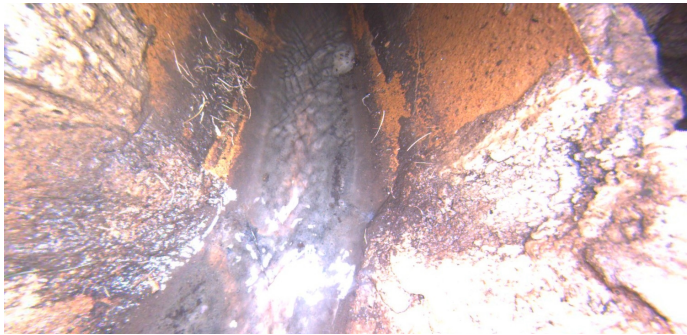
Code:	<b>DAE</b>
Description:	<b>Deposits Attached Encrustation</b>
Distance (ft):	<b>9.1</b>
Structural Grade:	<b>0</b>
O&M Grade:	<b>2</b>
Clock Start/From:	<b>3</b>
Clock To:	<b>6</b>
1st Value:	
2nd Value:	
Value Percent:	<b>5.000</b>
Step:	<b>NO</b>
Remarks:

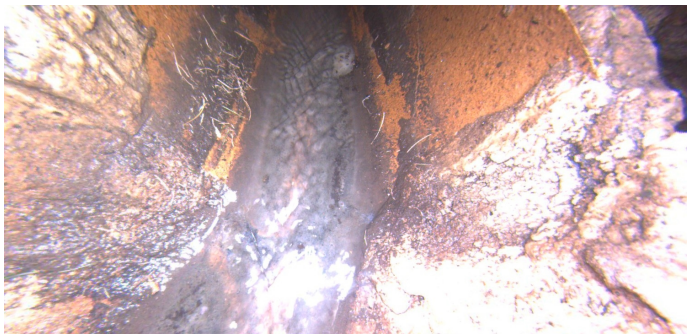
Code:	<b>RMB</b>
Description:	<b>Roots Medium Barrel</b>
Distance (ft):	<b>9.1</b>
Structural Grade:	<b>0</b>
O&M Grade:	<b>4</b>
Clock Start/From:	<b>7</b>
Clock To:	<b>10</b>
1st Value:	
2nd Value:	
Value Percent:	<b>5.000</b>
Step:	<b>NO</b>
Remarks:
