# Manhole Inspection Report

Date:	05/17/2018	Weather:		Coding:	RZMACP
MH#:	M-405-031	Owner:	NA	Len. Surveyed:	9.0
P.O.#:		Surveyor:	Jen Costello	Rim to Invert:	10.0
Customer:		Cert. #:	U-907-5518	Wall Material:	Concrete (reinforced)

Street:	North of 49th Ave. 145' East of Crest	Project:	Hobart, IN
City:	Hobart, IN	GPS Northing:	2897056.376
Location:		GPS Easting:	2897056.376
Drain Area:	West	GPS Accuracy:	Sub-Meter
Cover Shape:	Circular	Evidence of Surcharge:	No
Cover Size:	22.5	Potential for Runoff:	None
Comments:

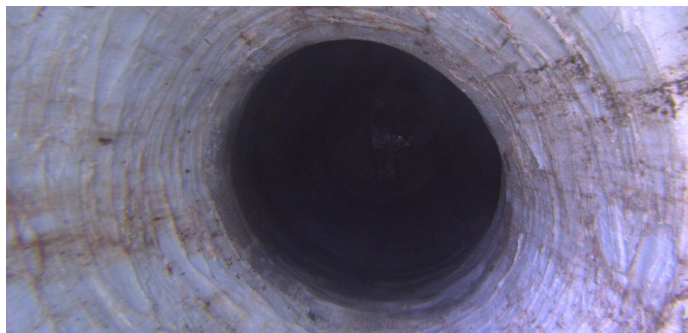
Code: **MGO**  
Description: **General Observation**

Distance (ft): **.0**  
Structural Grade: **0**  
O&M Grade: **0**  
Clock Start/From:  
Clock To:  
1st Value:  
2nd Value:  
Value Percent:  
Step: **NO**  
Remarks: **ACCESS MH**

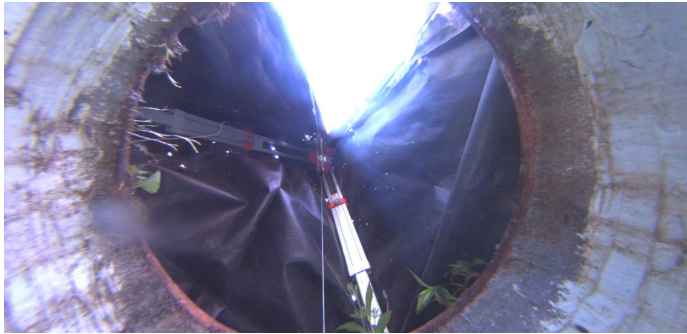
Code:	<b>MGO</b>
Description:	<b>General Observation</b>
Distance (ft):	<b>1.4</b>
Structural Grade:	<b>0</b>
O&M Grade:	<b>0</b>
Clock Start/From:	
Clock To:	
1st Value:	
2nd Value:	
Value Percent:	
Step:	<b>NO</b>
Remarks:	<b>UNDERSIDE OF FRAME</b>

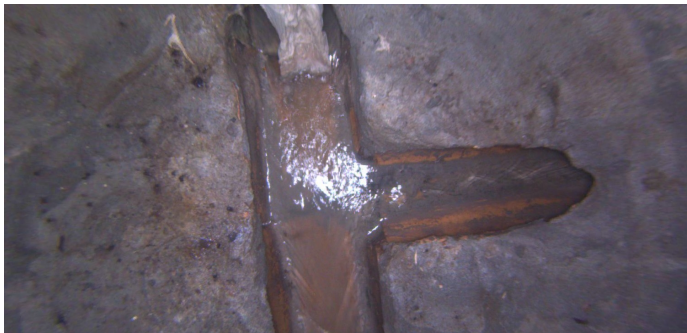
Code:	<b>VC</b>
Description:	<b>Vermin Cockroach</b>
Distance (ft):	<b>8.1</b>
Structural Grade:	<b>0</b>
O&M Grade:	<b>1</b>
Clock Start/From:	
Clock To:	
1st Value:	
2nd Value:	
Value Percent:	
Step:	<b>NO</b>
Remarks:

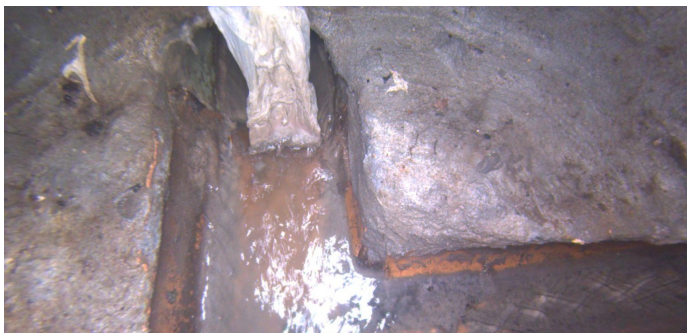
Code:	<b>DAR</b>
Description:	<b>Deposits Attached Ragging</b>
Distance (ft):	<b>9.0</b>
Structural Grade:	<b>0</b>
O&M Grade:	<b>2</b>
Clock Start/From:	<b>12</b>
Clock To:	
1st Value:	
2nd Value:	
Value Percent:	<b>5.000</b>
Step:	<b>NO</b>
Remarks:

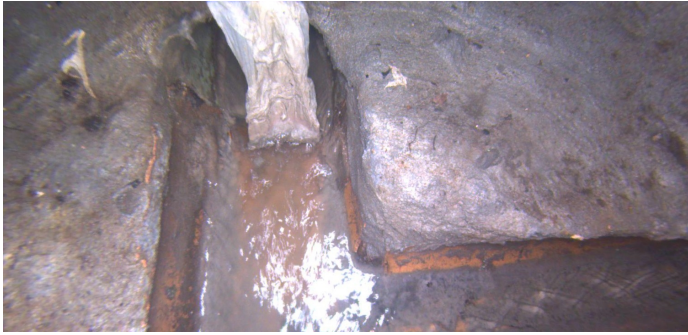
Code:	<b>MGO</b>
Description:	<b>General Observation</b>
Distance (ft):	<b>9.0</b>
Structural Grade:	<b>0</b>
O&M Grade:	<b>0</b>
Clock Start/From:	
Clock To:	
1st Value:	
2nd Value:	
Value Percent:	
Step:	<b>NO</b>
Remarks:	<b>END SURVEY</b>
