Manhole Inspection Report

Date:	04/20/2018	Weather:		Coding:	RZMACP
MH#:	M-405-038	Owner:	NA	Len. Surveyed:	8.4
P.O.#:		Surveyor:	Jen Costello	Rim to Invert:	9.9
Customer:		Cert. #:	U-907-5518	Wall Material:	Concrete (reinforced)

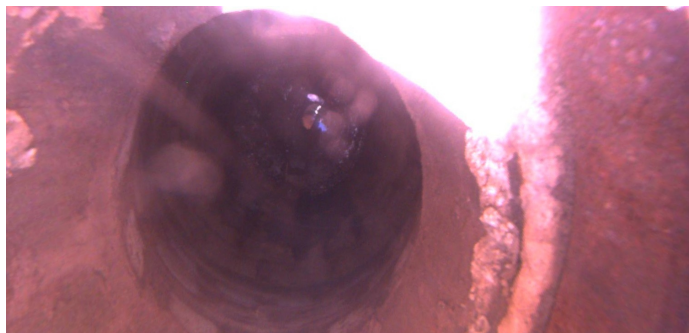
Code: **MGO**
Description: **General Observation**

Distance (ft): **.0**
Structural Grade: **0**
O&M Grade: **0**
Clock Start/From:
Clock To:
1st Value:
2nd Value:
Value Percent:
Step: **NO**
Remarks: **ACCESS MH**

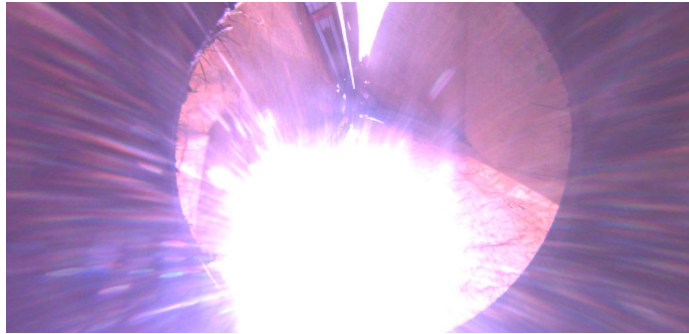
Code:	MGO
Description:	General Observation
Distance (ft):	1.2
Structural Grade:	0
O&M Grade:	0
Clock Start/From:	
Clock To:	
1st Value:	
2nd Value:	
Value Percent:	
Step:	NO
Remarks:	UNDERSIDE OF FRAME

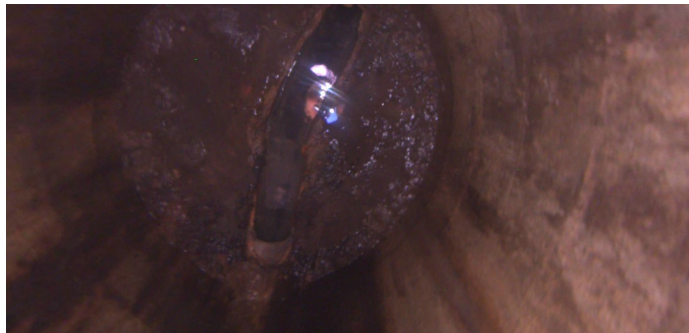
Code:	IW
Description:	Infil Weeper
Distance (ft):	5.4
Structural Grade:	0
O&M Grade:	2
Clock Start/From:	12
Clock To:	12
1st Value:	
2nd Value:	
Value Percent:	
Step:	NO
Remarks:

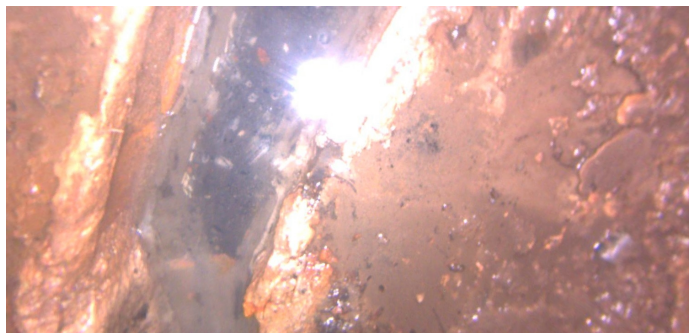
Code:	MGO
Description:	General Observation
Distance (ft):	8.4
Structural Grade:	0
O&M Grade:	0
Clock Start/From:	
Clock To:	
1st Value:	
2nd Value:	
Value Percent:	
Step:	NO
Remarks:	END SURVEY
