# Manhole Inspection Report

Date:	05/17/2018	Weather:		Coding:	RZMACP
MH#:	M-405-039	Owner:	NA	Len. Surveyed:	9.5
P.O.#:		Surveyor:	Jen Costello	Rim to Invert:	10.5
Customer:		Cert. #:	U-907-5518	Wall Material:	Corrugated Metal

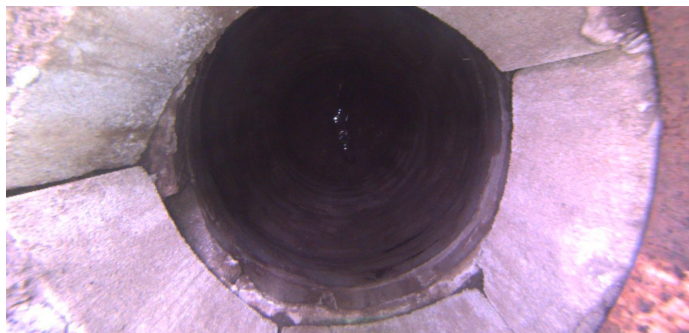
Code: **MGO**  
Description: **General Observation**

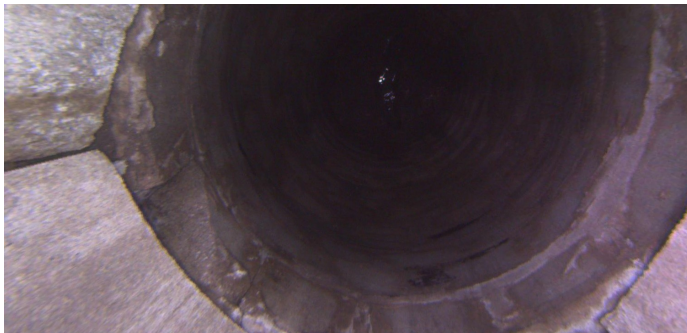
Code: **B**  
Description: **Broken**
