Manhole Inspection Report

Date:	05/17/2018	Weather:		Coding:	RZMACP
MH#:	M-405-044	Owner:	NA	Len. Surveyed:	15.6
P.O.#:		Surveyor:	Jen Costello	Rim to Invert:	17.8
Customer:		Cert. #:	U-907-5518	Wall Material:	Concrete (reinforced)

Street:	3rd St. 128' East of Softwood Dr.	Project:	Hobart, IN
City:	Hobart, IN	GPS Northing:	41.53276443
Location:		GPS Easting:	-87.28575134
Drain Area:	West	GPS Accuracy:	Nearest Meter
Cover Shape:	Circular	Evidence of Surcharge:	No
Cover Size:	22.5	Potential for Runoff:	None
Comments:

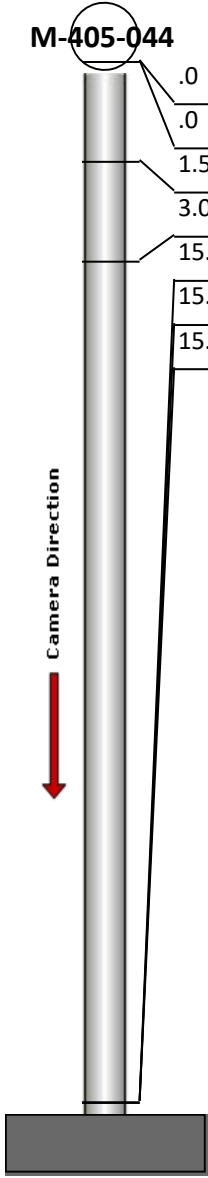
.0	MGO	General Observation	10	NA
	.0	CM	Crack Multiple	21	S 3
	1.5	SAV	Surface Aggregate Visible	35	S 3
	3.0	MGO	General Observation	51	NA
	15.6	OBR	Obstacle Rocks	90	M 2
	15.6	SAV	Surface Aggregate Visible	101	S 3
	15.6	MGO	General Observation	112	NA

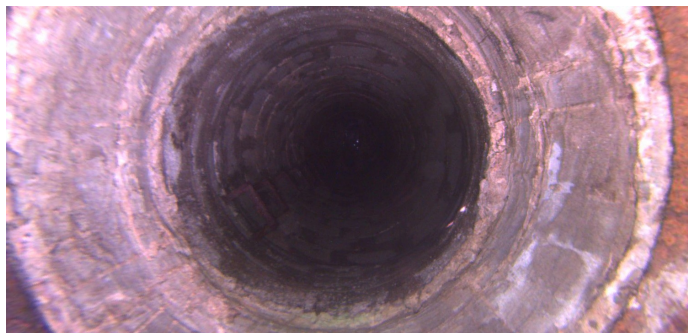
Code: **MGO**
Description: **General Observation**

Distance (ft): **.0**
Structural Grade: **0**
O&M Grade: **0**
Clock Start/From:
Clock To:
1st Value:
2nd Value:
Value Percent:
Step: **NO**
Remarks: **ACCESS MH**

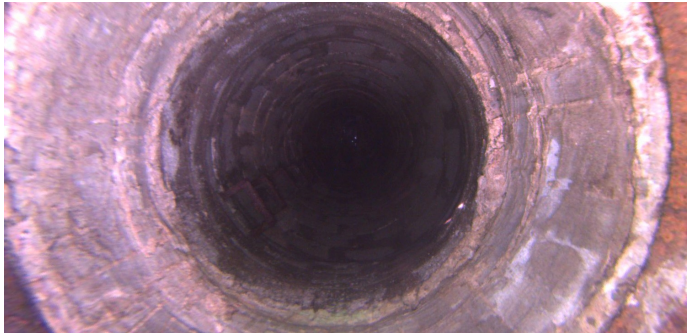
Code: **CM**
Description: **Crack Multiple**

Distance (ft): **.0**
Structural Grade: **3**
O&M Grade: **0**
Clock Start/From: **12**
Clock To: **12**
1st Value:
2nd Value:
Value Percent:
Step: **NO**
Remarks:

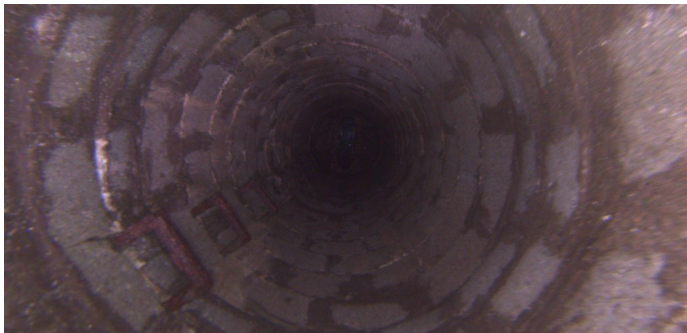
Code: **SAV**
Description: **Surface Aggregate Visible**

Distance (ft): **1.5**
Structural Grade: **3**
O&M Grade: **0**
Clock Start/From: **12**
Clock To: **12**
1st Value:
2nd Value:
Value Percent:
Step: **NO**
Remarks:

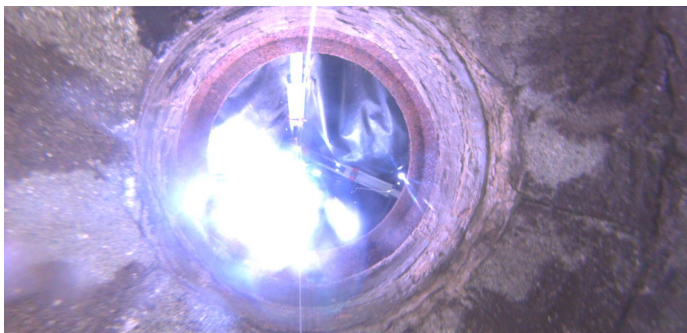
Code: **MGO**
Description: **General Observation**

Distance (ft): **3.0**
Structural Grade: **0**
O&M Grade: **0**
Clock Start/From:
Clock To:
1st Value:
2nd Value:
Value Percent:
Step: **NO**
Remarks: **UNDERSIDE OF FRAME**

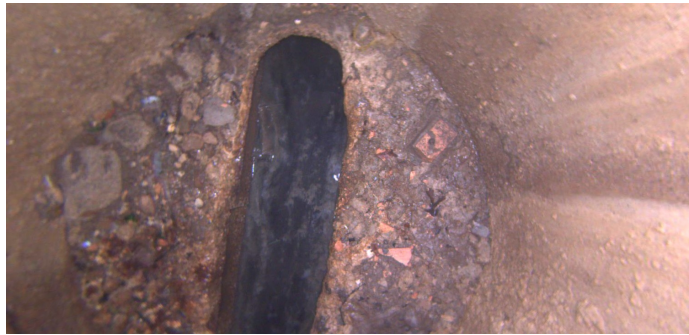
Code: **OBR**
Description: **Obstacle Rocks**

Distance (ft): **15.6**
Structural Grade: **0**
O&M Grade: **2**
Clock Start/From: **12**
Clock To: **12**
1st Value:
2nd Value:
Value Percent: **10.000**
Step: **NO**
Remarks:

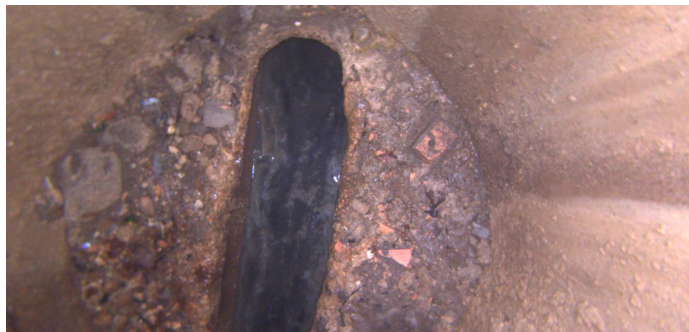
Code: **SAV**
Description: **Surface Aggregate Visible**

Distance (ft): **15.6**
Structural Grade: **3**
O&M Grade: **0**
Clock Start/From: **12**
Clock To: **12**
1st Value:
2nd Value:
Value Percent:
Step: **NO**
Remarks:

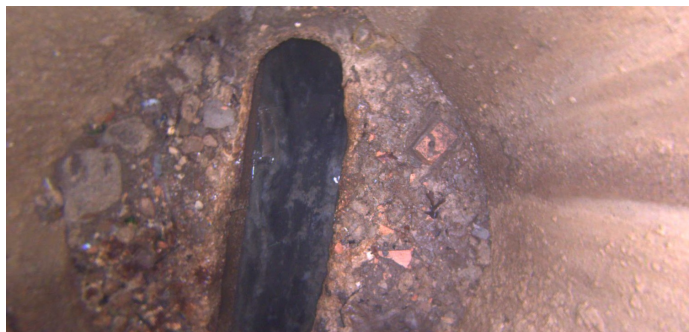
Code: **MGO**
Description: **General Observation**

Distance (ft): **15.6**
Structural Grade: **0**
O&M Grade: **0**
Clock Start/From:
Clock To:
1st Value:
2nd Value:
Value Percent:
Step: **NO**
Remarks: **END SURVEY**
