# Manhole Inspection Report

Date:	<b>05/13/2018</b>	Weather:		Coding:	<b>RZMACP</b>
MH#:	<b>M-405-068</b>	Owner:	<b>NA</b>	Len. Surveyed:	<b>6.4</b>
P.O.#:		Surveyor:	<b>Jen Costello</b>	Rim to Invert:	<b>7.4</b>
Customer:		Cert. #:	<b>U-907-5518</b>	Wall Material:	<b>Brick</b>

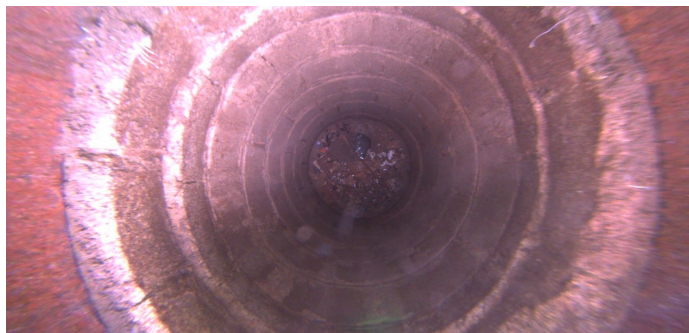
Code: **MGO**  
Description: **General Observation**

Distance (ft): **.0**  
Structural Grade: **0**  
O&M Grade: **0**  
Clock Start/From:  
Clock To:  
1st Value:  
2nd Value:  
Value Percent:  
Step: **NO**  
Remarks: **ACCESS MH**

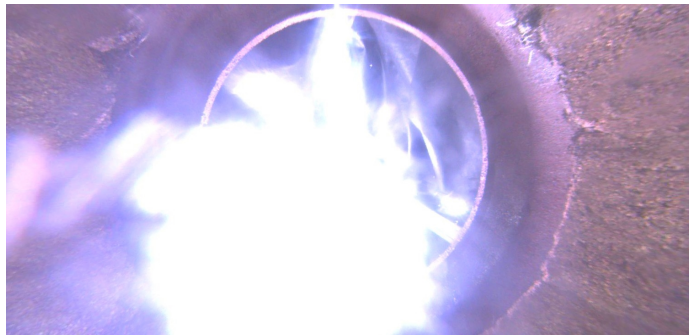
Code: **MGO**  
Description: **General Observation**

Distance (ft): **1.8**  
Structural Grade: **0**  
O&M Grade: **0**  
Clock Start/From:  
Clock To:  
1st Value:  
2nd Value:  
Value Percent:  
Step: **NO**  
Remarks: **UNDERSIDE OF FRAME**

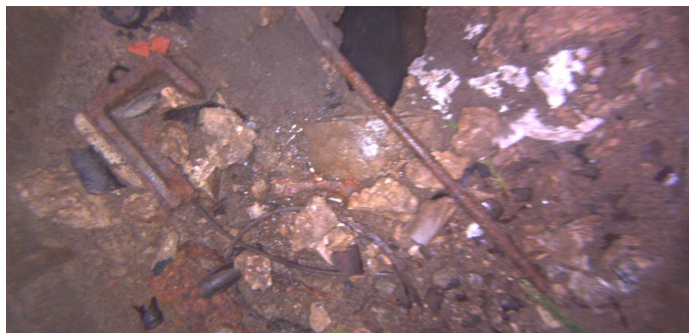
Code: **OBR**  
Description: **Obstacle Rocks**

Distance (ft): **5.4**  
Structural Grade: **0**  
O&M Grade: **2**  
Clock Start/From: **12**  
Clock To: **12**  
1st Value:  
2nd Value:  
Value Percent: **10.000**  
Step: **NO**  
Remarks: **BENCH AND CHANNEL BURIED**

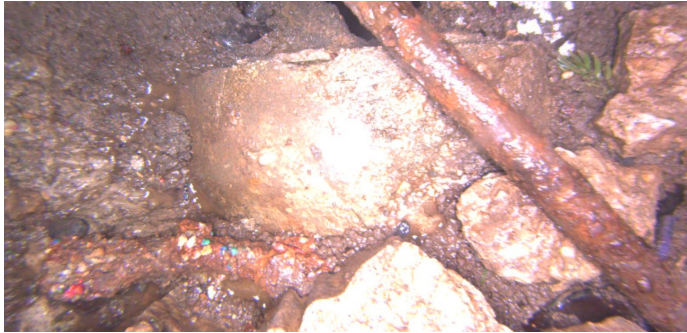
Code: **MGO**  
Description: **General Observation**

Distance (ft): **6.4**  
Structural Grade: **0**  
O&M Grade: **0**  
Clock Start/From:  
Clock To:  
1st Value:  
2nd Value:  
Value Percent:  
Step: **NO**  
Remarks: **END SURVEY**
