Manhole Inspection Report

Date:	04/24/2018	Weather:		Coding:	RZMACP
MH#:	M-406-002	Owner:	NA	Len. Surveyed:	11.3
P.O.#:		Surveyor:	Jen Costello	Rim to Invert:	12.2
Customer:		Cert. #:	U-907-5518	Wall Material:	Concrete (reinforced)

Street:	Wabash Pl. and South of 4th Pl.	Project:	Hobart, IN
City:	Hobart, IN	GPS Northing:	2899313.293
Location:		GPS Easting:	2899313.293
Drain Area:	West	GPS Accuracy:	Sub-Meter
Cover Shape:	Circular	Evidence of Surcharge:	No
Cover Size:	22.5	Potential for Runoff:	None
Comments:

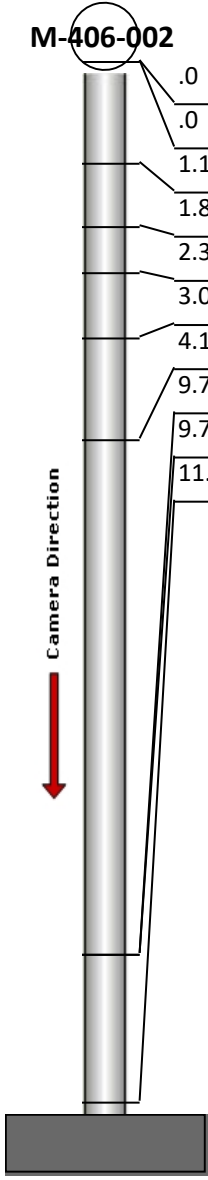
.0	MGO	General Observation	10	NA
	.0	SSS	Surface Spalling	20	S 2
	1.1	SSS	Surface Spalling	33	S 2
	1.8	FM	Fracture Multiple	45	S 4
	2.3	MGO	General Observation	59	NA
	3.0	IW	Infil Weeper	74	M 2
	4.1	SRV	Surface Reinforcement Visible	87	S 5
	9.7	SAV	Surface Aggregate Visible	109	S 3
	9.7	DSGV	Deposits Settled Gravel	121	M 2
	11.3	MGO	General Observation	136	NA

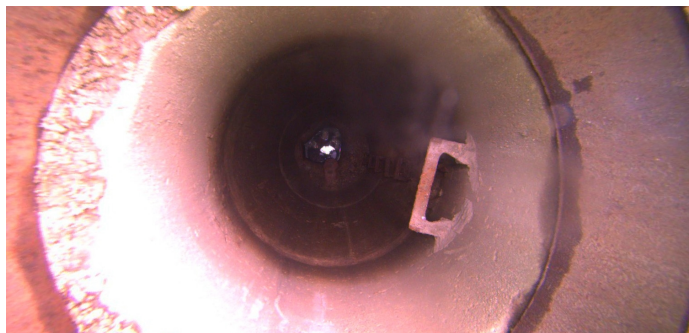
Code: **MGO**
Description: **General Observation**

Distance (ft): **.0**
Structural Grade: **0**
O&M Grade: **0**
Clock Start/From:
Clock To:
1st Value:
2nd Value:
Value Percent:
Step: **NO**
Remarks: **access MH**

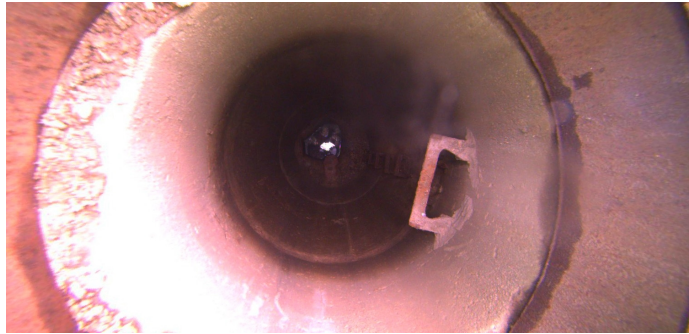
Code: **SSS**
Description: **Surface Spalling**

Distance (ft): **.0**
Structural Grade: **2**
O&M Grade: **0**
Clock Start/From: **8**
Clock To: **12**
1st Value:
2nd Value:
Value Percent:
Step: **NO**
Remarks:

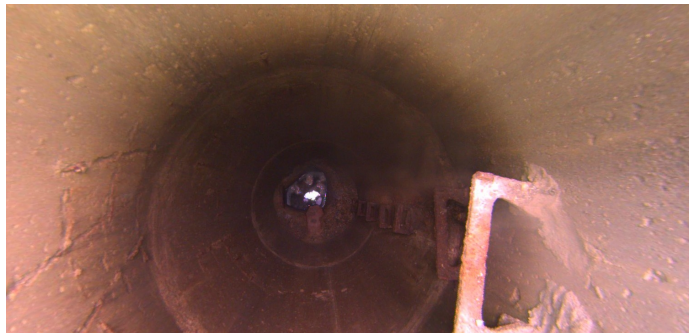
Code: **SSS**
Description: **Surface Spalling**

Distance (ft): **1.1**
Structural Grade: **2**
O&M Grade: **0**
Clock Start/From: **12**
Clock To: **12**
1st Value:
2nd Value:
Value Percent:
Step: **NO**
Remarks:

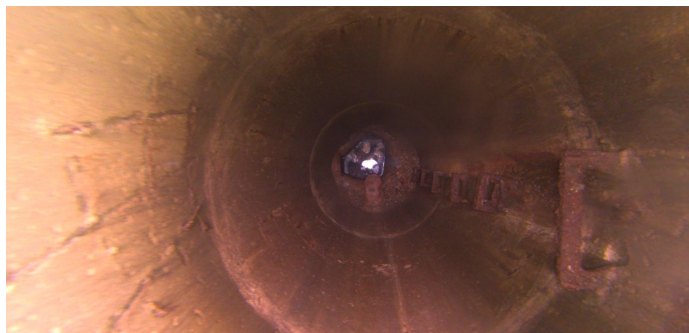
Code: **FM**
Description: **Fracture Multiple**

Distance (ft): **1.8**
Structural Grade: **4**
O&M Grade: **0**
Clock Start/From: **8**
Clock To: **9**
1st Value:
2nd Value:
Value Percent:
Step: **NO**
Remarks:

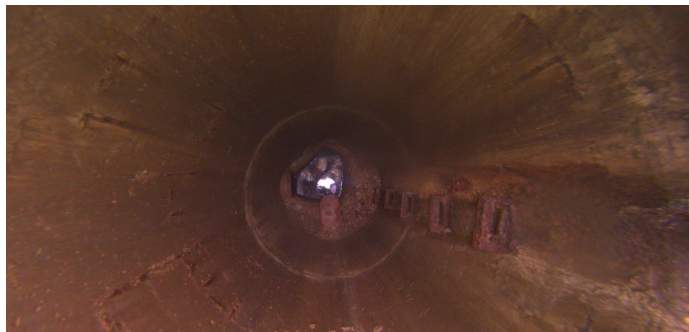
Code: **IW**
Description: **Infil Weeper**

Distance (ft): **3.0**
Structural Grade: **0**
O&M Grade: **2**
Clock Start/From: **9**
Clock To: **3**
1st Value:
2nd Value:
Value Percent:
Step: **NO**
Remarks:

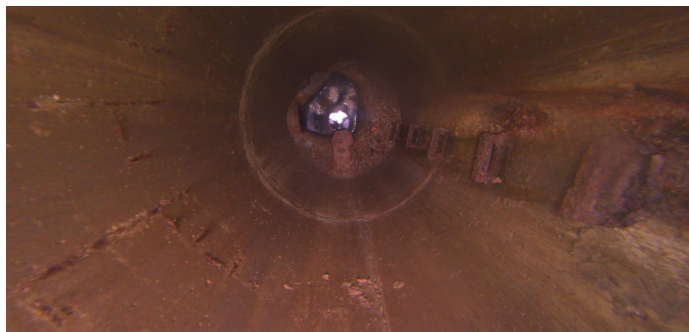
Code: **SRV**
Description: **Surface Reinforcement Visible**

Distance (ft): **4.1**
Structural Grade: **5**
O&M Grade: **0**
Clock Start/From: **6**
Clock To: **9**
1st Value:
2nd Value:
Value Percent:
Step: **NO**
Remarks:

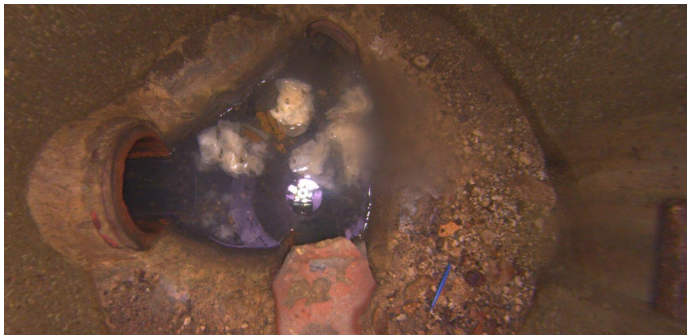
Code: **DSGV**
Description: **Deposits Settled Gravel**

Distance (ft): **9.7**
Structural Grade: **0**
O&M Grade: **2**
Clock Start/From: **12**
Clock To: **12**
1st Value:
2nd Value:
Value Percent: **5.000**
Step: **NO**
Remarks:

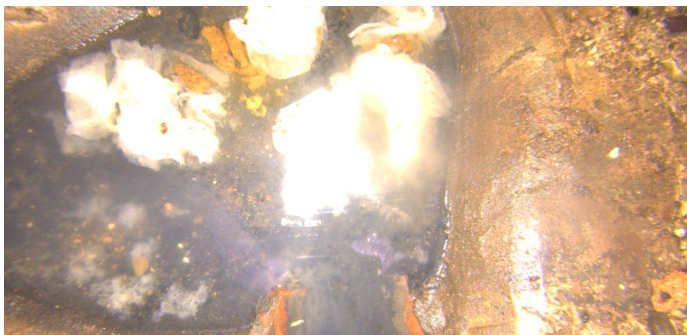
Code: **MGO**
Description: **General Observation**

Distance (ft): **11.3**
Structural Grade: **0**
O&M Grade: **0**
Clock Start/From:
Clock To:
1st Value:
2nd Value:
Value Percent:
Step: **NO**
Remarks: **END SURVEY**
