# Manhole Inspection Report

Date:	<b>04/24/2018</b>	Weather:		Coding:	<b>RZMACP</b>
MH#:	<b>M-407-001</b>	Owner:	<b>NA</b>	Len. Surveyed:	<b>5.1</b>
P.O.#:		Surveyor:	<b>John Kuglmaier</b>	Rim to Invert:	<b>5.0</b>
Customer:		Cert. #:	<b>U-1215-07002349</b>	Wall Material:	<b>Concrete (reinforced)</b>

Street:	<b>On Lake View Dr. South of 10th St.</b>	Project:	<b>Hobart, IN</b>
City:	<b>Hobart, IN</b>	GPS Northing:	<b>2899125.824</b>
Location:		GPS Easting:	<b>2899125.824</b>
Drain Area:	<b>Southwest</b>	GPS Accuracy:	<b>Sub-Meter</b>
Cover Shape:	<b>Circular</b>	Evidence of Surcharge:	<b>Yes</b>
Cover Size:	<b>22.5</b>	Potential for Runoff:	<b>None</b>
Comments:

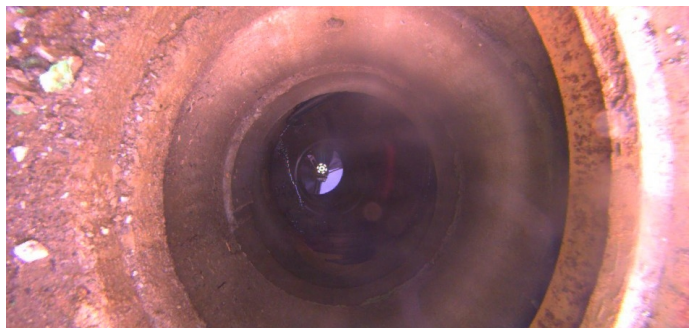
Code: **MGP**  
Description: **General Photo**

Distance (ft): **.0**  
Structural Grade: **0**  
O&M Grade: **0**  
Clock Start/From:  
Clock To:  
1st Value:  
2nd Value:  
Value Percent:  
Step: **NO**  
Remarks:

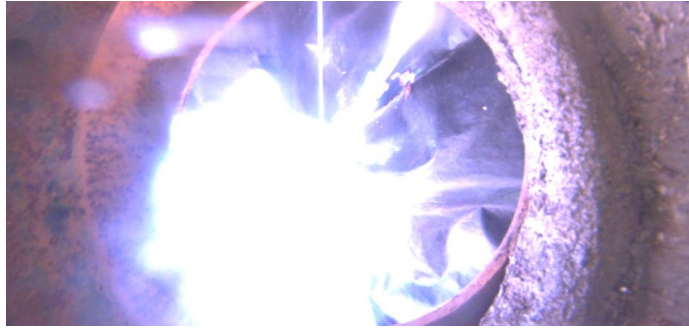
Code: **MGP**  
Description: **General Photo**

Distance (ft): **2.2**  
Structural Grade: **0**  
O&M Grade: **0**  
Clock Start/From:  
Clock To:  
1st Value:  
2nd Value:  
Value Percent:  
Step: **NO**  
Remarks:

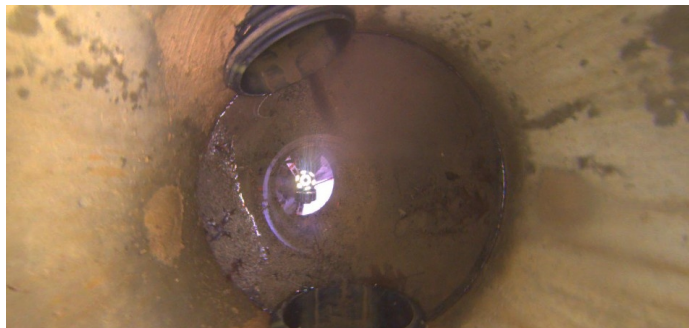
Code: **MGO**  
Description: **General Observation**

Distance (ft): **2.6**  
Structural Grade: **0**  
O&M Grade: **0**  
Clock Start/From:  
Clock To:  
1st Value:  
2nd Value:  
Value Percent:  
Step: **NO**  
Remarks: **Surcharge**

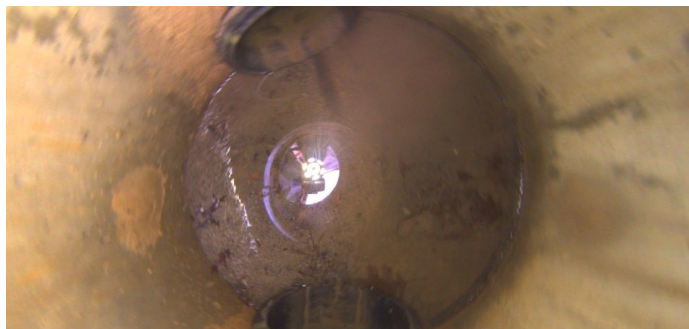
Code: **DSF**  
Description: **Deposits Settled Fine**

Distance (ft): **2.8**  
Structural Grade: **0**  
O&M Grade: **2**  
Clock Start/From: **12**  
Clock To: **12**  
1st Value:  
2nd Value:  
Value Percent: **5.000**  
Step: **NO**  
Remarks:

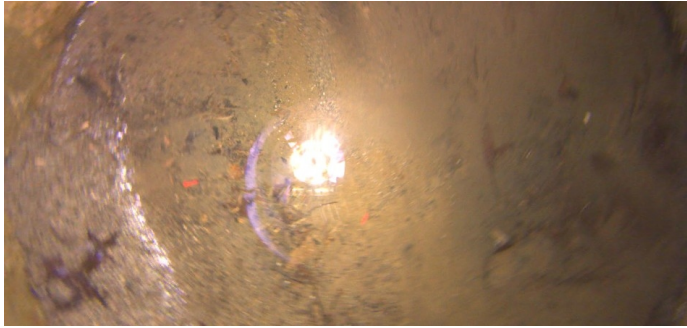
Code:	<b>MGO</b>
Description:	<b>General Observation</b>
Distance (ft):	<b>4.2</b>
Structural Grade:	<b>0</b>
O&M Grade:	<b>0</b>
Clock Start/From:	
Clock To:	
1st Value:	
2nd Value:	
Value Percent:	
Step:	<b>NO</b>
Remarks:	<b>Ins. Comp.</b>
