Manhole Inspection Report

Date:	10/09/2022	Weather:		Coding:	RZMACP
MH#:	M-503-003	Owner:	NA	Len. Surveyed:	12.0
P.O.#:		Surveyor:	Jen Costello	Rim to Invert:	12.9
Customer:		Cert. #:	U-907-5518	Wall Material:	Brick

Street:	Wisconsin St. 29' North of 40th Plac	Project:	Hobart, IN
City:	Hobart, IN	GPS Northing:	2293559.85
Location:	Other	GPS Easting:	2901771.089
Drain Area:	Northwest	GPS Accuracy:	Sub-Meter
Cover Shape:	Circular	Evidence of Surcharge:	No
Cover Size:	24.0	Potential for Runoff:	None
Comments:

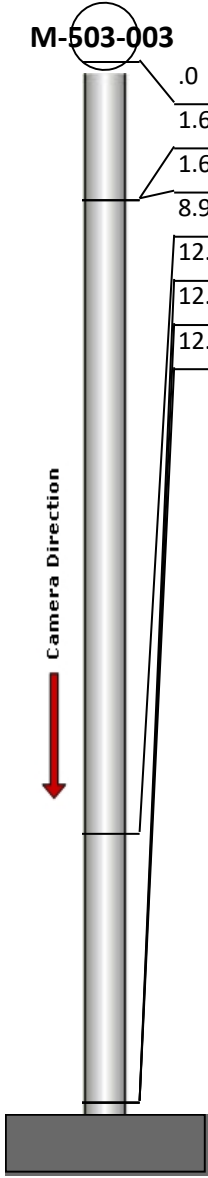
Position	Code	Observation	Video (sec)	Grade

.0	MGO	General Observation	10	NA
	1.6	SAV	Surface Aggregate Visible	25	S 3
	1.6	MGO	General Observation	38	NA
	8.9	IW	Infil Weeper	65	M 2
	12.0	DSF	Deposits Settled Fine	83	M 2
	12.0	SAV	Surface Aggregate Visible	94	S 3
	12.0	MGO	General Observation	104	NA

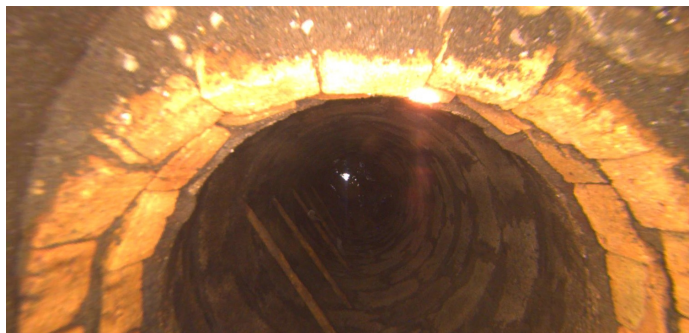
Code: **MGO**
Description: **General Observation**

Distance (ft): **.0**
Structural Grade: **0**
O&M Grade: **0**
Clock Start/From:
Clock To:
1st Value:
2nd Value:
Value Percent:
Step: **NO**
Remarks: **access mh**

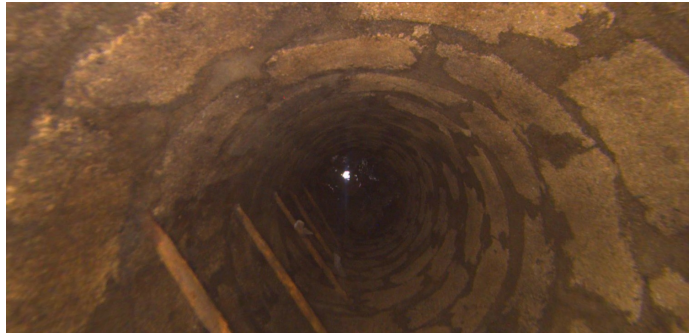
Code: **SAV**
Description: **Surface Aggregate Visible**

Distance (ft): **1.6**
Structural Grade: **3**
O&M Grade: **0**
Clock Start/From: **12**
Clock To: **12**
1st Value:
2nd Value:
Value Percent:
Step: **NO**
Remarks:

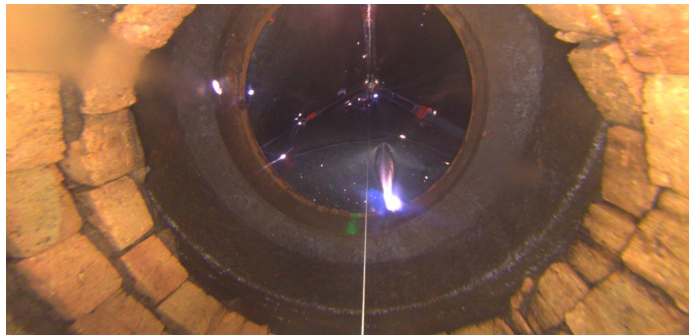
Code: **MGO**
Description: **General Observation**

Distance (ft): **1.6**
Structural Grade: **0**
O&M Grade: **0**
Clock Start/From:
Clock To:
1st Value:
2nd Value:
Value Percent:
Step: **NO**
Remarks: **underside of frame**

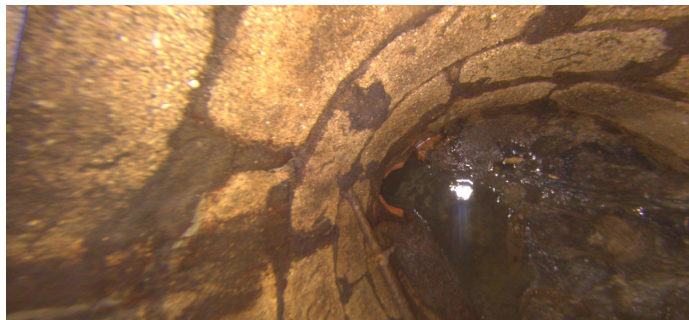
Code: **IW**
Description: **Infil Weeper**

Distance (ft): **8.9**
Structural Grade: **0**
O&M Grade: **2**
Clock Start/From: **9**
Clock To:
1st Value:
2nd Value:
Value Percent:
Step: **NO**
Remarks:

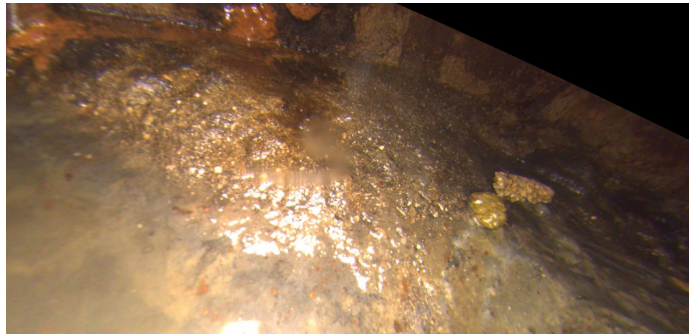
Code: **DSF**
Description: **Deposits Settled Fine**

Distance (ft): **12.0**
Structural Grade: **0**
O&M Grade: **2**
Clock Start/From: **12**
Clock To: **12**
1st Value:
2nd Value:
Value Percent: **5.000**
Step: **NO**
Remarks:

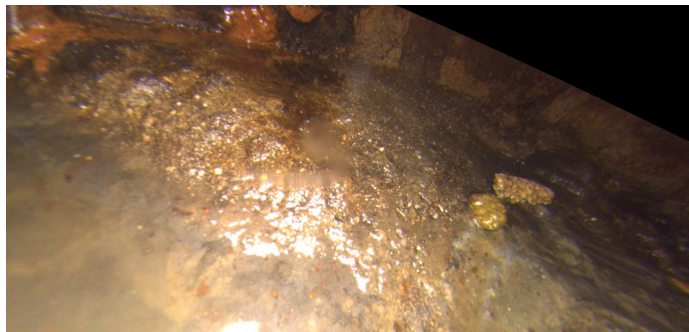
Code: **SAV**
Description: **Surface Aggregate Visible**

Distance (ft): **12.0**
Structural Grade: **3**
O&M Grade: **0**
Clock Start/From: **12**
Clock To: **12**
1st Value:
2nd Value:
Value Percent:
Step: **NO**
Remarks:

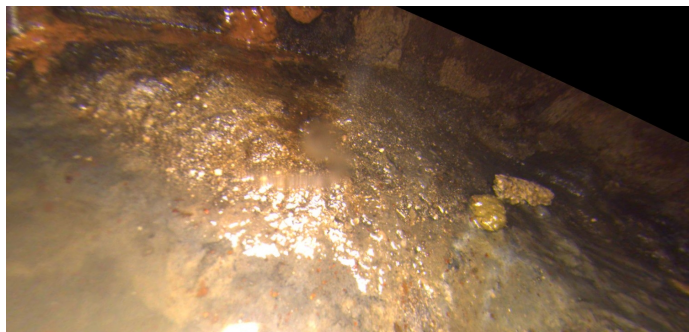
Code: **MGO**
Description: **General Observation**

Distance (ft): **12.0**
Structural Grade: **0**
O&M Grade: **0**
Clock Start/From:
Clock To:
1st Value:
2nd Value:
Value Percent:
Step: **NO**
Remarks: **end of survey**
