Manhole Inspection Report

| MH#: | M-503-012 | Owner: | NA | Len. Surveyed: | 8.2 |

| Street: | Virginia St. 166' South of 39th Pl. | Project: | Hobart, IN |

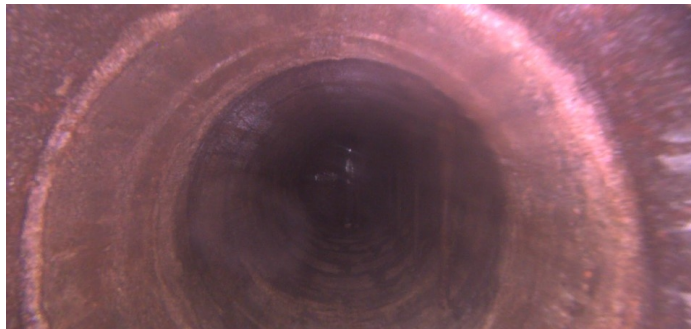
Code: **MGP**
Description: **General Photo**

Distance (ft): **.0**
Structural Grade: **0**
O&M Grade: **0**
Clock Start/From:
Clock To:
1st Value:
2nd Value:
Value Percent:
Step: **NO**
Remarks:

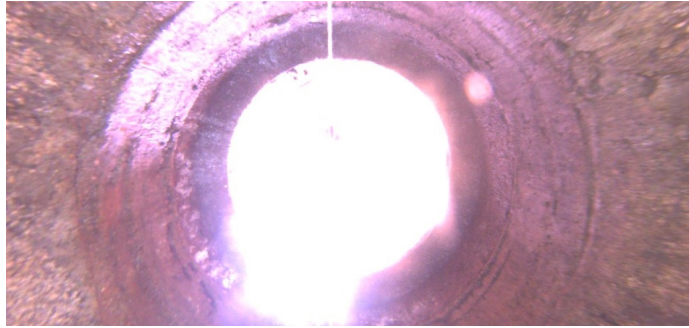
Code: **MGP**
Description: **General Photo**

Distance (ft): **2.7**
Structural Grade: **0**
O&M Grade: **0**
Clock Start/From:
Clock To:
1st Value:
2nd Value:
Value Percent:
Step: **NO**
Remarks:

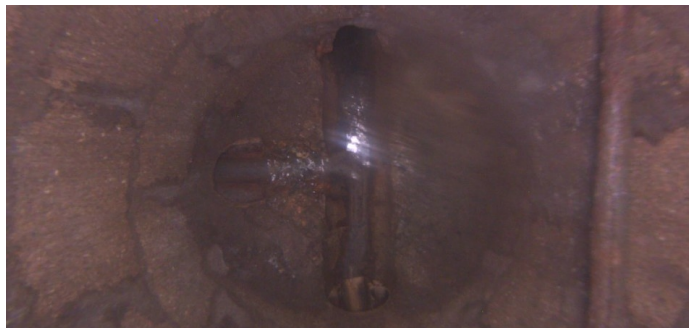
Code: **DSF**
Description: **Deposits Settled Fine**

Distance (ft): **5.8**
Structural Grade: **0**
O&M Grade: **2**
Clock Start/From: **12**
Clock To: **12**
1st Value:
2nd Value:
Value Percent: **10.000**
Step: **NO**
Remarks:

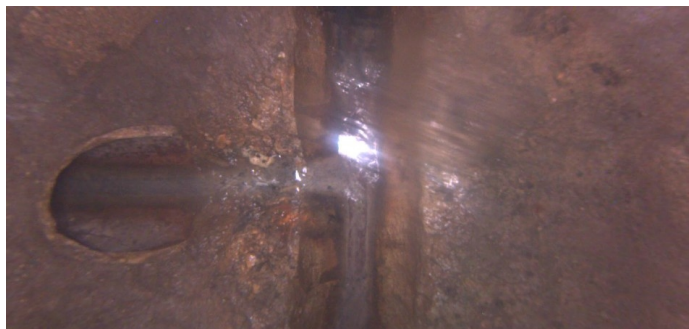
Code: **MGO**
Description: **General Observation**

Distance (ft): **7.2**
Structural Grade: **0**
O&M Grade: **0**
Clock Start/From:
Clock To:
1st Value:
2nd Value:
Value Percent:
Step: **NO**
Remarks: **Ins. Comp.**
