Manhole Inspection Report

Date:	10/06/2022	Weather:		Coding:	RZMACP
MH#:	M-503-021	Owner:	NA	Len. Surveyed:	8.5
P.O.#:		Surveyor:	Jen Costello	Rim to Invert:	9.2
Customer:		Cert. #:	U-907-5518	Wall Material:	Brick

Street:	Virginia St. 166' South of 39th Ave.	Project:	Hobart, IN
City:	Hobart, IN	GPS Northing:	2294294.809
Location:	Other	GPS Easting:	2901043.91
Drain Area:	Northwest	GPS Accuracy:	Sub-Meter
Cover Shape:	Circular	Evidence of Surcharge:	No
Cover Size:	24.0	Potential for Runoff:	None
Comments:

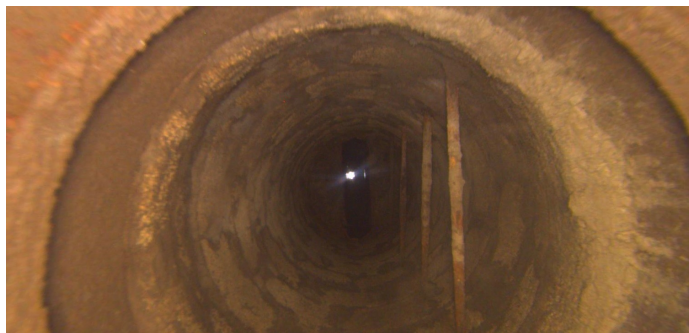
Code: **MGO**
Description: **General Observation**

Distance (ft): **.0**
Structural Grade: **0**
O&M Grade: **0**
Clock Start/From:
Clock To:
1st Value:
2nd Value:
Value Percent:
Step: **NO**
Remarks: **access mh**

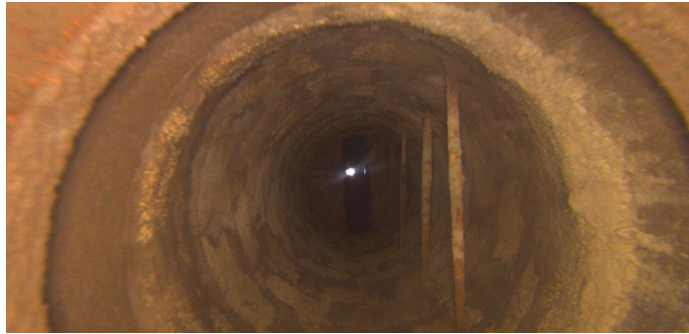
Code: **SAV**
Description: **Surface Aggregate Visible**

Distance (ft): **.0**
Structural Grade: **3**
O&M Grade: **0**
Clock Start/From: **12**
Clock To: **12**
1st Value:
2nd Value:
Value Percent:
Step: **NO**
Remarks:

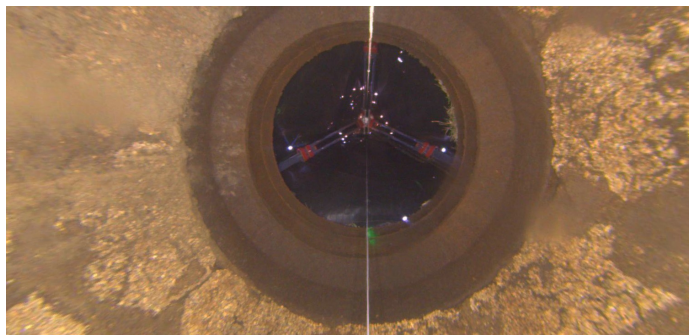
Code: **MGO**
Description: **General Observation**

Distance (ft): **3.1**
Structural Grade: **0**
O&M Grade: **0**
Clock Start/From:
Clock To:
1st Value:
2nd Value:
Value Percent:
Step: **NO**
Remarks: **underside of frame**

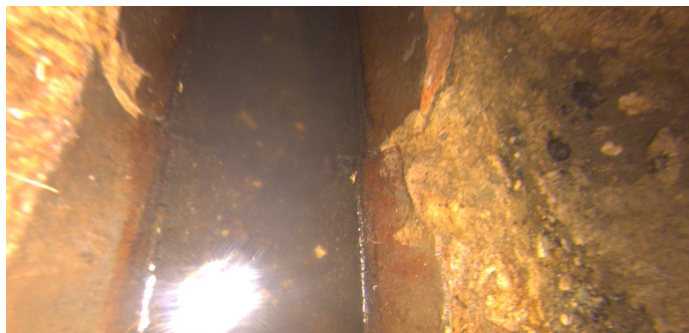
Code: **DSC**
Description: **Deposits Settled Compacted**

Distance (ft): **8.0**
Structural Grade: **0**
O&M Grade: **2**
Clock Start/From: **12**
Clock To: **12**
1st Value:
2nd Value:
Value Percent: **5.000**
Step: **NO**
Remarks:

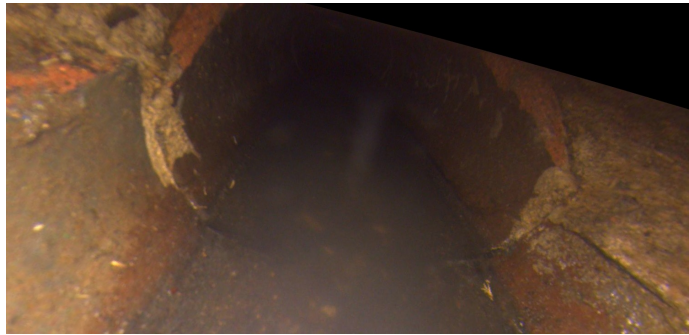
Code: **MGO**
Description: **General Observation**

Distance (ft): **8.5**
Structural Grade: **0**
O&M Grade: **0**
Clock Start/From:
Clock To:
1st Value:
2nd Value:
Value Percent:
Step: **NO**
Remarks: **end of survey**

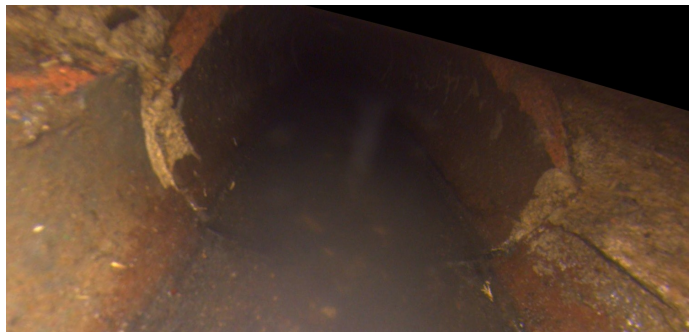
Code: **SAV**
Description: **Surface Aggregate Visible**

Distance (ft): **8.5**
Structural Grade: **3**
O&M Grade: **0**
Clock Start/From: **12**
Clock To: **12**
1st Value:
2nd Value:
Value Percent:
Step: **NO**
Remarks:
