Manhole Inspection Report

Street:	Virginia St. 26' South of Pennsylvani	Project:	Hobart, IN
City:	Hobart, IN	GPS Northing:	2900994.061
Location:		GPS Easting:	2900994.061
Drain Area:	Northwest	GPS Accuracy:	Sub-Meter
Cover Shape:	Circular	Evidence of Surcharge:	Yes
Cover Size:	23.0	Potential for Runoff:	None
Comments:

M-503-028

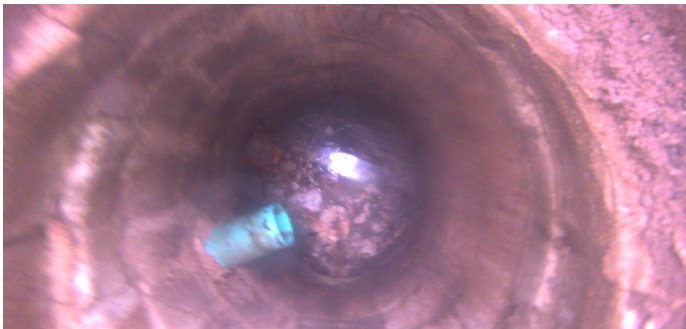
Code:	MGP
Description:	General Photo

Distance (ft):	.0
Structural Grade:	0
O&M Grade:	0
Clock Start/From:	
Clock To:	
1st Value:	
2nd Value:	
Value Percent:	
Step:	NO
Remarks:

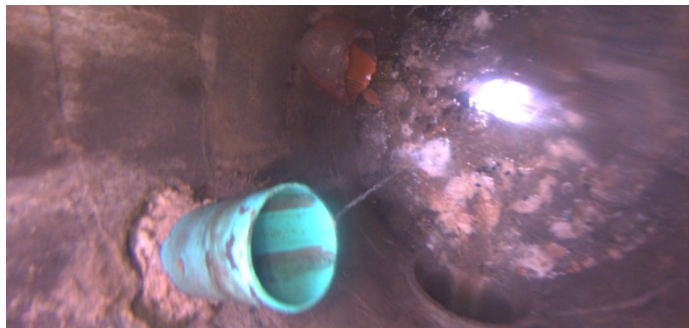
Code: **RFC**
Description: **Roots Fine Connection**

Distance (ft): **2.4**
Structural Grade: **0**
O&M Grade: **1**
Clock Start/From: **7**
Clock To:
1st Value:
2nd Value:
Value Percent:
Step: **NO**
Remarks:

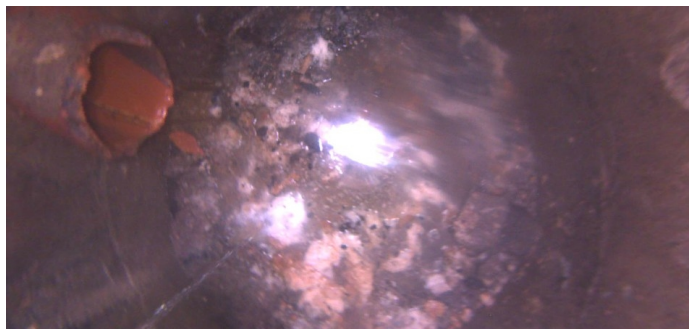
Code: **DAZ**
Description: **Deposits Attached Other**

Distance (ft): **3.2**
Structural Grade: **0**
O&M Grade: **2**
Clock Start/From: **12**
Clock To: **12**
1st Value:
2nd Value:
Value Percent: **10.000**
Step: **NO**
Remarks: **Mixed materials**

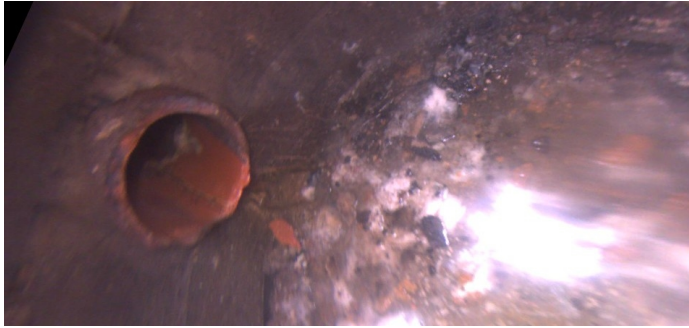
Code: **RFC**
Description: **Roots Fine Connection**

Distance (ft): **3.9**
Structural Grade: **0**
O&M Grade: **1**
Clock Start/From: **9**
Clock To:
1st Value:
2nd Value:
Value Percent:
Step: **NO**
Remarks:
