Manhole Inspection Report

Date:	04/10/2018	Weather:		Coding:	RZMACP
MH#:	M-503-030	Owner:	NA	Len. Surveyed:	3.8
P.O.#:		Surveyor:	John Kuglmaier	Rim to Invert:	5.0
Customer:		Cert. #:	U-1215-07002349	Wall Material:	Concrete (reinforced)

Street:	Delaware St. 372' South of 40th Ave.	Project:	Hobart, IN
City:	Hobart, IN	GPS Northing:	2900682.172
Location:		GPS Easting:	2900682.172
Drain Area:	Northwest	GPS Accuracy:	Sub-Meter
Cover Shape:	Circular	Evidence of Surcharge:	No
Cover Size:	23.0	Potential for Runoff:	None
Comments:

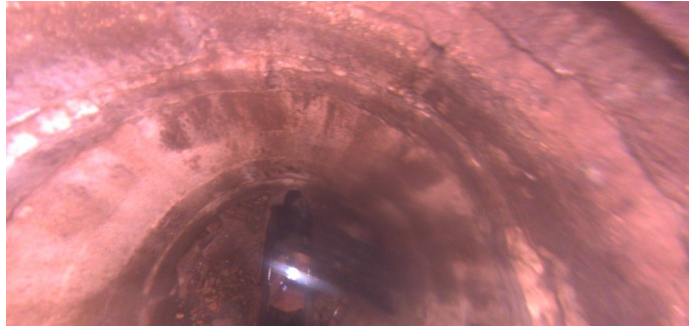
Code:	MGP
Description:	General Photo

Distance (ft):	.0
Structural Grade:	0
O&M Grade:	0
Clock Start/From:	
Clock To:	
1st Value:	
2nd Value:	
Value Percent:	
Step:	NO
Remarks:

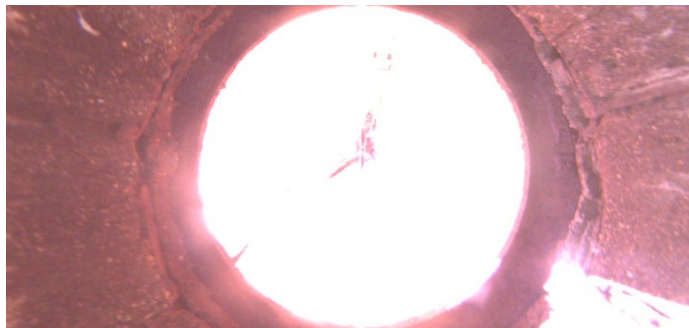
Code: **IS**
Description: **Infil Stain**

Distance (ft): **.0**
Structural Grade: **0**
O&M Grade: **0**
Clock Start/From: **11**
Clock To: **2**
1st Value:
2nd Value:
Value Percent:
Step: **NO**
Remarks:

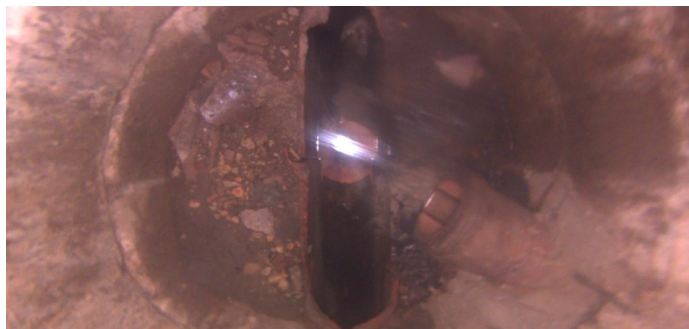
Code: **MGP**
Description: **General Photo**

Distance (ft): **1.8**
Structural Grade: **0**
O&M Grade: **0**
Clock Start/From:
Clock To:
1st Value:
2nd Value:
Value Percent:
Step: **NO**
Remarks:

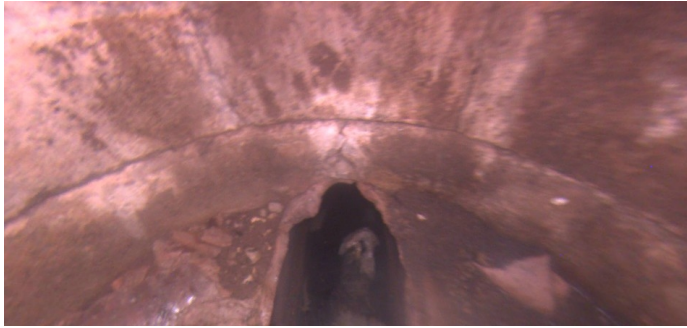
Code: **DAZ**
Description: **Deposits Attached Other**

Distance (ft): **2.0**
Structural Grade: **0**
O&M Grade: **2**
Clock Start/From: **12**
Clock To: **12**
1st Value:
2nd Value:
Value Percent: **5.000**
Step: **NO**
Remarks: **Mixed materials**

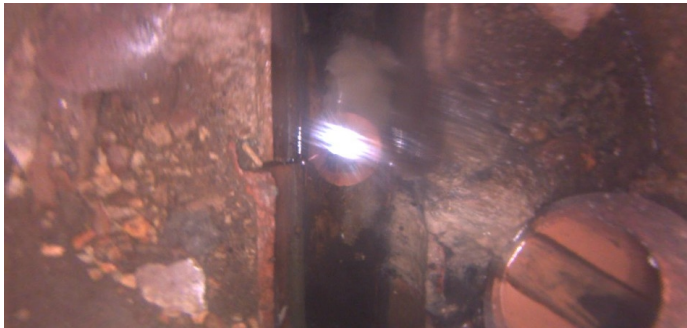
Code: **CL**
Description: **Crack Longitudinal**

Distance (ft): **2.9**
Structural Grade: **2**
O&M Grade: **0**
Clock Start/From: **12**
Clock To:
1st Value:
2nd Value:
Value Percent:
Step: **NO**
Remarks:
