Manhole Inspection Report

O&M Index:	3.00	O&M Quick:	3100	O&M Rating:	3.00
Structural Index:	5.00	Structural Quick:	5100	Structural Rating:	5.00
Overall Index:	4.00	Overall Quick:	5131	Overall Rating:	8.00

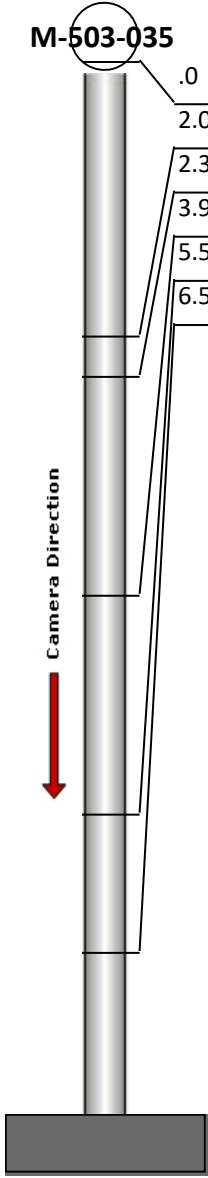
.0	MGP	General Photo	10	NA
	2.0	SRV	Surface Reinforcement Visible	26	S 5
	2.3	MGP	General Photo	40	NA
	3.9	IS	Infil Stain	57	NA
	5.5	DSF	Deposits Settled Fine	71	M 3
	6.5	MGO	General Observation	85	NA

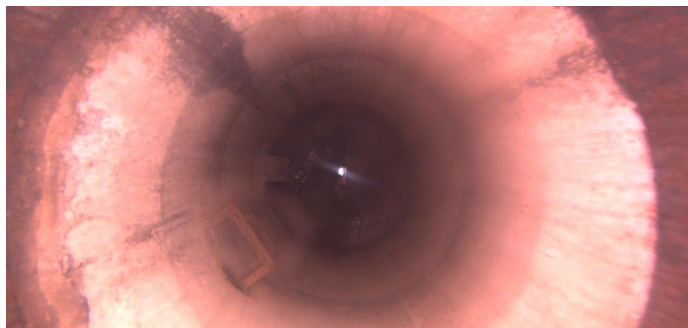
Code: **MGP**
Description: **General Photo**

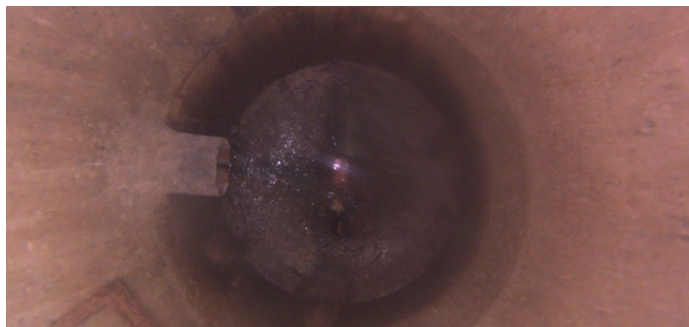
Code:	IS
Description:	Infil Stain
Distance (ft):	3.9
Structural Grade:	0
O&M Grade:	0
Clock Start/From:	12
Clock To:	12
1st Value:	
2nd Value:	
Value Percent:	
Step:	NO
Remarks:

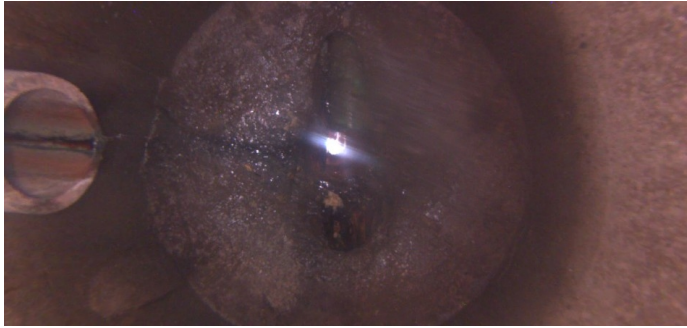
Code:	DSF
Description:	Deposits Settled Fine
Distance (ft):	5.5
Structural Grade:	0
O&M Grade:	3
Clock Start/From:	12
Clock To:	12
1st Value:	
2nd Value:	
Value Percent:	15.000
Step:	NO
Remarks:
