Manhole Inspection Report

Date:	10/07/2022	Weather:		Coding:	RZMACP
MH#:	M-503-040	Owner:	NA	Len. Surveyed:	8.0
P.O.#:		Surveyor:	Todd Machine	Rim to Invert:	9.5
Customer:		Cert. #:	P0038859-082022	Wall Material:	Concrete (cast in place)

Street:	Pennsylvania St. and Cavender St.	Project:	Hobart, IN
City:	Hobart, IN	GPS Northing:	2294368.341
Location:	Other	GPS Easting:	2900008.495
Drain Area:	Northwest	GPS Accuracy:	Sub-Meter
Cover Shape:	Circular	Evidence of Surcharge:	No
Cover Size:	24.0	Potential for Runoff:	None
Comments:

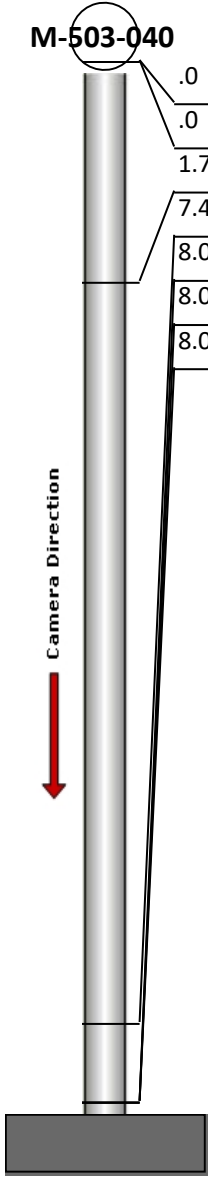
.0	MGO	General Observation	10	NA
	.0	SRI	Surface Roughness Increased	21	S 1
	1.7	MGO	General Observation	38	NA
	7.4	IW	Infil Weeper	64	M 2
	8.0	DSF	Deposits Settled Fine	76	M 2
	8.0	SRI	Surface Roughness Increased	88	S 1
	8.0	MGO	General Observation	98	NA

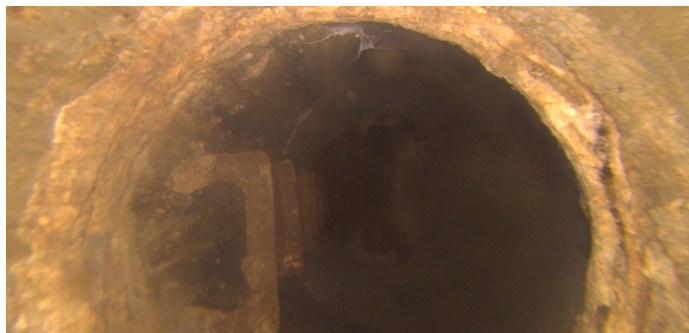
Code: **MGO**
Description: **General Observation**

Distance (ft): **.0**
Structural Grade: **0**
O&M Grade: **0**
Clock Start/From:
Clock To:
1st Value:
2nd Value:
Value Percent:
Step: **NO**
Remarks: **access mh**

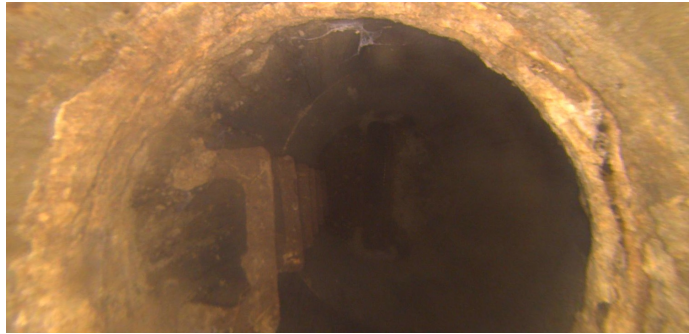
Code: **SRI**
Description: **Surface Roughness Increased**

Distance (ft): **.0**
Structural Grade: **1**
O&M Grade: **0**
Clock Start/From: **12**
Clock To: **12**
1st Value:
2nd Value:
Value Percent:
Step: **NO**
Remarks:

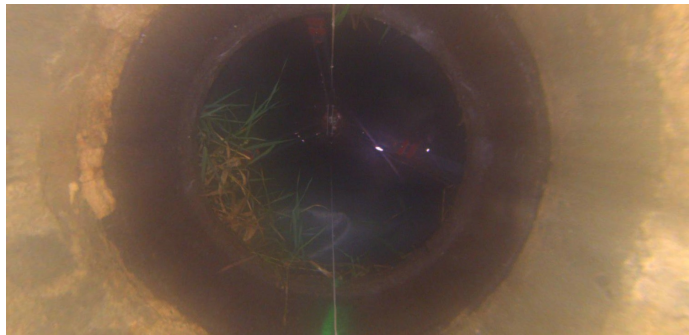
Code: **MGO**
Description: **General Observation**

Distance (ft): **1.7**
Structural Grade: **0**
O&M Grade: **0**
Clock Start/From:
Clock To:
1st Value:
2nd Value:
Value Percent:
Step: **NO**
Remarks: **underside of frame**

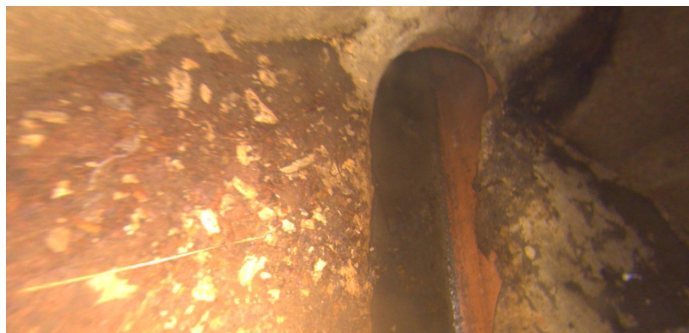
Code: **IW**
Description: **Infil Weeper**

Distance (ft): **7.4**
Structural Grade: **0**
O&M Grade: **2**
Clock Start/From: **1**
Clock To:
1st Value:
2nd Value:
Value Percent:
Step: **NO**
Remarks:

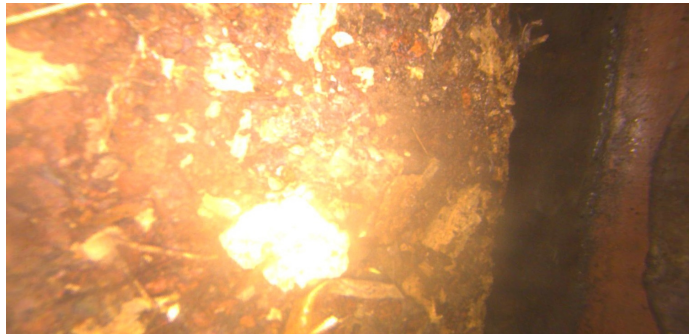
Code: **DSF**
Description: **Deposits Settled Fine**

Distance (ft): **8.0**
Structural Grade: **0**
O&M Grade: **2**
Clock Start/From: **12**
Clock To: **12**
1st Value:
2nd Value:
Value Percent: **5.000**
Step: **NO**
Remarks:

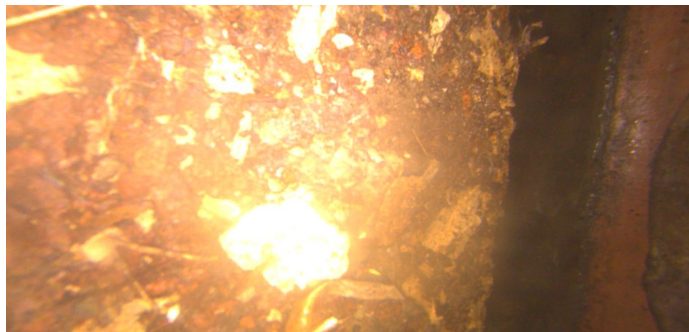
Code: **SRI**
Description: **Surface Roughness Increased**

Distance (ft): **8.0**
Structural Grade: **1**
O&M Grade: **0**
Clock Start/From: **12**
Clock To: **12**
1st Value:
2nd Value:
Value Percent:
Step: **NO**
Remarks:

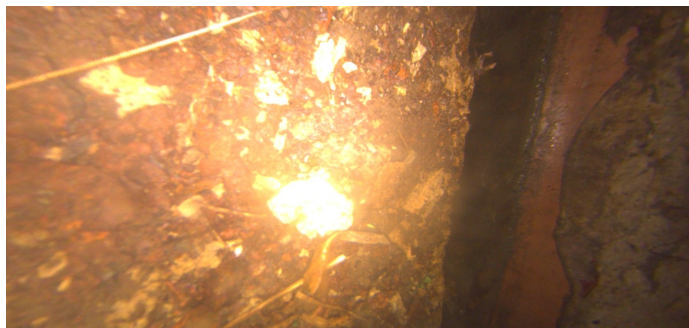
Code: **MGO**
Description: **General Observation**

Distance (ft): **8.0**
Structural Grade: **0**
O&M Grade: **0**
Clock Start/From:
Clock To:
1st Value:
2nd Value:
Value Percent:
Step: **NO**
Remarks: **End Of Survey**
