Manhole Inspection Report

Date:	04/11/2018	Weather:		Coding:	RZMACP
MH#:	M-503-043	Owner:	NA	Len. Surveyed:	8.6
P.O.#:		Surveyor:	John Kuglmaier	Rim to Invert:	10.3
Customer:		Cert. #:	U-1215-07002349	Wall Material:	Concrete (reinforced)

Street:	Pennsylvania St. 105' West of Guyer	Project:	Hobart, IN
City:	Hobart, IN	GPS Northing:	2899613.025
Location:		GPS Easting:	2899613.025
Drain Area:	Northwest	GPS Accuracy:	Sub-Meter
Cover Shape:	Circular	Evidence of Surcharge:	Yes
Cover Size:	23.0	Potential for Runoff:	None
Comments:

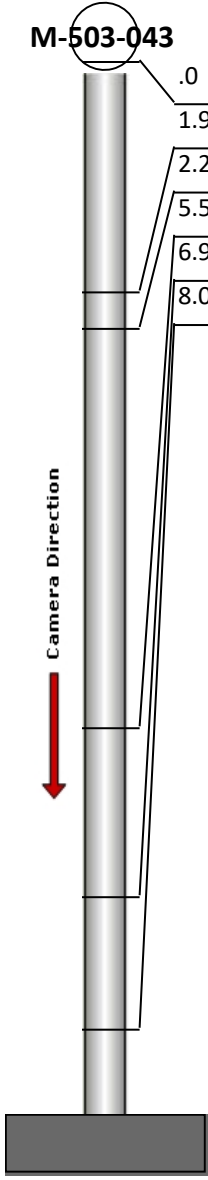
M-503-043				
	.0	MGP	General Photo	10	NA
	1.9	MGP	General Photo	28	NA
	2.2	IS	Infil Stain	42	NA
	5.5	OBZ	Obstacle Other	60	M 5
	6.9	DSF	Deposits Settled Fine	74	M 2
	8.0	MGO	General Observation	88	NA

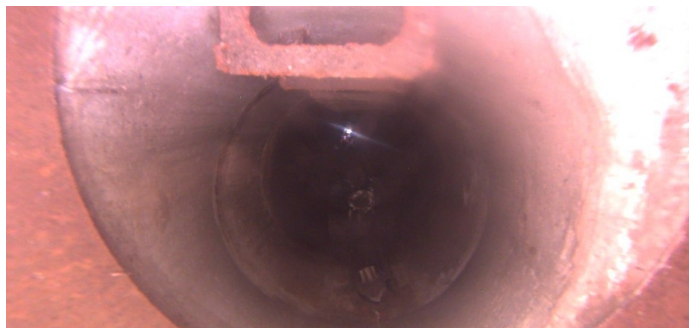
Code: **MGP**
Description: **General Photo**

Distance (ft): **.0**
Structural Grade: **0**
O&M Grade: **0**
Clock Start/From:
Clock To:
1st Value:
2nd Value:
Value Percent:
Step: **NO**
Remarks:

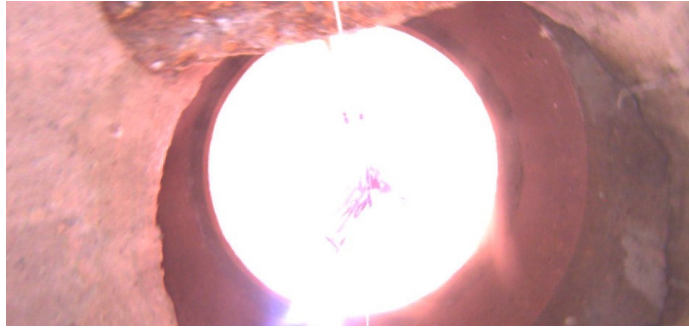
Code: **MGP**
Description: **General Photo**

Distance (ft): **1.9**
Structural Grade: **0**
O&M Grade: **0**
Clock Start/From:
Clock To:
1st Value:
2nd Value:
Value Percent:
Step: **NO**
Remarks:

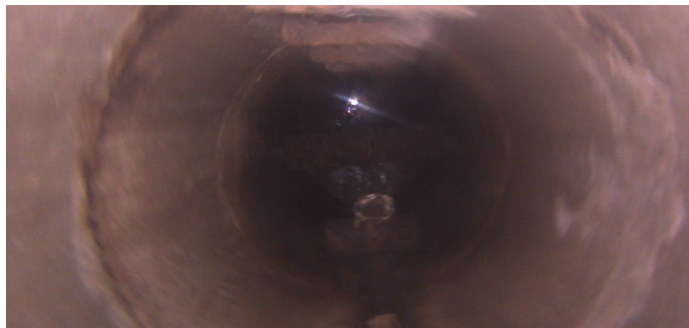
Code: **IS**
Description: **Infil Stain**

Distance (ft): **2.2**
Structural Grade: **0**
O&M Grade: **0**
Clock Start/From: **12**
Clock To: **12**
1st Value:
2nd Value:
Value Percent:
Step: **NO**
Remarks:

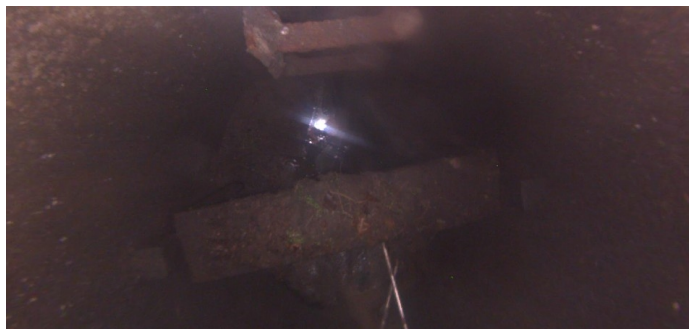
Code: **OBZ**
Description: **Obstacle Other**

Distance (ft): **5.5**
Structural Grade: **0**
O&M Grade: **5**
Clock Start/From: **3**
Clock To: **8**
1st Value:
2nd Value:
Value Percent: **35.000**
Step: **NO**
Remarks: **Wooden bench**

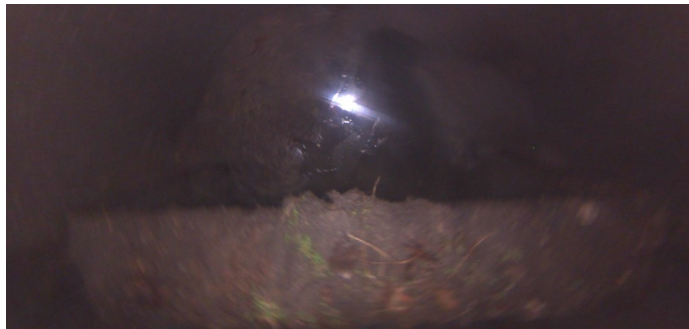
Code:	DSF
Description:	Deposits Settled Fine
Distance (ft):	6.9
Structural Grade:	0
O&M Grade:	2
Clock Start/From:	12
Clock To:	12
1st Value:	
2nd Value:	
Value Percent:	10.000
Step:	NO
Remarks:

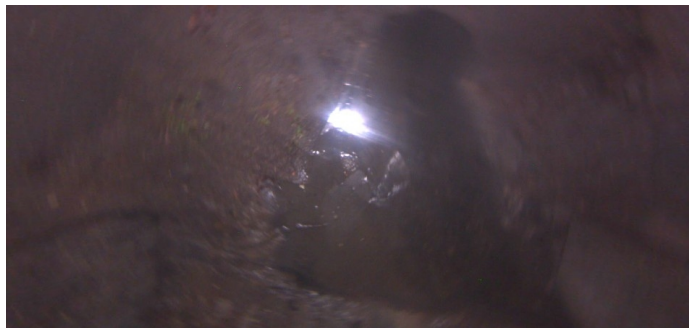
Code:	MGO
Description:	General Observation
Distance (ft):	8.0
Structural Grade:	0
O&M Grade:	0
Clock Start/From:	
Clock To:	
1st Value:	
2nd Value:	
Value Percent:	
Step:	NO
Remarks:	Ins. Comp.
