# Manhole Inspection Report

Date:	<b>04/09/2018</b>	Weather:		Coding:	<b>RZMACP</b>
MH#:	<b>M-503-045</b>	Owner:	<b>NA</b>	Len. Surveyed:	<b>6.7</b>
P.O.#:		Surveyor:	<b>John Kuglmaier</b>	Rim to Invert:	<b>8.7</b>
Customer:		Cert. #:	<b>U-1215-07002349</b>	Wall Material:	<b>Concrete (reinforced)</b>

Street:	<b>289' East of Virginia St. 172' South o</b>	Project:	<b>Hobart, IN</b>
City:	<b>Hobart, IN</b>	GPS Northing:	<b>2901599.068</b>
Location:		GPS Easting:	<b>2901599.068</b>
Drain Area:	<b>Northwest</b>	GPS Accuracy:	<b>Sub-Meter</b>
Cover Shape:	<b>Circular</b>	Evidence of Surcharge:	<b>No</b>
Cover Size:	<b>23.0</b>	Potential for Runoff:	<b>None</b>
Comments:

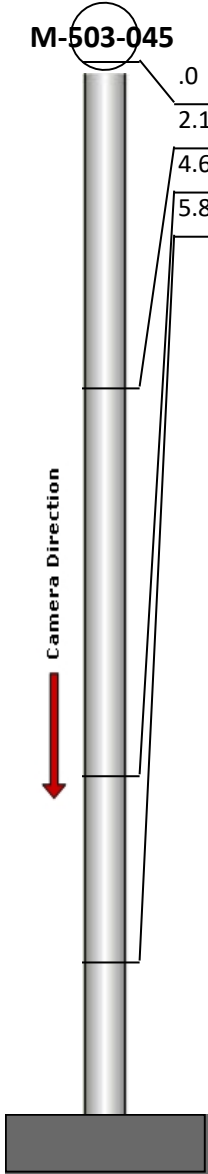
.0	MGP	General Photo	10	NA
	2.1	MGP	General Photo	28	NA
	4.6	DSF	Deposits Settled Fine	47	M 2
	5.8	MGO	General Observation	61	NA

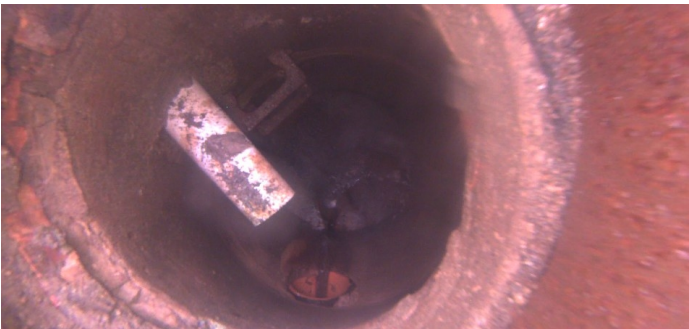
Code: **MGP**  
 Description: **General Photo**

Distance (ft): **.0**  
 Structural Grade: **0**  
 O&M Grade: **0**  
 Clock Start/From:  
 Clock To:  
 1st Value:  
 2nd Value:  
 Value Percent:  
 Step: **NO**  
 Remarks:

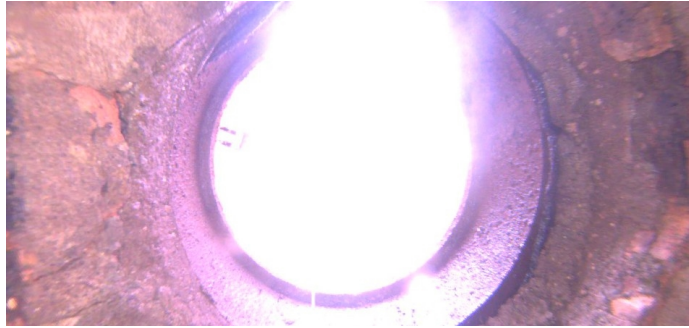
Code: **MGP**  
Description: **General Photo**

Distance (ft): **2.1**  
Structural Grade: **0**  
O&M Grade: **0**  
Clock Start/From:  
Clock To:  
1st Value:  
2nd Value:  
Value Percent:  
Step: **NO**  
Remarks:

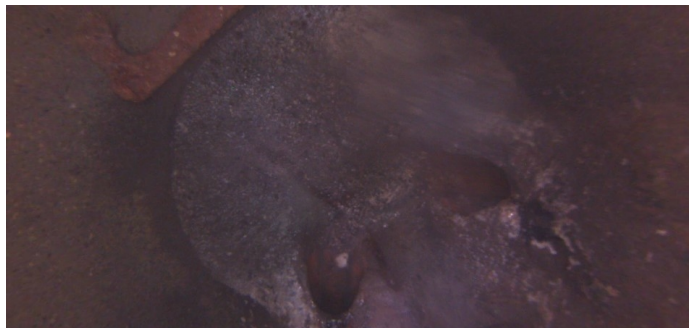
Code: **DSF**  
Description: **Deposits Settled Fine**

Distance (ft): **4.6**  
Structural Grade: **0**  
O&M Grade: **2**  
Clock Start/From: **12**  
Clock To: **12**  
1st Value:  
2nd Value:  
Value Percent: **5.000**  
Step: **NO**  
Remarks:

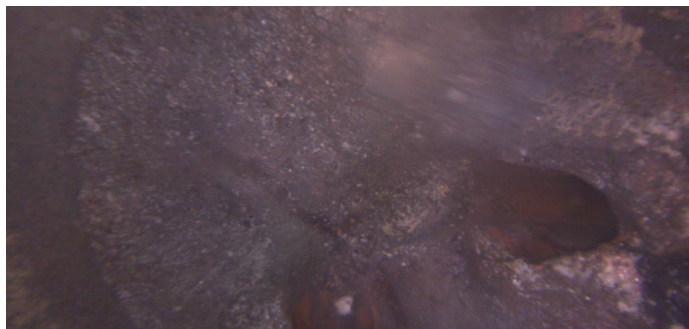
Code: **MGO**  
Description: **General Observation**

Distance (ft): **5.8**  
Structural Grade: **0**  
O&M Grade: **0**  
Clock Start/From:  
Clock To:  
1st Value:  
2nd Value:  
Value Percent:  
Step: **NO**  
Remarks: **Ins. Comp.**
