Manhole Inspection Report

Date:	04/09/2018	Weather:		Coding:	RZMACP
MH#:	M-503-049	Owner:	NA	Len. Surveyed:	7.1
P.O.#:		Surveyor:	John Kuglmaier	Rim to Invert:	8.5
Customer:		Cert. #:	U-1215-07002349	Wall Material:	Concrete (reinforced)

Street:	305' West of Virginia St. 171' South	Project:	Hobart, IN
City:	Hobart, IN	GPS Northing:	2900742.811
Location:		GPS Easting:	2900742.811
Drain Area:	Northwest	GPS Accuracy:	Sub-Meter
Cover Shape:	Circular	Evidence of Surcharge:	Yes
Cover Size:	23.0	Potential for Runoff:	None
Comments:

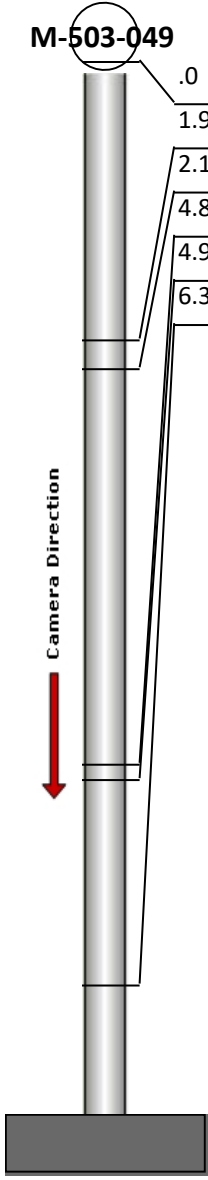
Position	Code	Observation	Video (sec)	Grade

.0	MGP	General Photo	10	NA
	1.9	IS	Infil Stain	25	NA
	2.1	MGP	General Photo	40	NA
	4.8	IS	Infil Stain	59	NA
	4.9	DSF	Deposits Settled Fine	71	M 2
	6.3	MGO	General Observation	85	NA

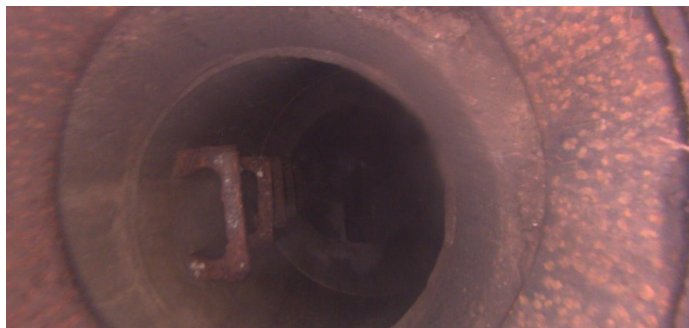
Code: **MGP**
Description: **General Photo**

Distance (ft): **.0**
Structural Grade: **0**
O&M Grade: **0**
Clock Start/From:
Clock To:
1st Value:
2nd Value:
Value Percent:
Step: **NO**
Remarks:

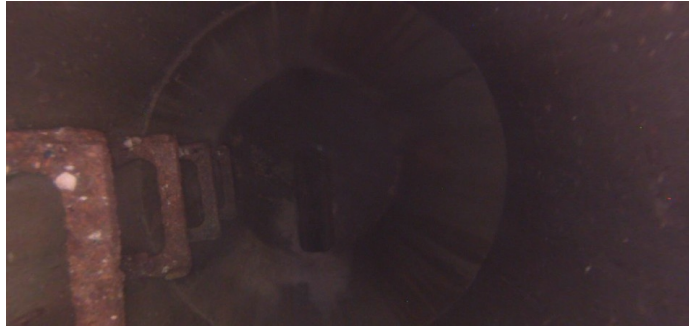
Code: **IS**
Description: **Infil Stain**

Distance (ft): **1.9**
Structural Grade: **0**
O&M Grade: **0**
Clock Start/From: **12**
Clock To: **12**
1st Value:
2nd Value:
Value Percent:
Step: **NO**
Remarks:

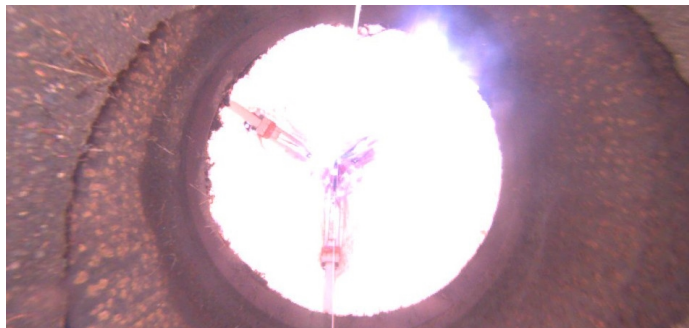
Code: **MGP**
Description: **General Photo**

Distance (ft): **2.1**
Structural Grade: **0**
O&M Grade: **0**
Clock Start/From:
Clock To:
1st Value:
2nd Value:
Value Percent:
Step: **NO**
Remarks:

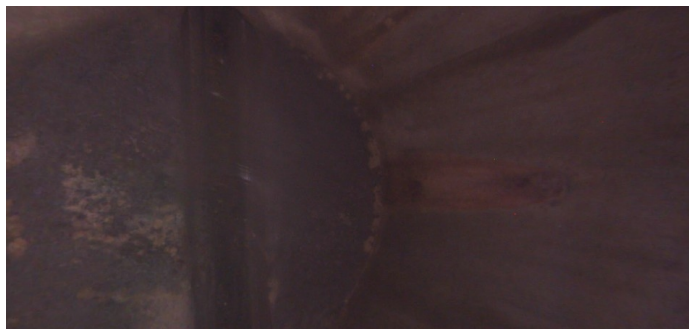
Code: **IS**
Description: **Infil Stain**

Distance (ft): **4.8**
Structural Grade: **0**
O&M Grade: **0**
Clock Start/From: **3**
Clock To:
1st Value:
2nd Value:
Value Percent:
Step: **NO**
Remarks:

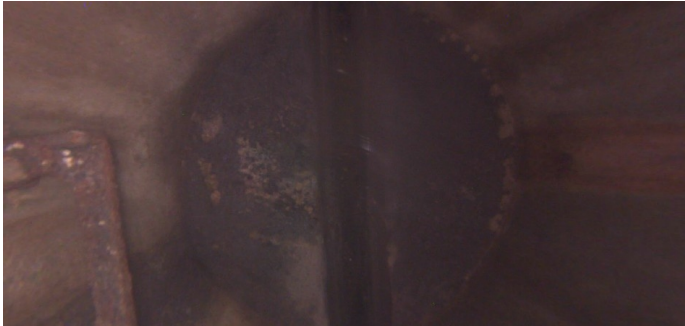
Code:	DSF
Description:	Deposits Settled Fine

Distance (ft):	4.9
Structural Grade:	0
O&M Grade:	2
Clock Start/From:	12
Clock To:	12
1st Value:	
2nd Value:	
Value Percent:	5.000
Step:	NO
Remarks:

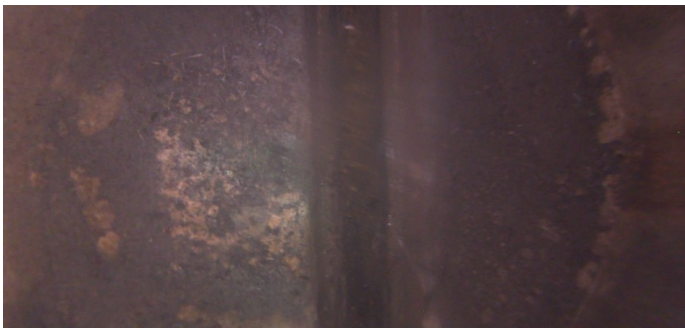
Code:	MGO
Description:	General Observation

Distance (ft):	6.3
Structural Grade:	0
O&M Grade:	0
Clock Start/From:	
Clock To:	
1st Value:	
2nd Value:	
Value Percent:	
Step:	NO
Remarks:	Ins. Comp.
