# Manhole Inspection Report

Date:	<b>04/09/2018</b>	Weather:		Coding:	<b>RZMACP</b>
MH#:	<b>M-503-050</b>	Owner:	<b>NA</b>	Len. Surveyed:	<b>7.3</b>
P.O.#:		Surveyor:	<b>John Kuglmaier</b>	Rim to Invert:	<b>8.6</b>
Customer:		Cert. #:	<b>U-1215-07002349</b>	Wall Material:	<b>Concrete (reinforced)</b>

Street:	<b>Colorado St. 169' North of 39th Ave.</b>	Project:	<b>Hobart, IN</b>
City:	<b>Hobart, IN</b>	GPS Northing:	<b>2900458.854</b>
Location:		GPS Easting:	<b>2900458.854</b>
Drain Area:	<b>Northwest</b>	GPS Accuracy:	<b>Sub-Meter</b>
Cover Shape:	<b>Circular</b>	Evidence of Surcharge:	<b>Yes</b>
Cover Size:	<b>23.0</b>	Potential for Runoff:	<b>None</b>
Comments:

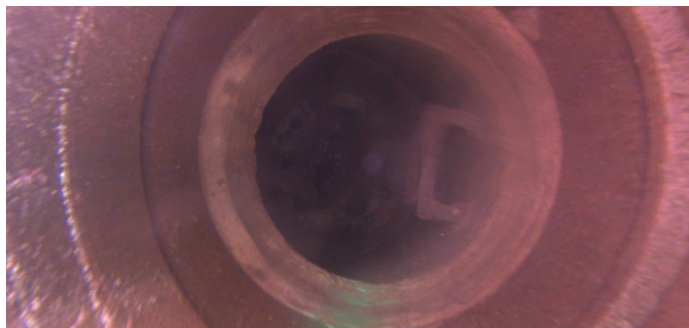
Code: **MGP**  
Description: **General Photo**

Distance (ft): **.0**  
Structural Grade: **0**  
O&M Grade: **0**  
Clock Start/From:  
Clock To:  
1st Value:  
2nd Value:  
Value Percent:  
Step: **NO**  
Remarks:

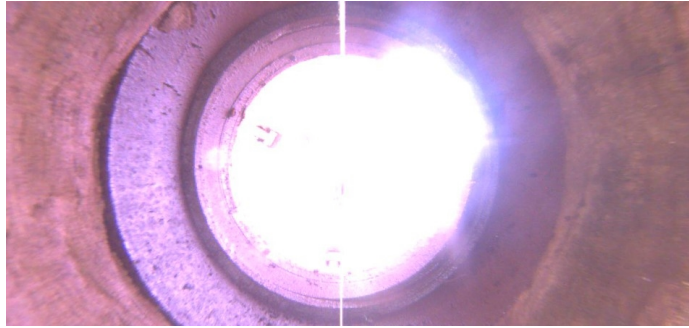
Code: **MGP**  
Description: **General Photo**

Distance (ft): **2.6**  
Structural Grade: **0**  
O&M Grade: **0**  
Clock Start/From:  
Clock To:  
1st Value:  
2nd Value:  
Value Percent:  
Step: **NO**  
Remarks:

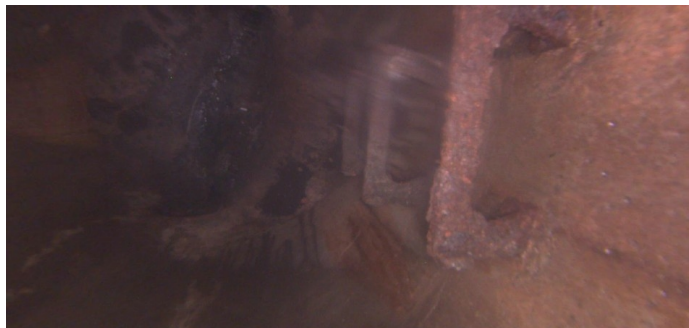
Code: **IS**  
Description: **Infil Stain**

Distance (ft): **3.8**  
Structural Grade: **0**  
O&M Grade: **0**  
Clock Start/From: **4**  
Clock To:  
1st Value:  
2nd Value:  
Value Percent:  
Step: **NO**  
Remarks:

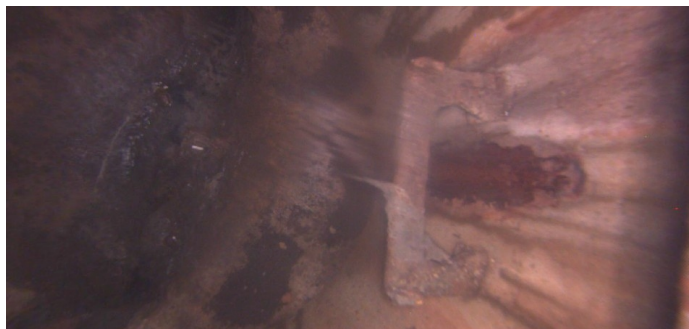
Code: **IS**  
Description: **Infil Stain**

Distance (ft): **5.3**  
Structural Grade: **0**  
O&M Grade: **0**  
Clock Start/From: **3**  
Clock To:  
1st Value:  
2nd Value:  
Value Percent:  
Step: **NO**  
Remarks:

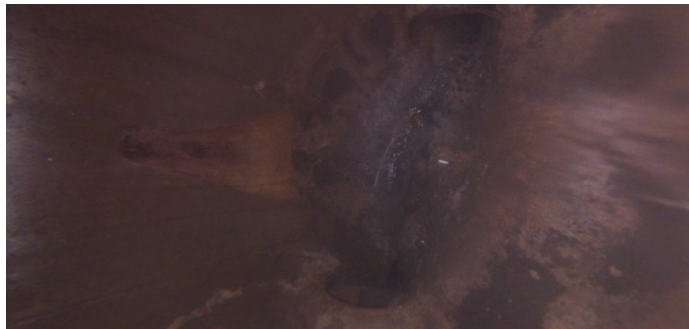
Code: **IS**  
Description: **Infil Stain**

Distance (ft): **5.3**  
Structural Grade: **0**  
O&M Grade: **0**  
Clock Start/From: **8**  
Clock To:  
1st Value:  
2nd Value:  
Value Percent:  
Step: **NO**  
Remarks:

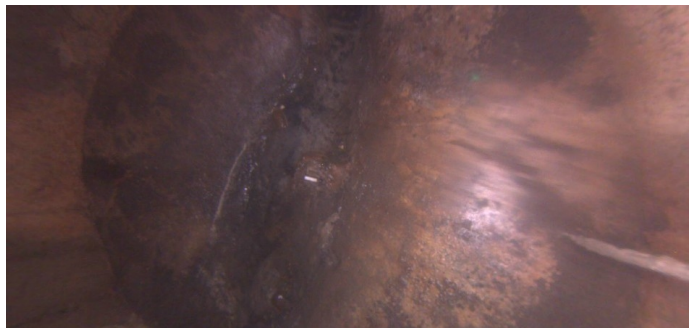
Code: **MGO**  
Description: **General Observation**

Distance (ft): **6.6**  
Structural Grade: **0**  
O&M Grade: **0**  
Clock Start/From:  
Clock To:  
1st Value:  
2nd Value:  
Value Percent:  
Step: **NO**  
Remarks: **Ins. Comp.**
