Manhole Inspection Report

Date:	10/06/2022	Weather:		Coding:	RZMACP
MH#:	M-503-053	Owner:	NA	Len. Surveyed:	8.6
P.O.#:		Surveyor:	Jen Costello	Rim to Invert:	9.5
Customer:		Cert. #:	U-907-5518	Wall Material:	Concrete (cast in place)

Street:	Intersection of Guyer St. and 38th P	Project:	Hobart, IN
City:	Hobart, IN	GPS Northing:	2294769.108
Location:	Other	GPS Easting:	2899693.631
Drain Area:	Northwest	GPS Accuracy:	Sub-Meter
Cover Shape:	Circular	Evidence of Surcharge:	Yes
Cover Size:	24.0	Potential for Runoff:	None
Comments:

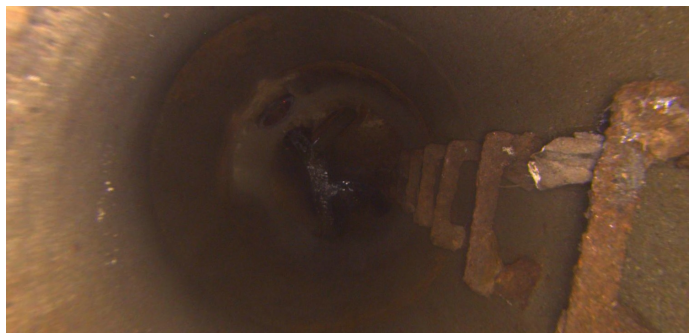
Code: **MGO**
Description: **General Observation**

Distance (ft): **.0**
Structural Grade: **0**
O&M Grade: **0**
Clock Start/From:
Clock To:
1st Value:
2nd Value:
Value Percent:
Step: **NO**
Remarks: **access mh**

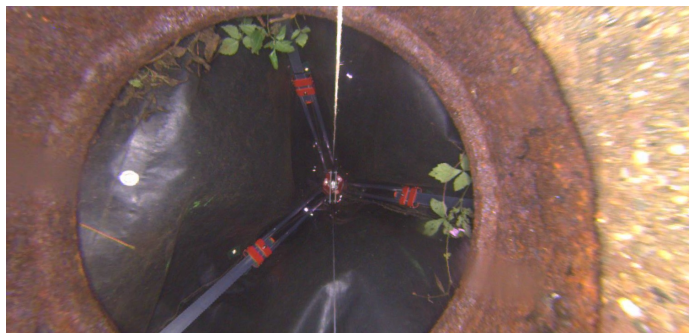
Code:	MGO
Description:	General Observation
Distance (ft):	1.2
Structural Grade:	0
O&M Grade:	0
Clock Start/From:	
Clock To:	
1st Value:	
2nd Value:	
Value Percent:	
Step:	NO
Remarks:	underside of frame

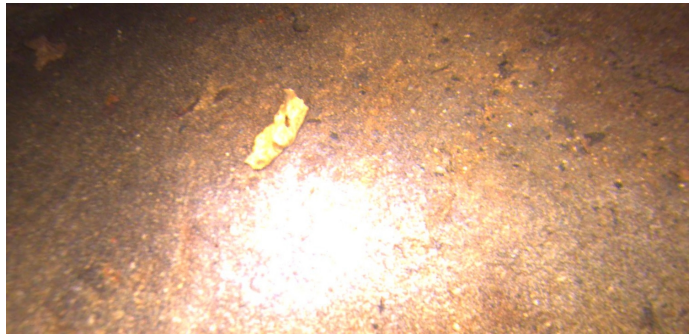
Code: **DAR**
Description: **Deposits Attached Ragging**

Distance (ft): **8.6**
Structural Grade: **0**
O&M Grade: **2**
Clock Start/From: **3**
Clock To: **4**
1st Value:
2nd Value:
Value Percent: **5.000**
Step: **NO**
Remarks:

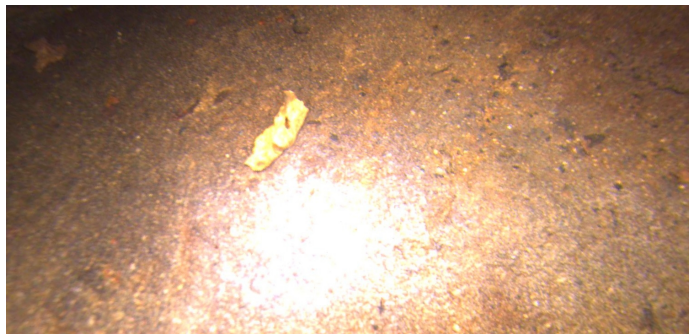
Code: **SRI**
Description: **Surface Roughness Increased**

Distance (ft): **8.6**
Structural Grade: **1**
O&M Grade: **0**
Clock Start/From: **12**
Clock To: **12**
1st Value:
2nd Value:
Value Percent:
Step: **NO**
Remarks:

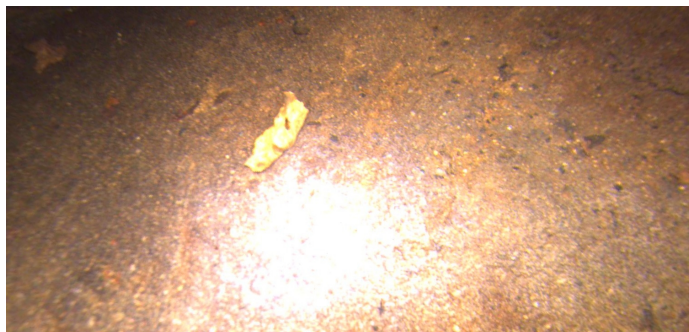
Code: **SRI**
Description: **Surface Roughness Increased**

Distance (ft): **8.6**
Structural Grade: **1**
O&M Grade: **0**
Clock Start/From: **12**
Clock To: **12**
1st Value:
2nd Value:
Value Percent:
Step: **NO**
Remarks:

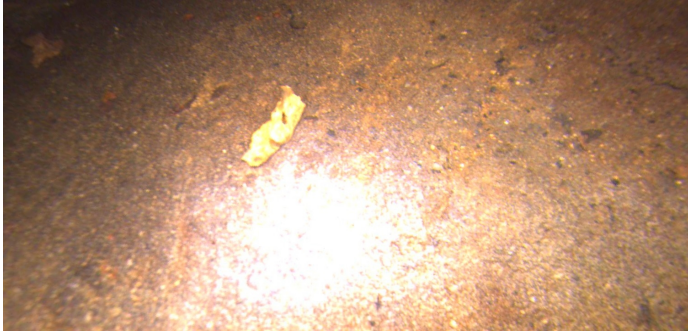
Code:	MGO
Description:	General Observation
Distance (ft):	8.6
Structural Grade:	0
O&M Grade:	0
Clock Start/From:	
Clock To:	
1st Value:	
2nd Value:	
Value Percent:	
Step:	NO
Remarks:	end of survey
