# Manhole Inspection Report

Date:	<b>04/08/2018</b>	Weather:		Coding:	<b>RZMACP</b>
MH#:	<b>M-503-055</b>	Owner:	<b>NA</b>	Len. Surveyed:	<b>6.6</b>
P.O.#:		Surveyor:	<b>John Kuglmaier</b>	Rim to Invert:	<b>8.0</b>
Customer:		Cert. #:	<b>U-1215-07002349</b>	Wall Material:	<b>Concrete (reinforced)</b>

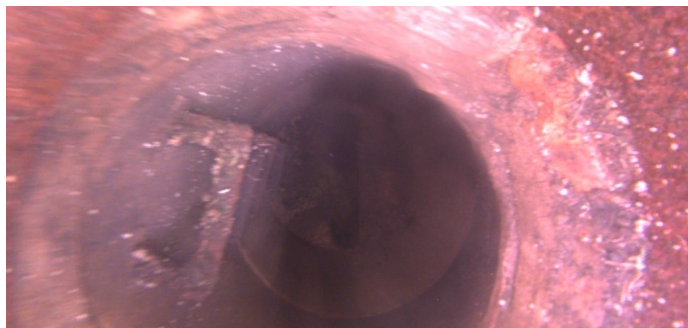
Code: **MGP**  
Description: **General Photo**

Distance (ft): **.0**  
Structural Grade: **0**  
O&M Grade: **0**  
Clock Start/From:  
Clock To:  
1st Value:  
2nd Value:  
Value Percent:  
Step: **NO**  
Remarks:

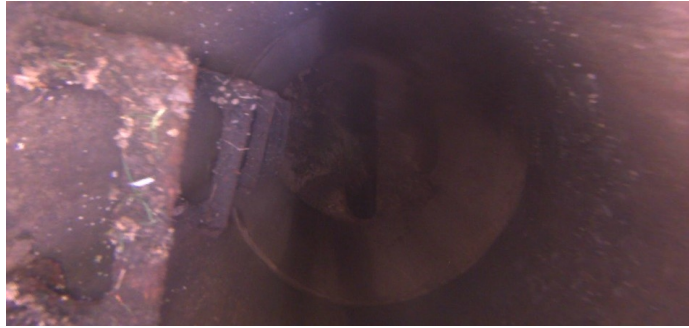
Code: **IS**  
Description: **Infil Stain**

Distance (ft): **1.0**  
Structural Grade: **0**  
O&M Grade: **0**  
Clock Start/From: **7**  
Clock To: **8**  
1st Value:  
2nd Value:  
Value Percent:  
Step: **NO**  
Remarks:

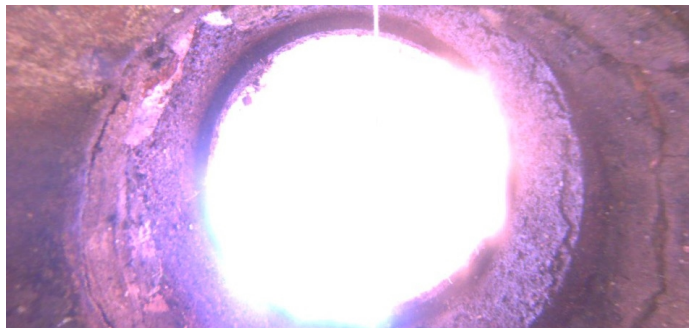
Code: **MGP**  
Description: **General Photo**

Distance (ft): **2.0**  
Structural Grade: **0**  
O&M Grade: **0**  
Clock Start/From:  
Clock To:  
1st Value:  
2nd Value:  
Value Percent:  
Step: **NO**  
Remarks:

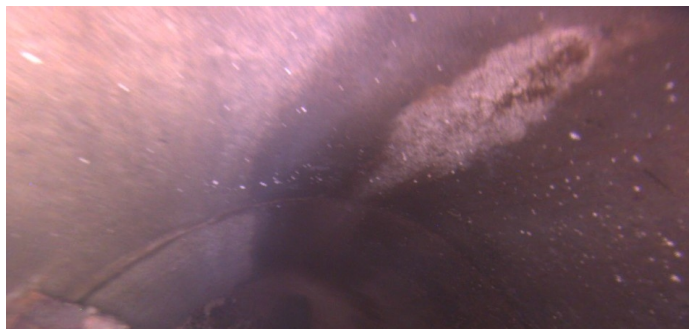
Code: **IS**  
Description: **Infil Stain**

Distance (ft): **2.1**  
Structural Grade: **0**  
O&M Grade: **0**  
Clock Start/From: **1**  
Clock To:  
1st Value:  
2nd Value:  
Value Percent:  
Step: **NO**  
Remarks:

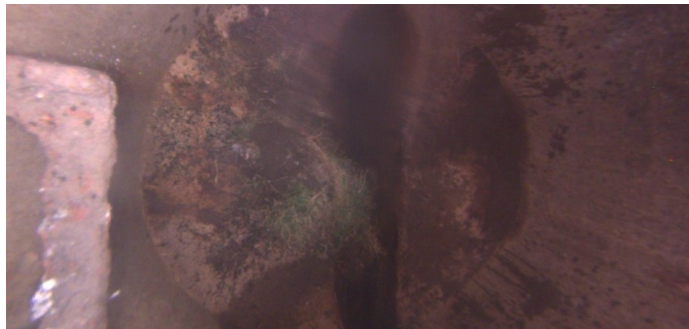
Code:	<b>DAZ</b>
Description:	<b>Deposits Attached Other</b>
Distance (ft):	<b>4.6</b>
Structural Grade:	<b>0</b>
O&M Grade:	<b>2</b>
Clock Start/From:	<b>12</b>
Clock To:	<b>12</b>
1st Value:	
2nd Value:	
Value Percent:	<b>5.000</b>
Step:	<b>NO</b>
Remarks:	<b>Mixed materials</b>

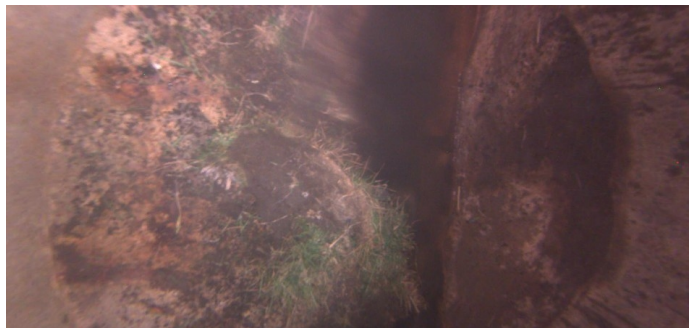
Code:	<b>MGO</b>
Description:	<b>General Observation</b>
Distance (ft):	<b>5.6</b>
Structural Grade:	<b>0</b>
O&M Grade:	<b>0</b>
Clock Start/From:	
Clock To:	
1st Value:	
2nd Value:	
Value Percent:	
Step:	<b>NO</b>
Remarks:	<b>Ins. Comp.</b>
