# Manhole Inspection Report

Date:	<b>04/08/2018</b>	Weather:		Coding:	<b>RZMACP</b>
MH#:	<b>M-503-061</b>	Owner:	<b>NA</b>	Len. Surveyed:	<b>9.9</b>
P.O.#:		Surveyor:	<b>John Kuglmaier</b>	Rim to Invert:	<b>10.7</b>
Customer:		Cert. #:	<b>U-1215-07002349</b>	Wall Material:	<b>Concrete (reinforced)</b>

Street:	<b>300' East of Virginia St. 170' South o</b>	Project:	<b>Hobart, IN</b>
City:	<b>Hobart, IN</b>	GPS Northing:	<b>2901339.644</b>
Location:		GPS Easting:	<b>2901339.644</b>
Drain Area:	<b>Northwest</b>	GPS Accuracy:	<b>Sub-Meter</b>
Cover Shape:	<b>Circular</b>	Evidence of Surcharge:	<b>No</b>
Cover Size:	<b>23.0</b>	Potential for Runoff:	<b>None</b>
Comments:

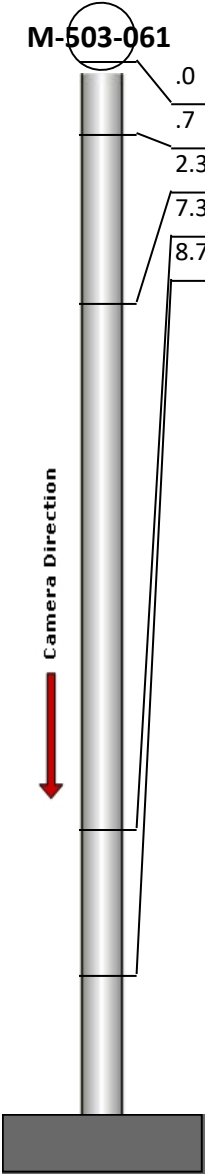
M-503-061				
	.0	MGP	General Photo	10	NA
	.7	DAZ	Deposits Attached Other	23	M 2
	2.3	MGP	General Photo	40	NA
	7.3	DAZ	Deposits Attached Other	64	M 2
	8.7	MGO	General Observation	78	NA

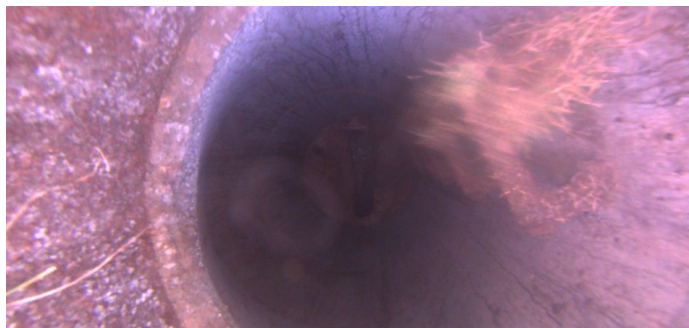
Code: **MGP**  
Description: **General Photo**

Distance (ft): **.0**  
Structural Grade: **0**  
O&M Grade: **0**  
Clock Start/From:  
Clock To:  
1st Value:  
2nd Value:  
Value Percent:  
Step: **NO**  
Remarks:

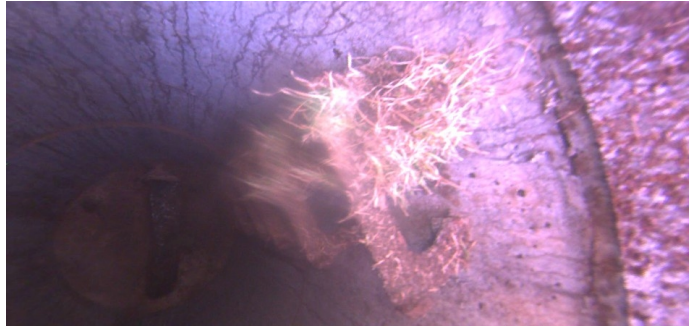
Code:	<b>DAZ</b>
Description:	<b>Deposits Attached Other</b>
Distance (ft):	<b>.7</b>
Structural Grade:	<b>0</b>
O&M Grade:	<b>2</b>
Clock Start/From:	<b>2</b>
Clock To:	
1st Value:	
2nd Value:	
Value Percent:	<b>5.000</b>
Step:	<b>YES</b>
Remarks:	<b>Mixed materials</b>

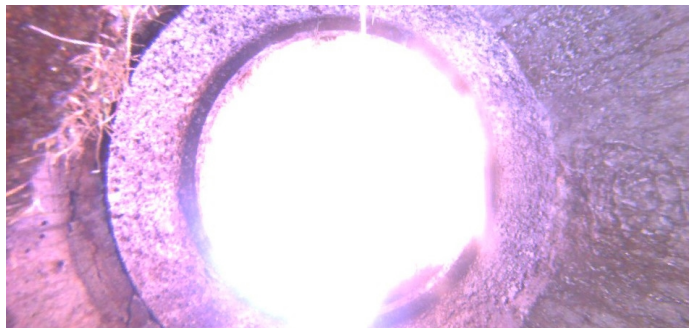
Code:	<b>MGP</b>
Description:	<b>General Photo</b>
Distance (ft):	<b>2.3</b>
Structural Grade:	<b>0</b>
O&M Grade:	<b>0</b>
Clock Start/From:	
Clock To:	
1st Value:	
2nd Value:	
Value Percent:	
Step:	<b>NO</b>
Remarks:

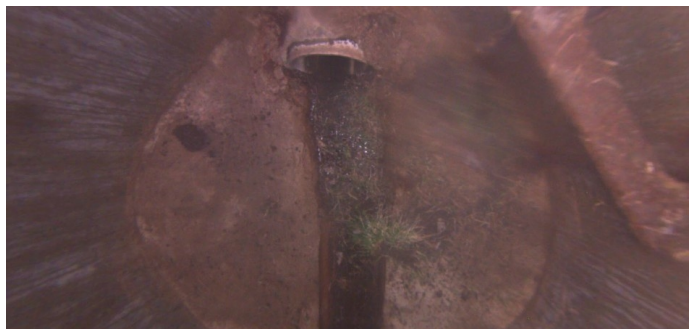
Code:	<b>DAZ</b>
Description:	<b>Deposits Attached Other</b>
Distance (ft):	<b>7.3</b>
Structural Grade:	<b>0</b>
O&M Grade:	<b>2</b>
Clock Start/From:	<b>1</b>
Clock To:	<b>4</b>
1st Value:	
2nd Value:	
Value Percent:	<b>5.000</b>
Step:	<b>NO</b>
Remarks:	<b>Mixed materials</b>

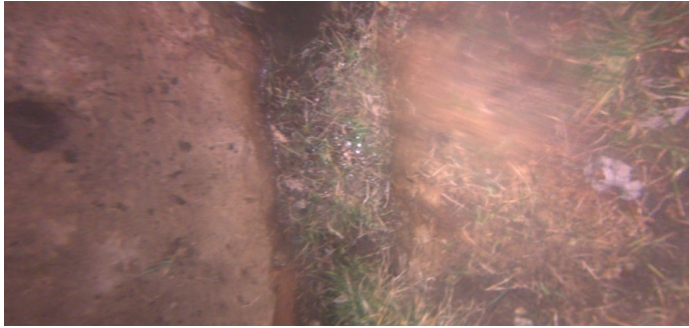
Code:	<b>MGO</b>
Description:	<b>General Observation</b>
Distance (ft):	<b>8.7</b>
Structural Grade:	<b>0</b>
O&M Grade:	<b>0</b>
Clock Start/From:	
Clock To:	
1st Value:	
2nd Value:	
Value Percent:	
Step:	<b>NO</b>
Remarks:	<b>Ins. Comp.</b>
