Manhole Inspection Report

Date:	10/07/2022	Weather:		Coding:	RZMACP
MH#:	M-503-066	Owner:	NA	Len. Surveyed:	4.0
P.O.#:		Surveyor:	Jen Costello	Rim to Invert:	4.9
Customer:		Cert. #:	U-907-5518	Wall Material:	Concrete (cast in place)

Street:	Wisconsin St. 287' South of 37th Ave	Project:	Hobart, IN
City:	Hobart, IN	GPS Northing:	2295485.635
Location:	Other	GPS Easting:	2901729.1
Drain Area:	Northwest	GPS Accuracy:	Sub-Meter
Cover Shape:	Circular	Evidence of Surcharge:	Yes
Cover Size:	24.0	Potential for Runoff:	None
Comments:

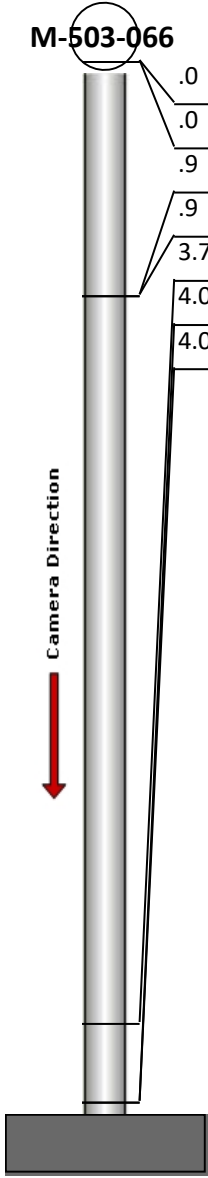
M-503-066				
	.0	MGO	General Observation	10	NA
	.0	SAV	Surface Aggregate Visible	21	S 3
	.9	MGO	General Observation	37	NA
	.9	DAR	Deposits Attached Ragging	50	M 2
	3.7	SAV	Surface Aggregate Visible	68	S 3
	4.0	SAV	Surface Aggregate Visible	81	S 3
	4.0	MGO	General Observation	92	NA

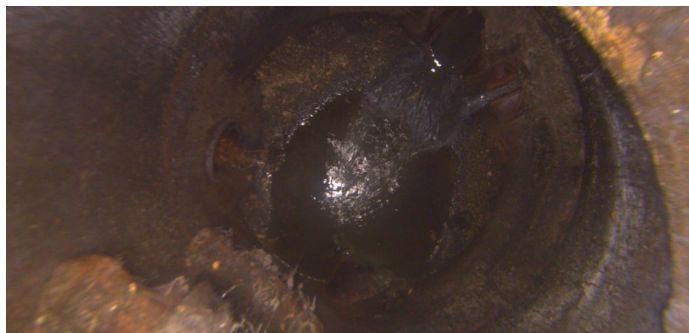
Code: **MGO**
Description: **General Observation**

Distance (ft): **.0**
Structural Grade: **0**
O&M Grade: **0**
Clock Start/From:
Clock To:
1st Value:
2nd Value:
Value Percent:
Step: **NO**
Remarks: **access mh**

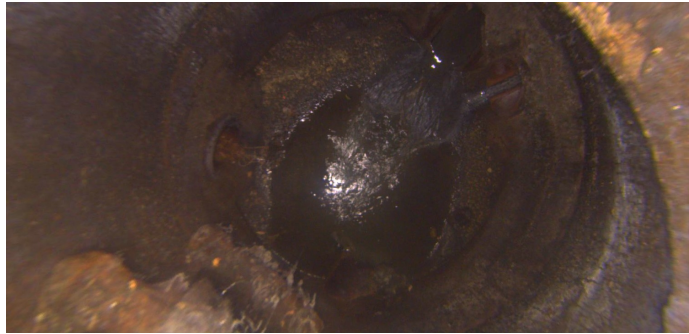
Code: **SAV**
Description: **Surface Aggregate Visible**

Distance (ft): **.0**
Structural Grade: **3**
O&M Grade: **0**
Clock Start/From: **12**
Clock To: **12**
1st Value:
2nd Value:
Value Percent:
Step: **NO**
Remarks:

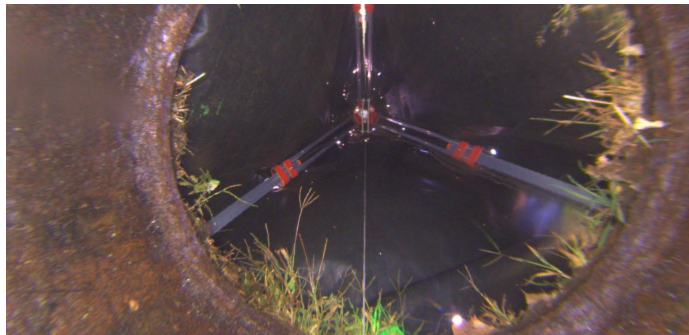
Code: **MGO**
Description: **General Observation**

Distance (ft): **.9**
Structural Grade: **0**
O&M Grade: **0**
Clock Start/From:
Clock To:
1st Value:
2nd Value:
Value Percent:
Step: **NO**
Remarks: **underside of frame**

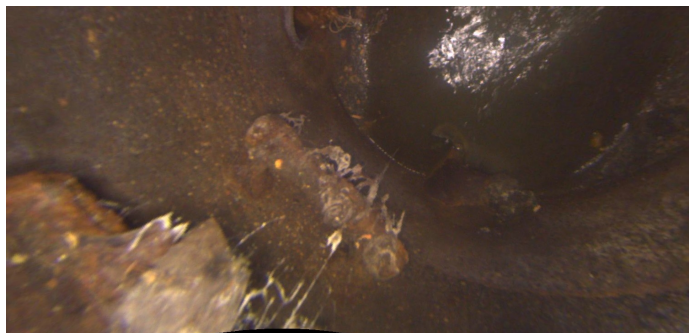
Code: **DAR**
Description: **Deposits Attached Ragging**

Distance (ft): **.9**
Structural Grade: **0**
O&M Grade: **2**
Clock Start/From: **8**
Clock To:
1st Value:
2nd Value:
Value Percent: **5.000**
Step: **YES**
Remarks:

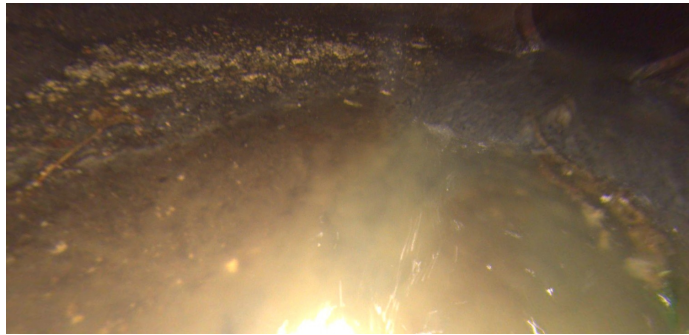
Code: **SAV**
Description: **Surface Aggregate Visible**

Distance (ft): **3.7**
Structural Grade: **3**
O&M Grade: **0**
Clock Start/From: **12**
Clock To: **12**
1st Value:
2nd Value:
Value Percent:
Step: **NO**
Remarks:

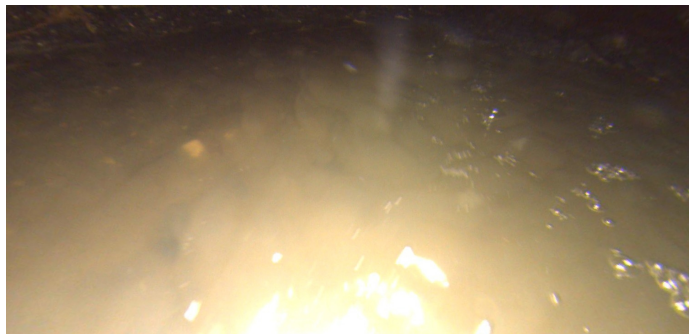
Code: **SAV**
Description: **Surface Aggregate Visible**

Distance (ft): **4.0**
Structural Grade: **3**
O&M Grade: **0**
Clock Start/From: **12**
Clock To: **12**
1st Value:
2nd Value:
Value Percent:
Step: **NO**
Remarks:

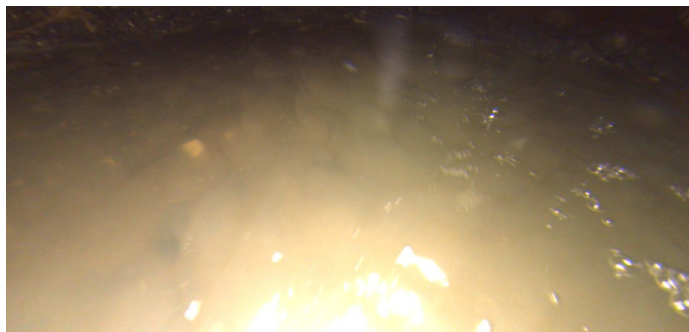
Code: **MGO**
Description: **General Observation**

Distance (ft): **4.0**
Structural Grade: **0**
O&M Grade: **0**
Clock Start/From:
Clock To:
1st Value:
2nd Value:
Value Percent:
Step: **NO**
Remarks: **end of survey**
