Manhole Inspection Report

Date:	10/06/2022	Weather:		Coding:	RZMACP
MH#:	M-503-074	Owner:	NA	Len. Surveyed:	11.6
P.O.#:		Surveyor:	Jen Costello	Rim to Invert:	12.9
Customer:		Cert. #:	U-907-5518	Wall Material:	Concrete (cast in place)

Street:	Intersection of Colorado St. and 38t	Project:	Hobart, IN
City:	Hobart, IN	GPS Northing:	2295162.961
Location:	Other	GPS Easting:	2900428.895
Drain Area:	Northwest	GPS Accuracy:	Sub-Meter
Cover Shape:	Circular	Evidence of Surcharge:	No
Cover Size:	24.0	Potential for Runoff:	None
Comments:

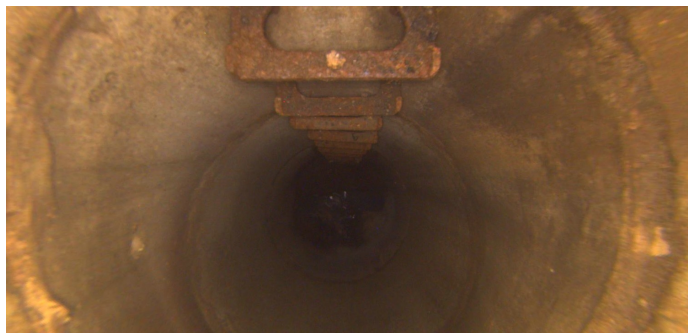
Code: **MGO**
Description: **General Observation**

Distance (ft): **.0**
Structural Grade: **0**
O&M Grade: **0**
Clock Start/From:
Clock To:
1st Value:
2nd Value:
Value Percent:
Step: **NO**
Remarks: **access mh**

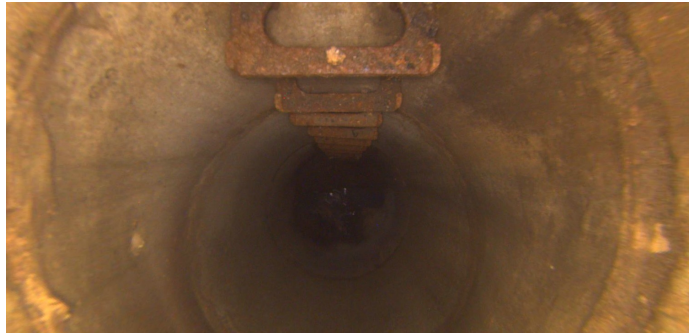
Code:	SRI
Description:	Surface Roughness Increased
Distance (ft):	.0
Structural Grade:	1
O&M Grade:	0
Clock Start/From:	12
Clock To:	12
1st Value:	
2nd Value:	
Value Percent:	
Step:	NO
Remarks:

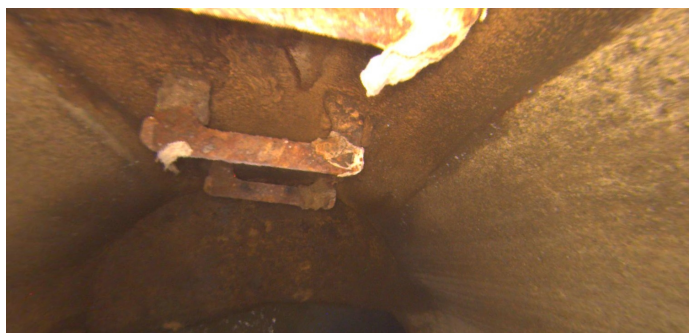
Code:	IW
Description:	Infil Weeper
Distance (ft):	8.0
Structural Grade:	0
O&M Grade:	2
Clock Start/From:	11
Clock To:	1
1st Value:	
2nd Value:	
Value Percent:	
Step:	NO
Remarks:
