Manhole Inspection Report

Date:	04/11/2018	Weather:		Coding:	RZMACP
MH#:	M-503-076	Owner:	NA	Len. Surveyed:	6.3
P.O.#:		Surveyor:	John Kuglmaier	Rim to Invert:	8.3
Customer:		Cert. #:	U-1215-07002349	Wall Material:	Concrete (reinforced)

Street:	383' East of Guyer St. 165' North of	Project:	Hobart, IN
City:	Hobart, IN	GPS Northing:	2900067.656
Location:		GPS Easting:	2900067.656
Drain Area:	Northwest	GPS Accuracy:	Sub-Meter
Cover Shape:	Circular	Evidence of Surcharge:	No
Cover Size:	23.0	Potential for Runoff:	None
Comments:

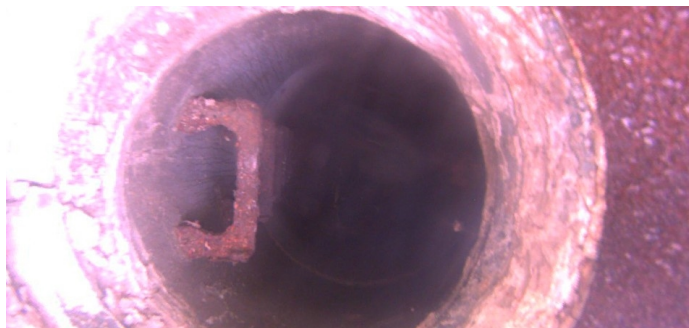
Code: **MGP**
Description: **General Photo**

Distance (ft): **.0**
Structural Grade: **0**
O&M Grade: **0**
Clock Start/From:
Clock To:
1st Value:
2nd Value:
Value Percent:
Step: **NO**
Remarks:

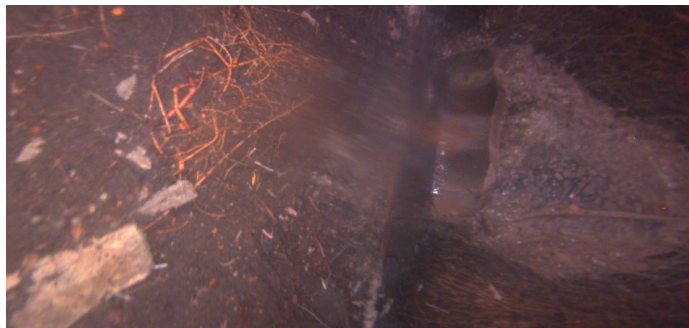
Code: **MGO**
Description: **General Observation**

Distance (ft): **5.8**
Structural Grade: **0**
O&M Grade: **0**
Clock Start/From:
Clock To:
1st Value:
2nd Value:
Value Percent:
Step: **NO**
Remarks: **Ins. Comp.**
