# Manhole Inspection Report

Date:	<b>04/08/2018</b>	Weather:		Coding:	<b>RZMACP</b>
MH#:	<b>M-503-077</b>	Owner:	<b>NA</b>	Len. Surveyed:	<b>6.8</b>
P.O.#:		Surveyor:	<b>John Kuglmaier</b>	Rim to Invert:	<b>8.1</b>
Customer:		Cert. #:	<b>U-1215-07002349</b>	Wall Material:	<b>Concrete (reinforced)</b>

Street:	<b>163' North of 38th Ave. 61' East of G</b>	Project:	<b>Hobart, IN</b>
City:	<b>Hobart, IN</b>	GPS Northing:	<b>2899746.222</b>
Location:		GPS Easting:	<b>2899746.222</b>
Drain Area:	<b>Northwest</b>	GPS Accuracy:	<b>Sub-Meter</b>
Cover Shape:	<b>Circular</b>	Evidence of Surcharge:	<b>No</b>
Cover Size:	<b>23.0</b>	Potential for Runoff:	<b>None</b>
Comments:

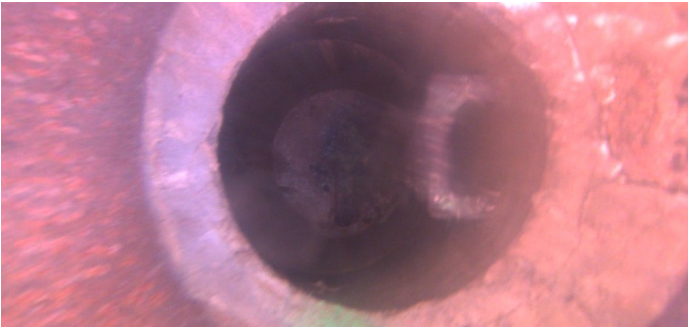
Code:

MGP

Description:

General Photo

Distance (ft):

.0

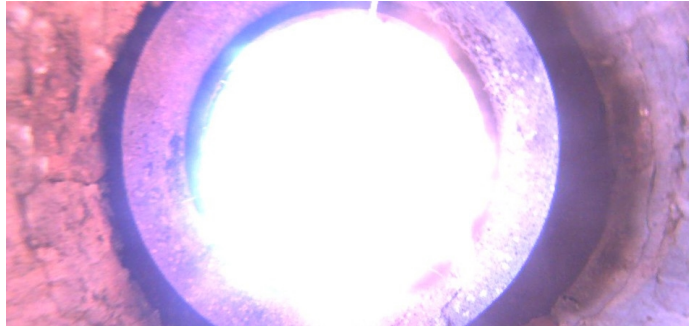
Code:	<b>MGP</b>
Description:	<b>General Photo</b>
Distance (ft):	<b>2.2</b>
Structural Grade:	<b>0</b>
O&M Grade:	<b>0</b>
Clock Start/From:	
Clock To:	
1st Value:	
2nd Value:	
Value Percent:	
Step:	<b>NO</b>
Remarks:

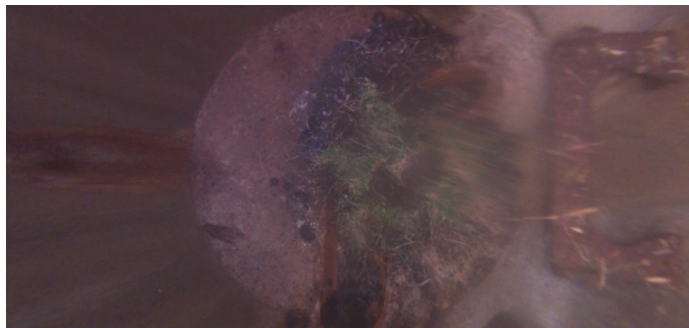
Code:	<b>DAZ</b>
Description:	<b>Deposits Attached Other</b>
Distance (ft):	<b>4.6</b>
Structural Grade:	<b>0</b>
O&M Grade:	<b>2</b>
Clock Start/From:	<b>12</b>
Clock To:	<b>12</b>
1st Value:	
2nd Value:	
Value Percent:	<b>10.000</b>
Step:	<b>NO</b>
Remarks:	<b>Mixed materials</b>

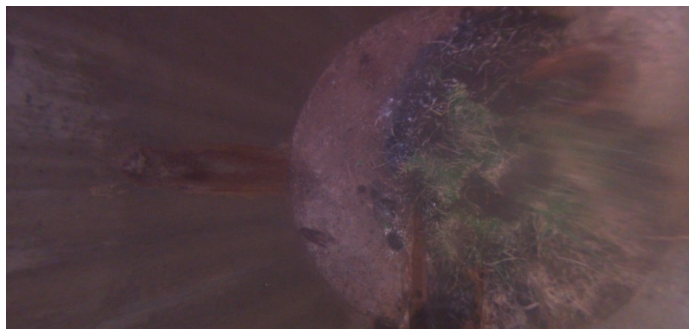
Code:	<b>IS</b>
Description:	<b>Infil Stain</b>
Distance (ft):	<b>4.6</b>
Structural Grade:	<b>0</b>
O&M Grade:	<b>0</b>
Clock Start/From:	<b>9</b>
Clock To:	
1st Value:	
2nd Value:	
Value Percent:	
Step:	<b>NO</b>
Remarks:

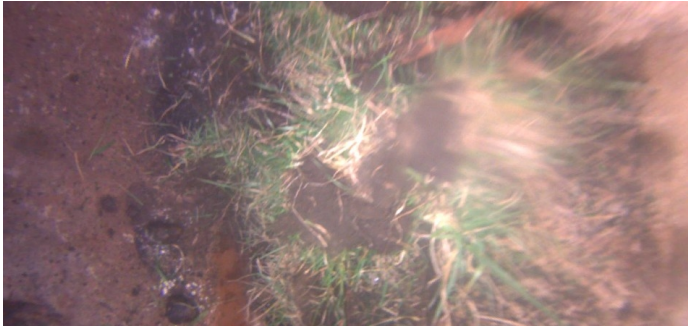
Code:	<b>MGO</b>
Description:	<b>General Observation</b>
Distance (ft):	<b>6.4</b>
Structural Grade:	<b>0</b>
O&M Grade:	<b>0</b>
Clock Start/From:	
Clock To:	
1st Value:	
2nd Value:	
Value Percent:	
Step:	<b>NO</b>
Remarks:	<b>Ins. Comp.</b>
