Manhole Inspection Report

Date:	03/30/2018	Weather:		Coding:	RZMACP
MH#:	M-503-079	Owner:	NA	Len. Surveyed:	8.2
P.O.#:		Surveyor:	John Kuglmaier	Rim to Invert:	10.0
Customer:		Cert. #:	U-1215-07002349	Wall Material:	Concrete (reinforced)

Street:	237' West of Colorado St. 158' North	Project:	Hobart, IN
City:	Hobart, IN	GPS Northing:	0.0
Location:		GPS Easting:	0.0
Drain Area:	Northwest	GPS Accuracy:	Nearest Meter
Cover Shape:	Circular	Evidence of Surcharge:	Yes
Cover Size:	23.0	Potential for Runoff:	None
Comments:

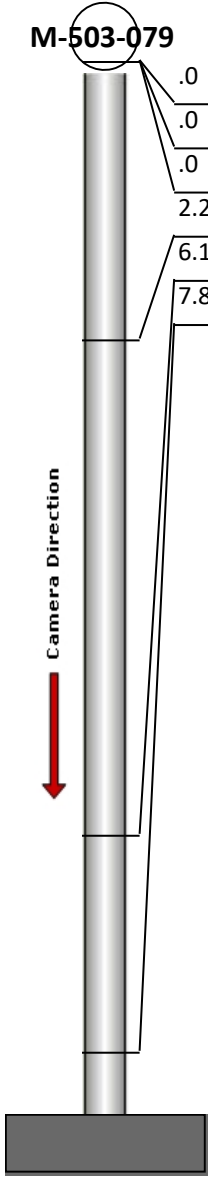
Position	Code	Observation	Video (sec)	Grade

.0	MGP	General Photo	10	NA
	.0	CS	Crack Spiral	22	S 2
	.0	CS	Crack Spiral	33	S 2
	2.2	MGP	General Photo	52	NA
	6.1	DAZ	Deposits Attached Other	74	M 2
	7.8	MGO	General Observation	89	NA

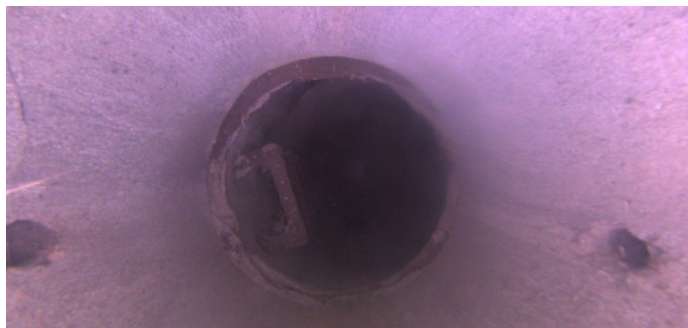
Code: **MGP**
Description: **General Photo**

Distance (ft): **.0**
Structural Grade: **0**
O&M Grade: **0**
Clock Start/From:
Clock To:
1st Value:
2nd Value:
Value Percent:
Step: **NO**
Remarks:

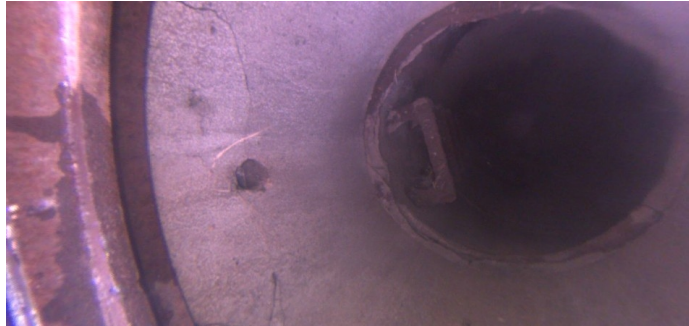
Code: **CS**
Description: **Crack Spiral**

Distance (ft): **.0**
Structural Grade: **2**
O&M Grade: **0**
Clock Start/From: **7**
Clock To: **10**
1st Value:
2nd Value:
Value Percent:
Step: **NO**
Remarks:

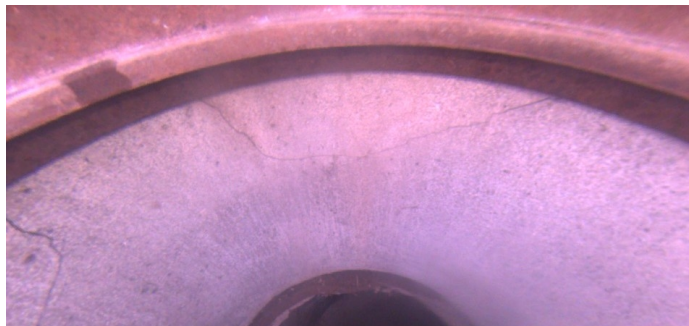
Code: **CS**
Description: **Crack Spiral**

Distance (ft): **.0**
Structural Grade: **2**
O&M Grade: **0**
Clock Start/From: **11**
Clock To: **1**
1st Value:
2nd Value:
Value Percent:
Step: **NO**
Remarks:

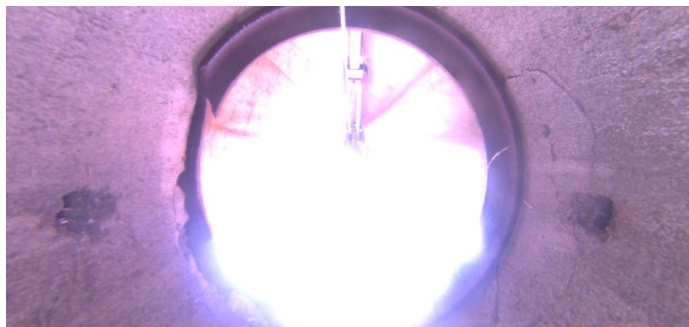
Code: **MGP**
Description: **General Photo**

Distance (ft): **2.2**
Structural Grade: **0**
O&M Grade: **0**
Clock Start/From:
Clock To:
1st Value:
2nd Value:
Value Percent:
Step: **NO**
Remarks:

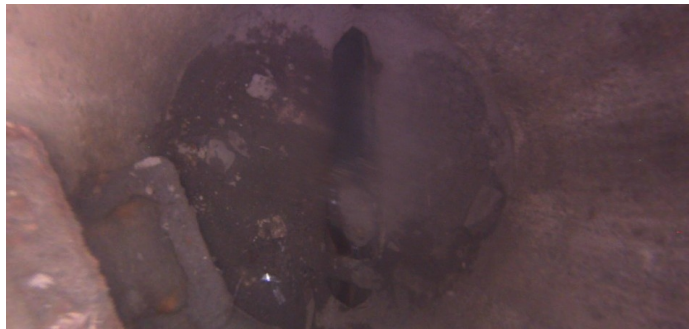
Code:	DAZ
Description:	Deposits Attached Other
Distance (ft):	6.1
Structural Grade:	0
O&M Grade:	2
Clock Start/From:	12
Clock To:	12
1st Value:	
2nd Value:	
Value Percent:	10.000
Step:	NO
Remarks:	Mixed materials

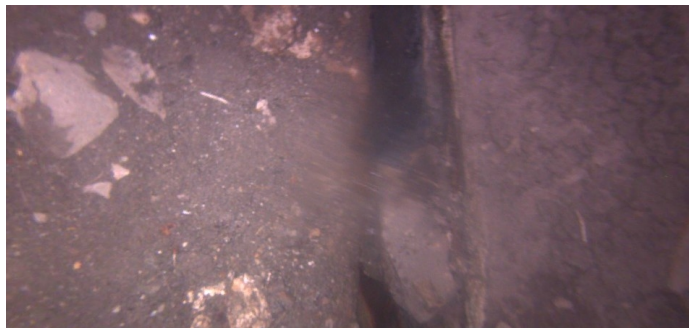
Code:	MGO
Description:	General Observation
Distance (ft):	7.8
Structural Grade:	0
O&M Grade:	0
Clock Start/From:	
Clock To:	
1st Value:	
2nd Value:	
Value Percent:	
Step:	NO
Remarks:	Ins. Comp.
