# Manhole Inspection Report

Date:	<b>03/30/2018</b>	Weather:		Coding:	<b>RZMACP</b>
MH#:	<b>M-503-081</b>	Owner:	<b>NA</b>	Len. Surveyed:	<b>6.8</b>
P.O.#:		Surveyor:	<b>John Kuglmaier</b>	Rim to Invert:	<b>8.3</b>
Customer:		Cert. #:	<b>U-1215-07002349</b>	Wall Material:	<b>Concrete (reinforced)</b>

Street:	<b>Guyer St. and Route 6. to the South</b>	Project:	<b>Hobart, IN</b>
City:	<b>Hobart, IN</b>	GPS Northing:	<b>0.0</b>
Location:		GPS Easting:	<b>0.0</b>
Drain Area:	<b>Northwest</b>	GPS Accuracy:	<b>Nearest Meter</b>
Cover Shape:	<b>Circular</b>	Evidence of Surcharge:	<b>No</b>
Cover Size:	<b>23.0</b>	Potential for Runoff:	<b>None</b>
Comments:

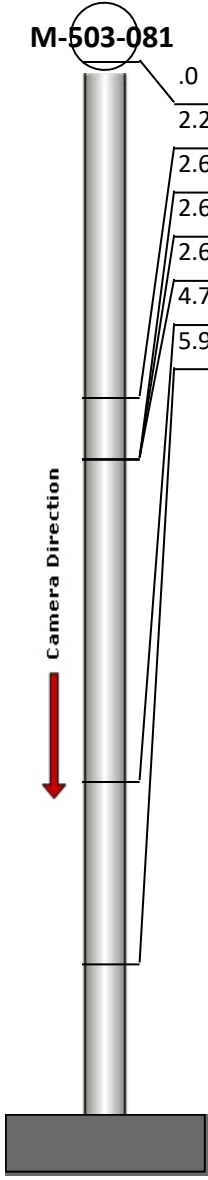
.0	MGP	General Photo	10	NA
	2.2	MGP	General Photo	28	NA
	2.6	IS	Infil Stain	43	NA
	2.6	IS	Infil Stain	54	NA
	2.6	IS	Infil Stain	66	NA
	4.7	DSF	Deposits Settled Fine	81	M 2
	5.9	MGO	General Observation	95	NA

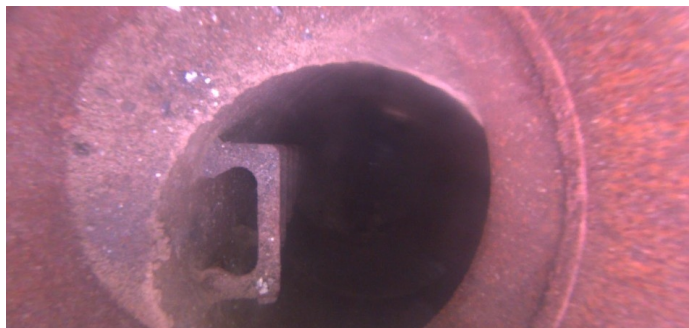
Code: **MGP**  
Description: **General Photo**

Distance (ft): **.0**  
Structural Grade: **0**  
O&M Grade: **0**  
Clock Start/From:  
Clock To:  
1st Value:  
2nd Value:  
Value Percent:  
Step: **NO**  
Remarks:

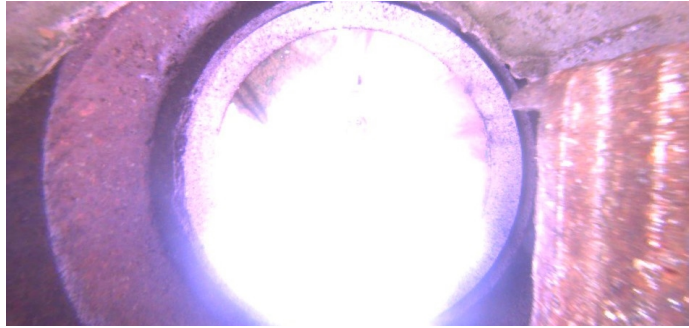
Code: **MGP**  
Description: **General Photo**

Distance (ft): **2.2**  
Structural Grade: **0**  
O&M Grade: **0**  
Clock Start/From:  
Clock To:  
1st Value:  
2nd Value:  
Value Percent:  
Step: **NO**  
Remarks:

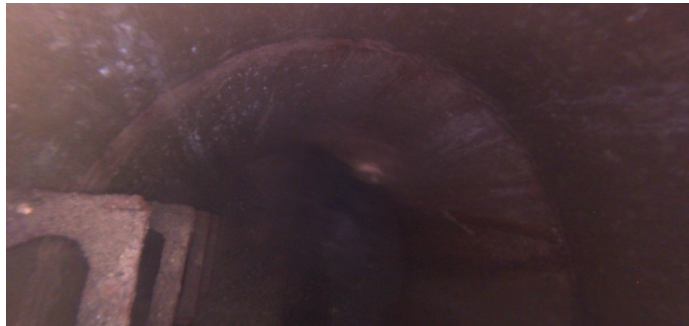
Code: **IS**  
Description: **Infil Stain**

Distance (ft): **2.6**  
Structural Grade: **0**  
O&M Grade: **0**  
Clock Start/From: **1**  
Clock To: **2**  
1st Value:  
2nd Value:  
Value Percent:  
Step: **NO**  
Remarks:

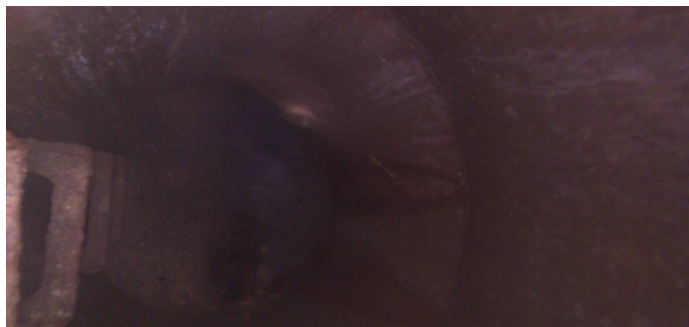
Code: **IS**  
Description: **Infil Stain**

Distance (ft): **2.6**  
Structural Grade: **0**  
O&M Grade: **0**  
Clock Start/From: **3**  
Clock To:  
1st Value:  
2nd Value:  
Value Percent:  
Step: **NO**  
Remarks:

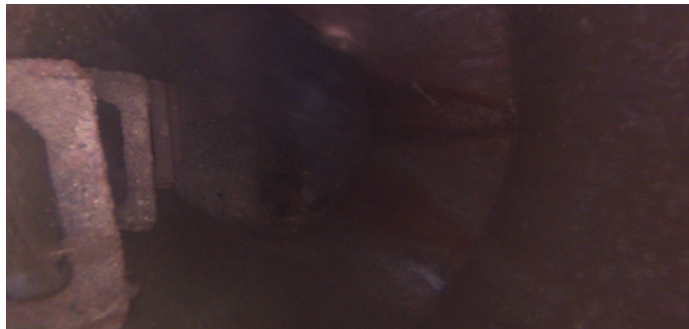
Code: **IS**  
Description: **Infil Stain**

Distance (ft): **2.6**  
Structural Grade: **0**  
O&M Grade: **0**  
Clock Start/From: **4**  
Clock To:  
1st Value:  
2nd Value:  
Value Percent:  
Step: **NO**  
Remarks:

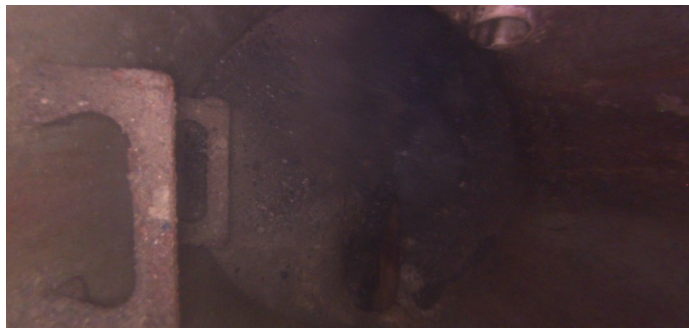
Code: **DSF**  
Description: **Deposits Settled Fine**

Distance (ft): **4.7**  
Structural Grade: **0**  
O&M Grade: **2**  
Clock Start/From: **12**  
Clock To: **12**  
1st Value:  
2nd Value:  
Value Percent: **5.000**  
Step: **NO**  
Remarks:

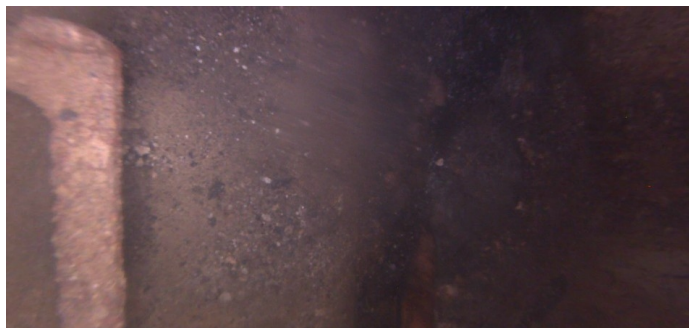
Code: **MGO**  
Description: **General Observation**

Distance (ft): **5.9**  
Structural Grade: **0**  
O&M Grade: **0**  
Clock Start/From:  
Clock To:  
1st Value:  
2nd Value:  
Value Percent:  
Step: **NO**  
Remarks: **Ins. Comp.**
