Manhole Inspection Report

Date:	10/06/2022	Weather:		Coding:	RZMACP
MH#:	M-503-082	Owner:	NA	Len. Surveyed:	10.4
P.O.#:		Surveyor:	Todd Machine	Rim to Invert:	11.7
Customer:		Cert. #:	P0038859-082022	Wall Material:	Concrete (cast in place)

Street:	Guyer St. and 38th Pl. to the West.	Project:	Hobart, IN
City:	Hobart, IN	GPS Northing:	2294919.792
Location:	Other	GPS Easting:	2899513.057
Drain Area:	Northwest	GPS Accuracy:	Sub-Meter
Cover Shape:	Circular	Evidence of Surcharge:	Yes
Cover Size:	24.0	Potential for Runoff:	None
Comments:

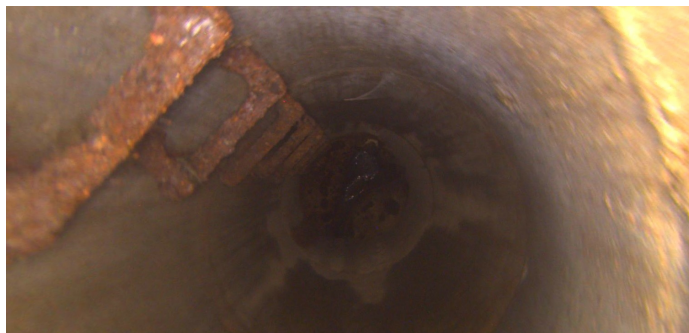
Code: **MGO**
Description: **General Observation**

Distance (ft): **.0**
Structural Grade: **0**
O&M Grade: **0**
Clock Start/From:
Clock To:
1st Value:
2nd Value:
Value Percent:
Step: **NO**
Remarks: **access mh**

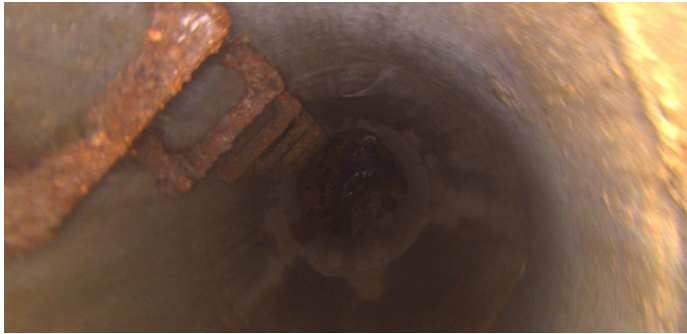
Code:	SRI
Description:	Surface Roughness Increased
Distance (ft):	.0
Structural Grade:	1
O&M Grade:	0
Clock Start/From:	12
Clock To:	12
1st Value:	
2nd Value:	
Value Percent:	
Step:	NO
Remarks:

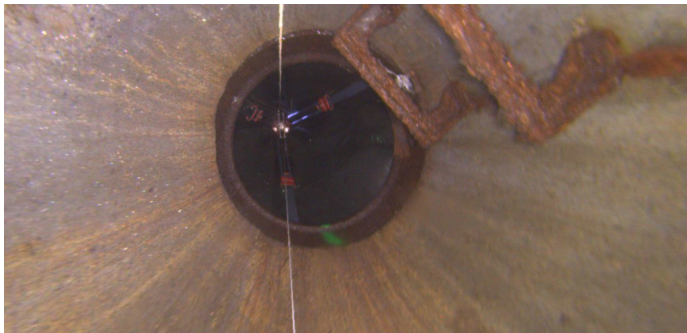
Code:	MGO
Description:	General Observation
Distance (ft):	3.1
Structural Grade:	0
O&M Grade:	0
Clock Start/From:	
Clock To:	
1st Value:	
2nd Value:	
Value Percent:	
Step:	NO
Remarks:	underside of frame

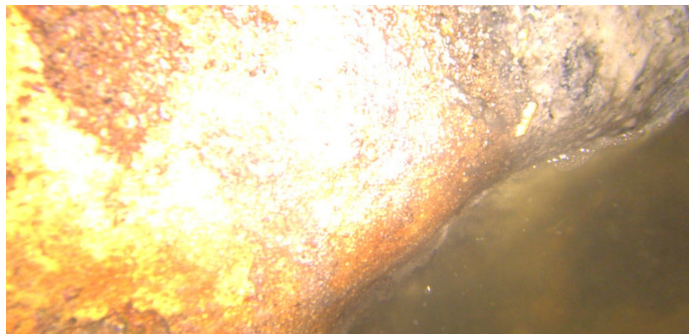
Code: **SRI**
Description: **Surface Roughness Increased**

Distance (ft): **10.4**
Structural Grade: **1**
O&M Grade: **0**
Clock Start/From: **3**
Clock To: **9**
1st Value:
2nd Value:
Value Percent:
Step: **NO**
Remarks:

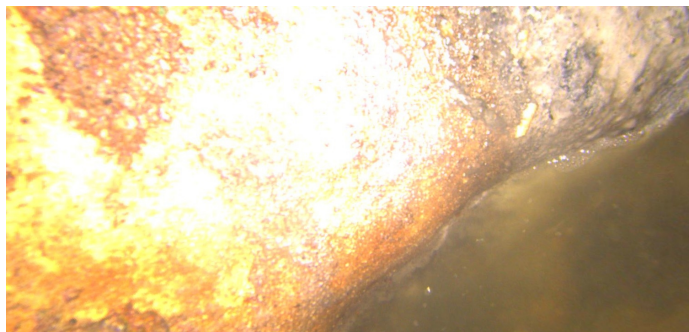
Code: **SRI**
Description: **Surface Roughness Increased**

Distance (ft): **10.4**
Structural Grade: **1**
O&M Grade: **0**
Clock Start/From: **12**
Clock To: **12**
1st Value:
2nd Value:
Value Percent:
Step: **NO**
Remarks:

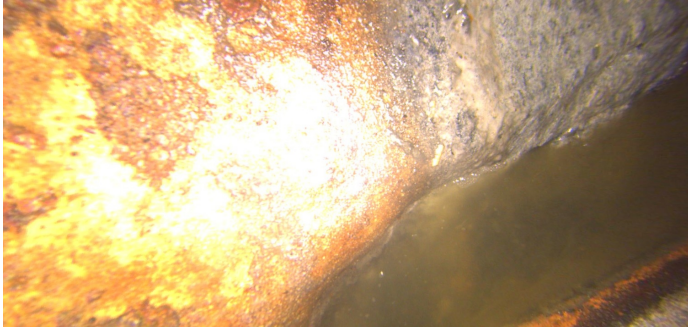
Code:	MGO
Description:	General Observation
Distance (ft):	10.4
Structural Grade:	0
O&M Grade:	0
Clock Start/From:	
Clock To:	
1st Value:	
2nd Value:	
Value Percent:	
Step:	NO
Remarks:	End Of Survey
